Mid-July 2017, Volume 19, No. 14

Driver Assistance Systems Gain Popularity on GM Models

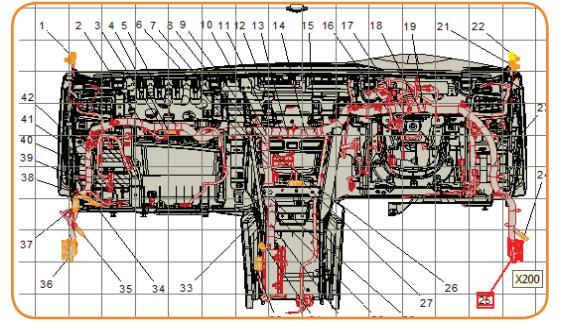
Connector X200

I-Shaft to Body Harness Contact

Wire damage may occur due to body harness contact with the steering intermediate shaft.

Repair the harness as

necessary. Move and secure the harness away from the intermediate shaft.

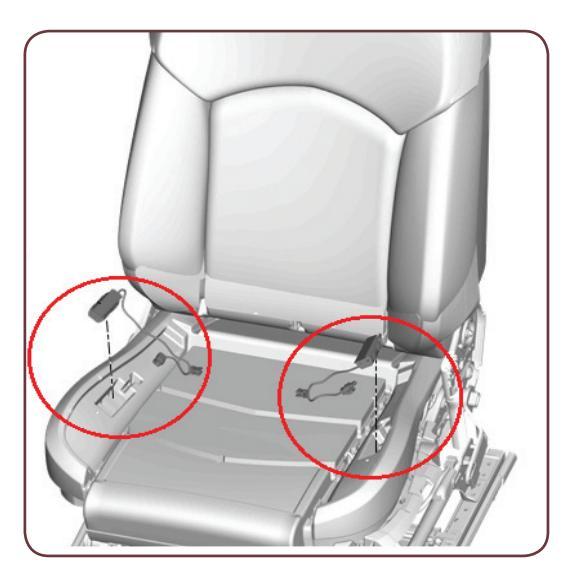
Haptic signal motors are located on either side of the driver's seat cushion.

Always check for any set DTCs (B172E – Driver Seat Cushion Left Rear Haptic Alert Motor Control Circuit; B172F – Driver Seat Cushion Right Rear Haptic Alert Motor Control Circuit) when diagnosing the Active Safety Seat. Do not replace the haptic signal motors unless diagnosis clearly points toward the motors as the cause of the condition. If there aren't any DTCs set, first check the Alert Type setting in the vehicle personalization menus.

If the haptic signal motors are to be replaced, remove the driver's seat cushion cover and pad to access the motors and electrical connectors.

Once the haptic signal motors are replaced, the Memory Seat Control Module should be cleared of any DTCs. It is not required to reflash or set up the module.

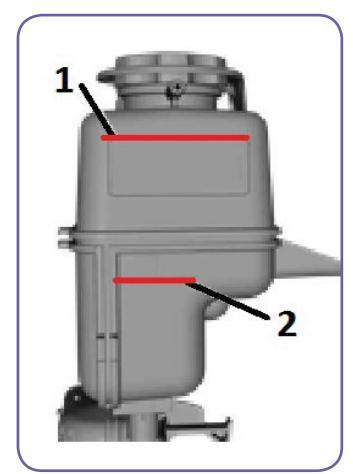
The coolant level in the reservoir should be between the top of the label (1) and the bottom of the low fill line (2).

underhood high voltage battery coolant reservoir. The coolant level should be between the top of the label (1) and the bottom of the low fill line (2). See illustration.

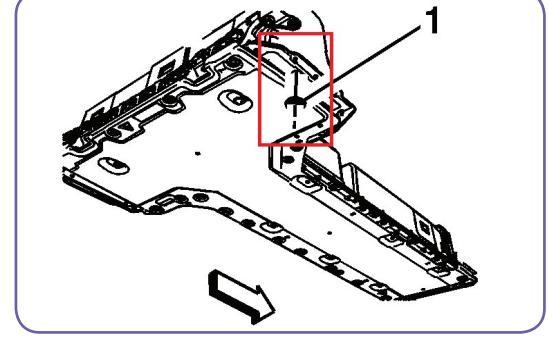
Also remove the drain plug for the battery pack to see if any water/ coolant drains out, indicating a coolant leak in the battery pack. Refer to PIC5920G for more information.

High voltage battery pack coolant rubber inspection plug (1)

inside the high voltage battery pack, the entire pack will need to be replaced. This is a very rare condition. Contact the GM Technical Assistance Center if any moisture is found during the drain plug inspection. The battery pack is currently on restriction.
