Confirm Correct Labor Codes with New Warranty Job Aid Tool

Duramax Diesel Cooling System Pressure Test Adapter

Camaro Rear Axle Moan

Proper Coolant Level on the 6.6L Duramax Diesel Engine

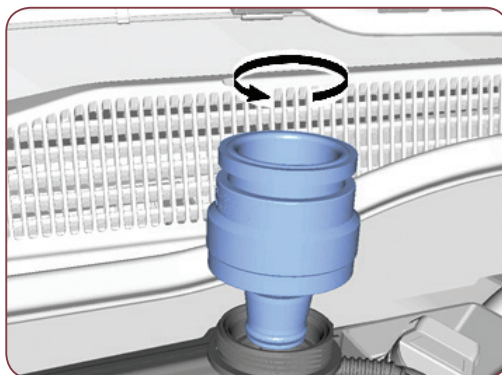
The GE-52098-A adapter has two seals and an extended component that close off the vent chamber portion of the surge tank. Without these two seals, the adapter cannot properly evacuate the cooling system because air will leak back in from the atmosphere vent cap on the side of the radiator surge tank.

The GE-52098-A adapter installs onto the surge tank.

When draining and filling the Duramax diesel (L5P) cooling system, only the GE-52098-A pressure test adapter should be used. Do not use an aftermarket adapter not designed for this application.

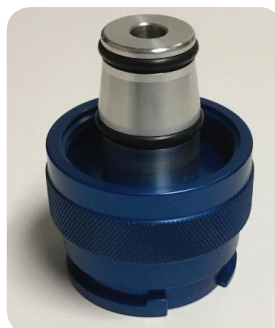
In some cases, instead of installing the GE-52098-A Cooling System Pressure Test Adapter on the radiator surge tank, an aftermarket pressure test adapter is being used instead that is not designed for evacuating and filling the cooling system. The adapter is a left-hand adapter that threads onto the top of the surge tank.

An aftermarket adapter not designed for this application that doesn't have these seals cannot isolate the vent chamber and the atmosphere vent cap because it does not reach down to the lower sealing area for the cap. As a result, it pulls vacuum against the vent cap. Without a proper vacuum on the system, it will not fill correctly, and air in the cooling system can cause engine damage.

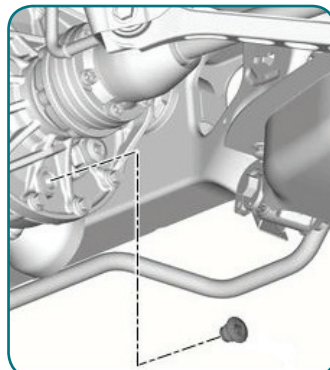
A moan sound may be heard from the rear of some 2016-2017 Camaro models while making a turn when the vehicle is cold or has sat for several hours. The sound usually is not noticeable after the vehicle has warmed up.

The moan sound may be caused by a slip/stick of the posi-traction clutch plates. If the sound is validated after driving the vehicle, replace the rear differential axle lubricant. The correct lubricant is critical for proper operation. Refer to the specifications in the appropriate Service Information. The correct lubricant is based on the engine/transmission components in the vehicle.

Rear differential axle drain plug

After replacing the rear differential axle lubricant, bring the gear lube up to operating temperature and perform multiple figure eight or lock steer turning maneuvers to work the gear lube into the clutch pack.

Allow the vehicle to cool back to ambient temperature and reevaluate the clutch moan sound. If the sound is still present, replace the rear differential axle lubricant and perform the steering maneuvers again. This sequence may need to be repeated several times to reduce or eliminate the moan sound. Be sure that the axle lubricant is brought up to operating temperature before each drain/fill.

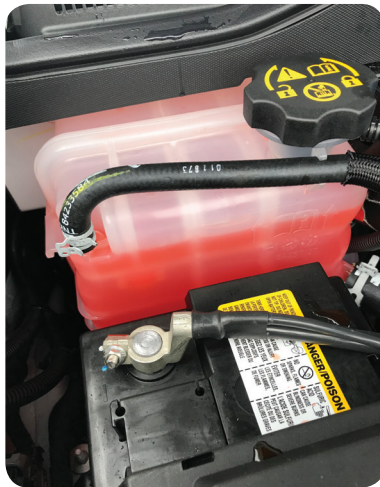
The low coolant level in the radiator surge tank may be due to the fill process at the assembly plant, which cannot purge all of the air from the cooling system and the surge tank. After the engine has been thermally cycled, air rises and causes the coolant to become lower than when initially filled.

During a Pre-Delivery Inspection (PDI), the coolant level may appear low, but is at a level high enough to keep the Low Coolant message off.

Coolant level at PDI. Coolant should be added to the surge tank when coolant is at this level.

During PDI, coolant should be added to fill the upper chamber of the radiator surge tank.

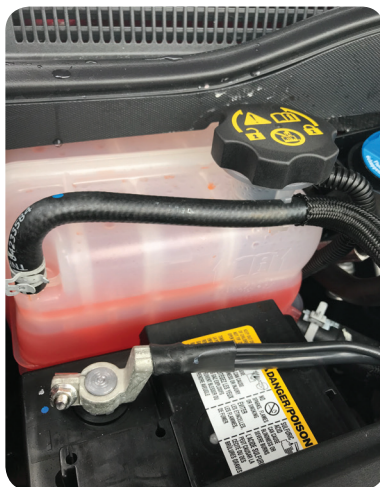
A coolant level that is low enough to turn on the Low Coolant message will be below the horizontal line

Low coolant level that will turn on the Low Coolant message.

across the radiator surge tank. The horizontal line is a baffle inside the surge tank that keeps the coolant from sloshing inside the tank and tripping the coolant level sensor, which is located below the baffle.

If a low coolant level is found, add one quart (0.946 liter) of Dex-Cool® coolant to the upper chamber of the coolant surge tank in order to bring the level up to the bottom of the surge tank fill neck.

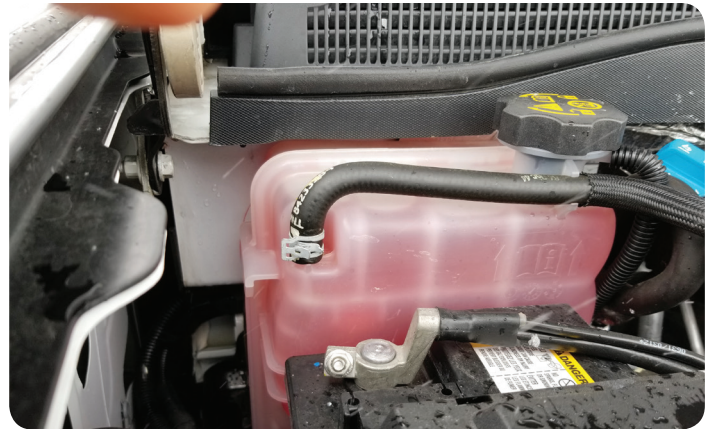
A full coolant level in the surge tank.

A full coolant level will show the coolant at the bottom of the radiator surge tank fill neck.
