Preventing an Inadvertent Airbag Deployment

Preventing an Inadvertent Airbag Deployment
Latest GDS2 Core Software Updates VIN Field
Install API Manager Message Displayed After Radio Replacement
Repair for Suspension Leans to the Left Condition
Updated Battery Part Numbers and CCA Chart
Recovery of Failed USB Radio Programming 6
Service Know-How6

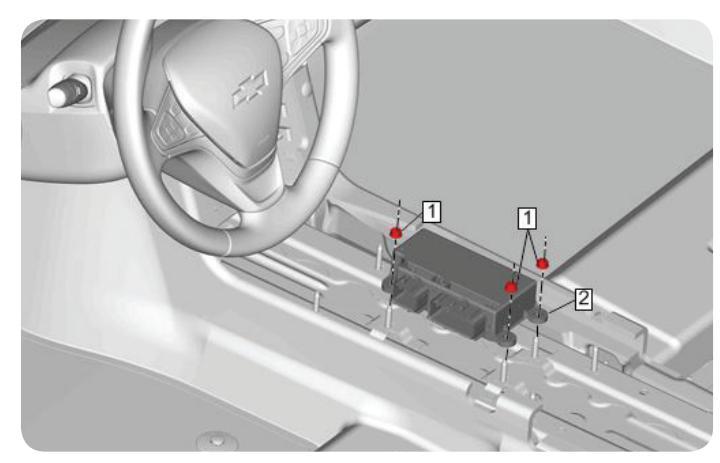
Sensing and Diagnostic Module

over while under power may result in airbag deployment. If the unbolted module is picked up or tilted, and the system is powered, the SDM may see this as a rollover event and the system will respond accordingly. In addition, do not strike or jolt the SDM, which may also be interpreted as a rollover or collision.

The SDM also maintains a reserved energy supply that provides deployment power for the air bags if the module loses battery power during a collision. Deployment power is available for as much as 2 minutes after disconnecting the vehicle power. Wait 2 minutes before working on any SIR system after disabling the system to prevent deployment of the air bags from the reserved energy supply.

Because of the possibility of deployment, the SDM fasteners should not be removed until the battery is disconnected and the SDM electrical connector is removed. The fasteners should be reinstalled and torqued to the proper specifications before reattaching the SDM electrical connector. The electrical connector must be reattached before reconnecting the negative battery cable to the battery.

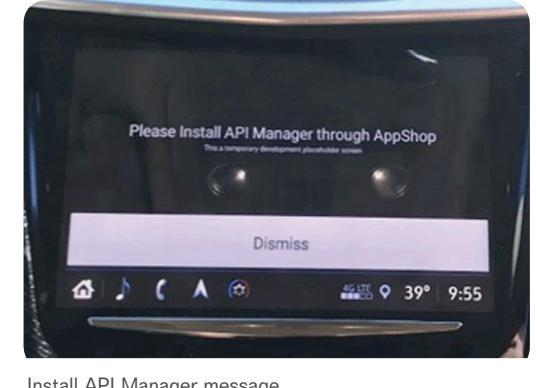
The Install **API** Manager message may occur if the radio reset procedure was not followed correctly prior to the removal of the radio. The Radio Replacement procedures in the Service Information have been updated.

Install API Manager message

If this message is displayed, reinstall the previously removed radio and then properly perform the radio reset procedure.

It also may be necessary to delete the app and download it again.

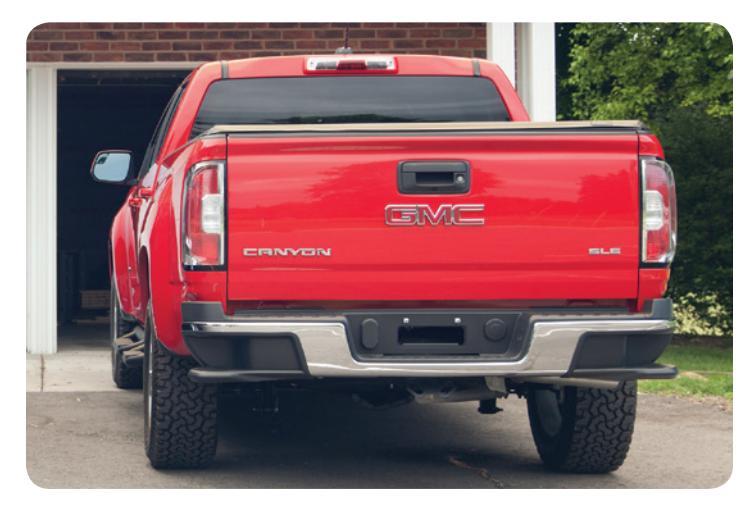
Some 2015-2018 Colorado and Canyon models may appear to be leaning slightly toward the left side due to the mass distribution of the vehicle.

If this condition is noticed, installing a shim on the rear left-side of the vehicle between the rear axle and the left-side leaf spring, or installing a shim on the rear left-side of the vehicle and a new front coil spring will adjust the suspension to correct the leaning appearance.

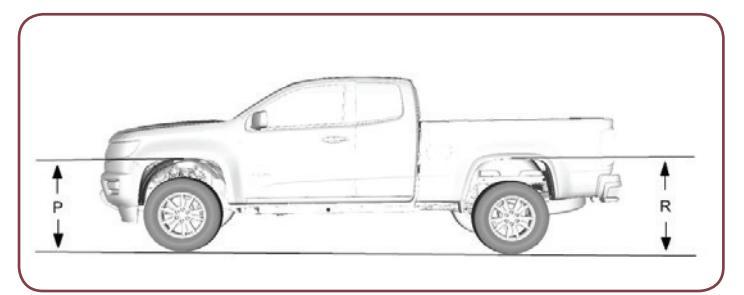
Measure the P and R trim heights from the top of the wheel opening to the ground.

- If the cross P height or cross R height (the difference between the left-side and right-side P height measurement or left-side and right-side R height measurement) is 12 mm (0.47 inches) or less, no repairs are necessary.
- If the cross P height measurement is 13 mm (0.5 inches) or more, install a shim and front coil spring.
- If the cross R height measurement is 13 mm (0.5 inches) or more, install a shim.

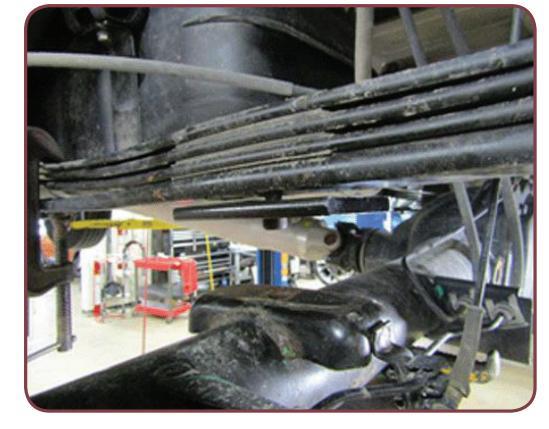
The shim slides under the spring.

The shim is installed between the leftrear leaf spring and the axle. Tension should be maintained on the leaf spring using a C-clamp on each end of the spring.

The shim slides under the spring and the bolt, up through the hole of the spring.

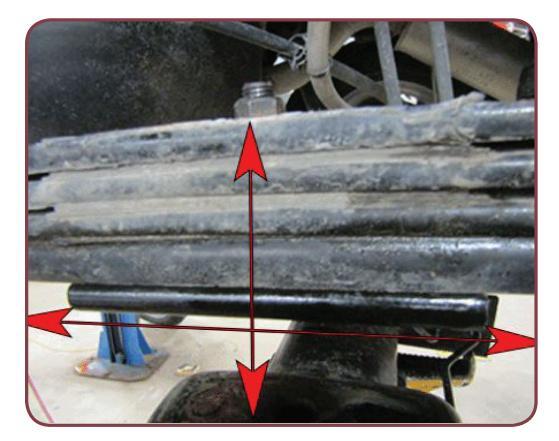
The shim should line up with the leaf spring.

The shim should line up with the leaf spring.

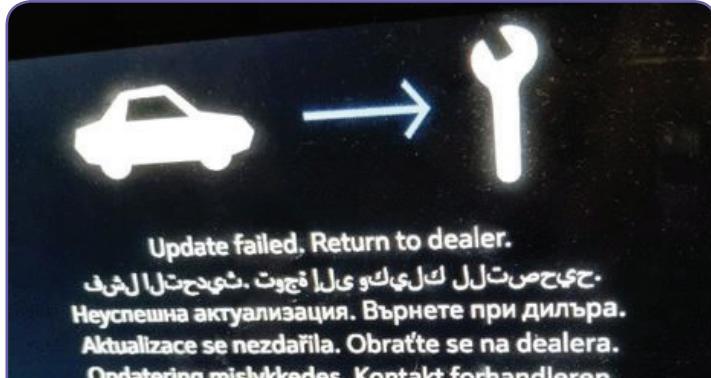
If an error occurs during USB radio programming on some 2017-2018 CTS; 2018 ATS, XTS and Terrain models equipped with infotainment system RPOs IOS, IOU or IOT, an "Update failed. Return to dealer." message may be displayed.

There are several reasons that this error message may be displayed. In most cases, the error message is the result of an issue with the USB thumb drive (or flash drive), or is due to improper use or operation of the USB thumb drive.

USB radio programming error message

If USB radio programming fails, remove and then reinstall the USB thumb drive in the vehicle's USB port. If the update status bar is displayed, allow the update to finish, which may take up to 18 minutes. If the update status bar does not appear, the source of the issue may be the contents of the USB thumb drive or the USB thumb drive itself.

Delete all files from the USB thumb drive and download the needed files again. Properly eject the USB thumb drive from the computer. Next, install the USB thumb drive and download the updated files to the vehicle. The update status bar should appear within 10 seconds.

If the update still does not start, try the programming again with a different high-quality USB 3.0 thumb drive. If the same image is displayed on the screen using a new 3.0 USB thumb drive, replace the radio.
