Mid-May 2018, Volume 20, No. 10

Super Cruise Update Provides Messaging Features

QR Code on Certification Label Offers More RPO Codes

Properly Connect Sensors during Air Distributor Case Replacement

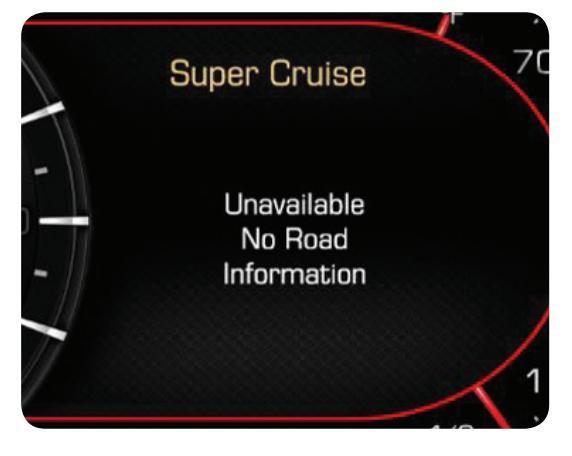
Super Cruise message displayed on the instrument cluster

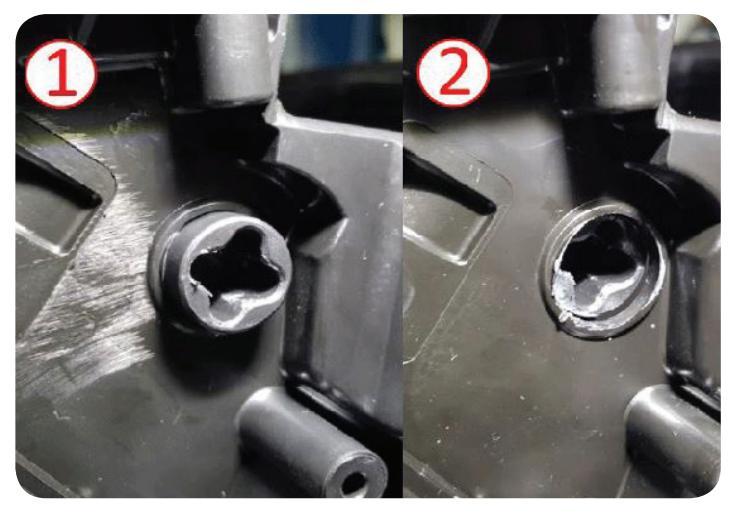
Some 2016-2017 Envision models may have warm air blowing through the rear HVAC vents when the air conditioning is commanded on. If this condition is found, the auxiliary temperature valve inside the A/C distributor case may be fractured, with the pivot for the temperature valve pulled away from the actuator motor.

Good temperature valve (1) and damaged temperature valve (2)

Verify the temperature valve is working properly. If the rear A/C vents are blowing warm air, replace the A/C distributor case. If the temperate valve is working correctly, refer to the appropriate Service Information to continue system diagnostics.

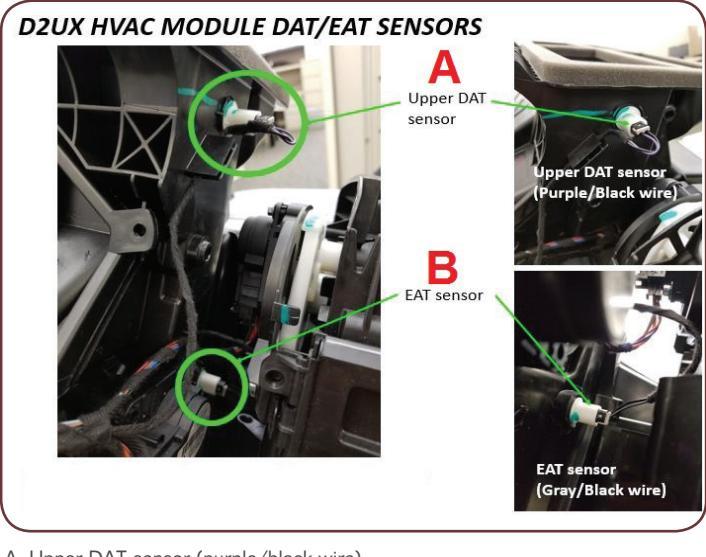
incorrectly connecting the replacement case. The wire harness length makes it possible for the temperature sensor connectors to be plugged into the wrong sensor. If the wires are connected to the wrong sensor, the passenger side vents may blow warm air.

The upper Duct Air Temperature (DAT) sensor has a purple/black wire. The Evaporator Air Temperature (EAT) sensor has a gray/ black wire. Confirm the wire color to ensure the wires are plugged into the correct location.

A. Upper DAT sensor (purple/black wire)

B. EAT sensor (gray/black wire)

When replacing the A/C distributor case, mark each of the temperature sensor wires and note their location prior to removal to avoid

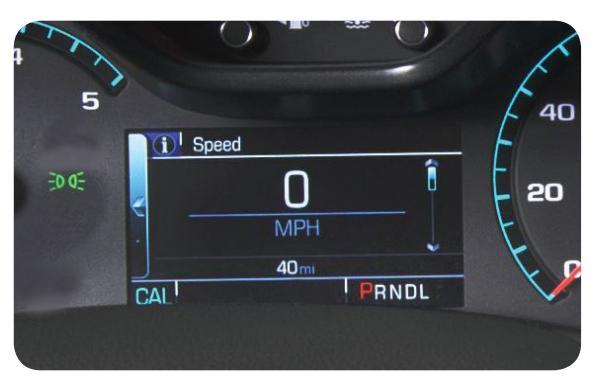
Digital speedometer display on the DIC

functionality was turned off for 2017 model year production vehicles, but some 2017 vehicles may have temporarily displayed the information before it permanently disappeared after a vehicle calibration update. The calibration update may have been performed for another repair.

If this speed limit icon and digital speedometer display condition is encountered, do not replace parts or attempt repairs as this feature is no longer available for 2017 model year vehicles.
