July 2019, Volume 21, No. 13

Re-Centering the Transmission Range Control Module

Pinched Instrument Panel Harness

Rough Idle After Engine Repairs

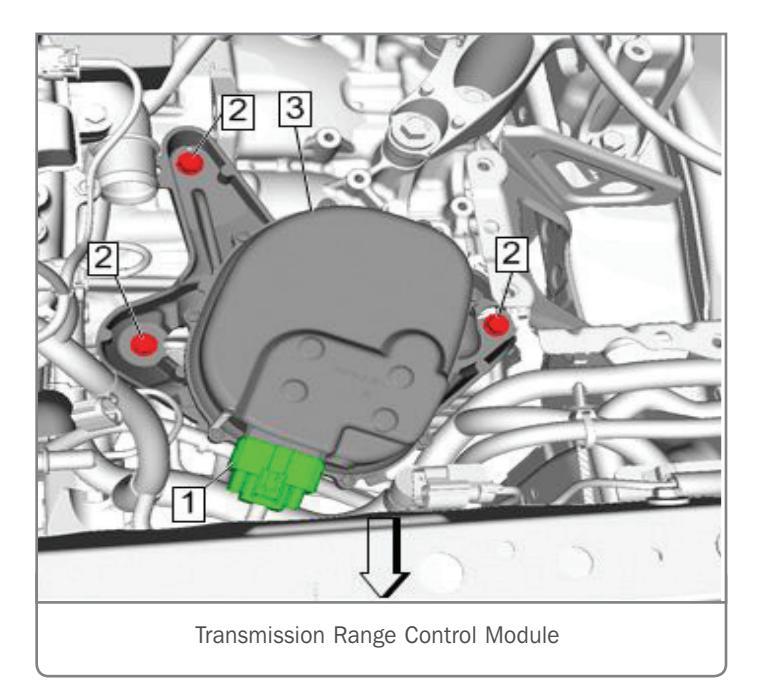
Some 2017-2019 XT5 and 2017 LaCrosse models may have a Service Transmission message displayed on the Driver Information Center along with one or more of the following DTCs: P0722, P0729, P0730, P0731, P0732, P0733, P0734, P0735, P073D, P073E, P07A2, P07E4, P07E5, and P1769. These conditions may be caused by misalignment of the coupler between the Transmission Range Control Module (TRCM) and the transmission. The TRCM will need to be re-centered.

Before re-centering the module, check the transmission fluid level. If the fluid is dark and has an overheated odor, any internal wear issues with the automatic transmission should be addressed.

Next, with the transmission in Park and the parking brake applied, perform the Backup Park Lock Actuator Disarming procedure.

With access to the TRCM, loosen (approximately 1/4 inch) the automatic transmission range selector actuator hardware module bolts.

Rotate the automatic transmission range selector actuator hardware module clockwise to the right lock position (blue line). Next, rotate the module counterclockwise to the left lock positon (green line). Finally, rotate the module clockwise until it is centered between both full lock positions (red line). **TIP:** The turning radius of the module will be very slight when centering.

Hold the module in place and tighten the hardware module bolts to prevent the actuator from moving from the center position. Tighten the bolts to specification.

With the module re-centered, perform the TRCM learn procedure (not for new modules). If the test fails, re-adjust the module and retest. The test fails again, refer to the appropriate Service Information for further diagnostics on the DTC set.

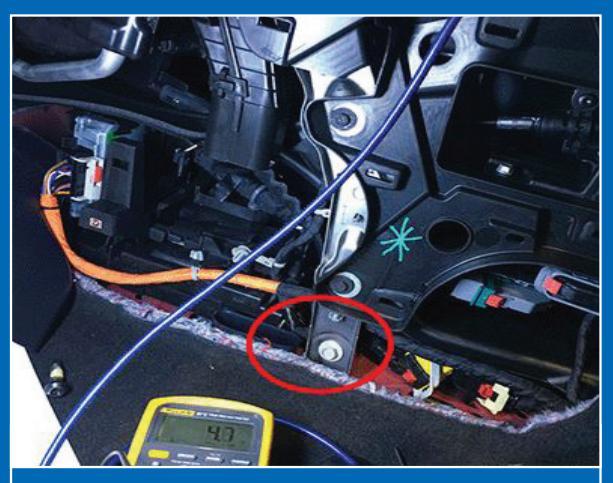
These conditions may be due to the instrument panel wiring harness being pinched behind the center console metal side brace on the left side of the console, resulting in a short condition. Remove the left side of the front floor console extension panel and inspect for the harness being pinched behind the vertical metal side brace.

Inspect for the harness being pinched behind the vertical metal side brace.

If the harness is pinched, repair the wiring as needed following the proper procedures in the appropriate Service Information. Ensure that the harness is not contacting the brake after making repairs.

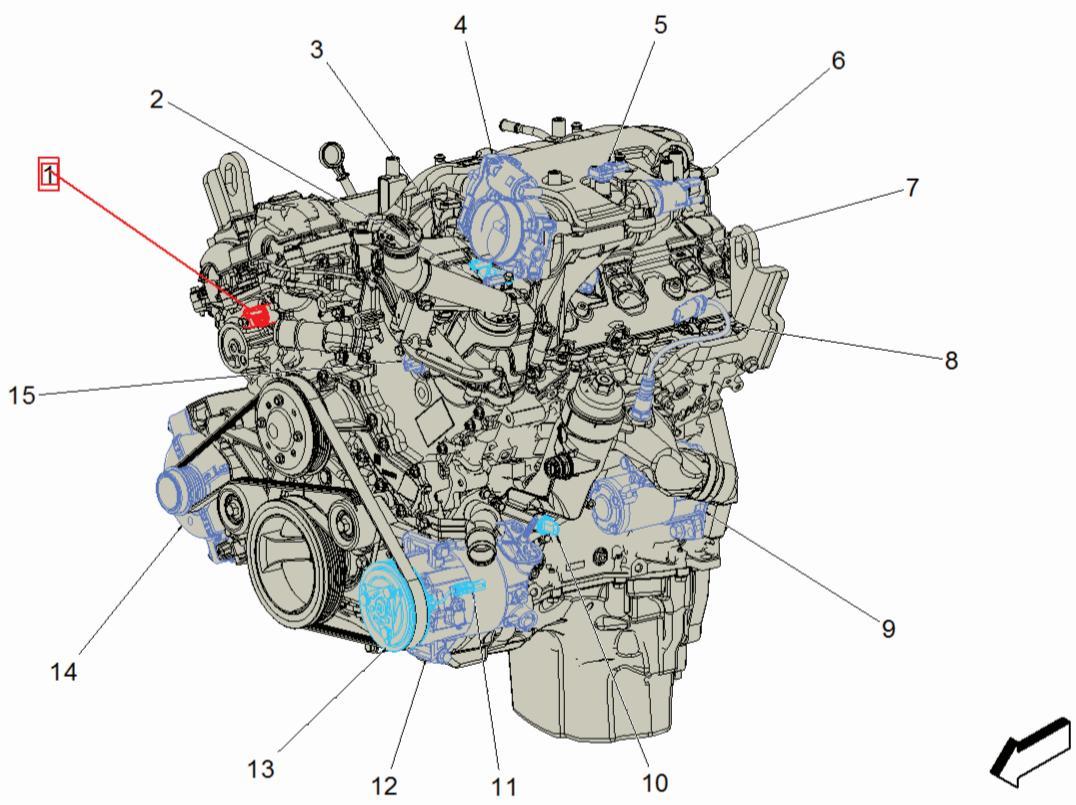
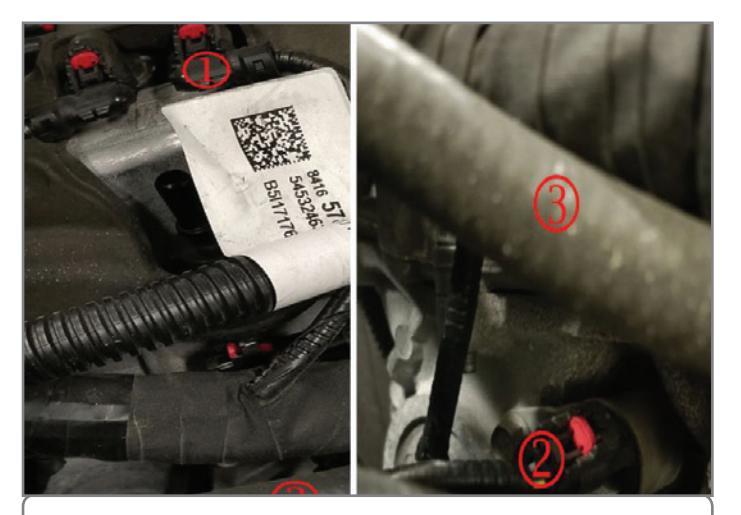
Connector for the Intake Actuator Park Lock Solenoid

The wiring connector for the Intake Camshaft Actuator Solenoid Bank 1 on top of the engine and the connector for the Intake Actuator Park Lock Solenoid in the front of the engine for bank 1 may have been swapped. These two connectors are identical and can only be identified by the wire color in the connector.

- 1. Bank 1 Intake Actuator Solenoid
- 2. Bank 1 Intake Park Lock Solenoid
- 3. Same hose in both photos shown for location

The Bank 1 Intake Actuator Solenoid connector and Bank 1 Park Lock Solenoid connector are shown in the photo, with the same hose identified to show location.

If these conditions are found, remove the connector and review the schematic in the appropriate Service Information to compare the wire colors. Verify that the correct connector is plugged into the actuator solenoid and lock solenoid.

If the connectors are incorrect, swap them back and clear the DTC to verify the repair. If the connectors are in the correct location, refer to the appropriate Service Information to continue diagnosis of DTC P0016.

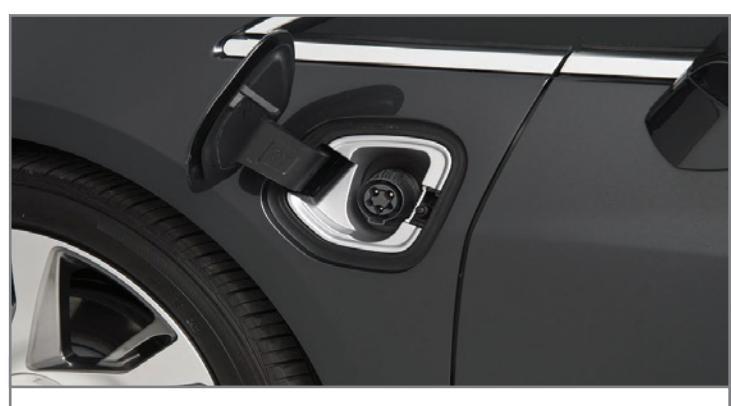
Battery charger receptacle

Some 2011-2015 Volt models and 2014-2016 ELR models may not shift out of Park. If this condition is present, there may be water intrusion in the X98 Hybrid/EV Battery Charger Receptacle, which may cause the vehicle to determine that the charging cord is plugged in. When the charging cord is plugged in, the vehicle will not shift out of Park.

- 1. Disable the high voltage system using SI Document ID 3610665
- 2. Unplug the charger receptacle and check if the vehicle now can be shifted out of Park.
- 3. If the condition is resolved, replace the Drive Motor Battery Charger Receptacle. Updated part numbers have been released.
