August 2019, Volume 21, No. 15

Super Cruise Increases Compatible Highway Network

Hydraulic Brake Conditions on Hybrid Vehicles Update

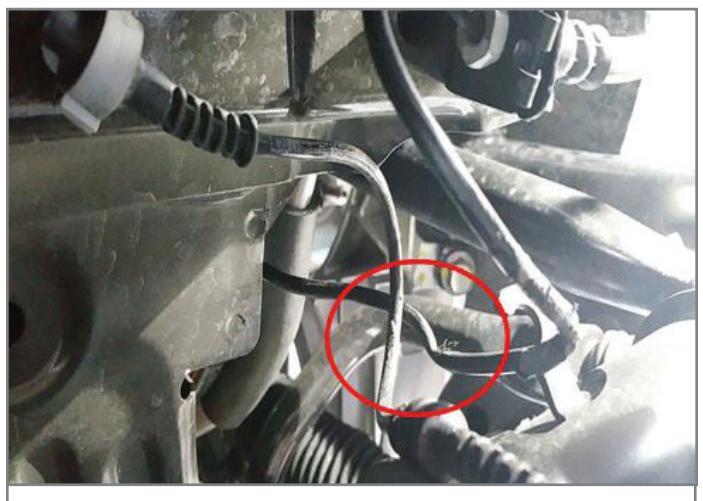
Misrouted Brake Line – A misrouted metal brake line may cause the line to kink, which would reduce the brake apply pressure to the wheel. DTC C05AD (Brake Blending System Performance) may set. This condition could occur if the misrouted line hits the shock tower when the wheel is turned. Repair the kinked metal brake line.

Misrouted front brake line

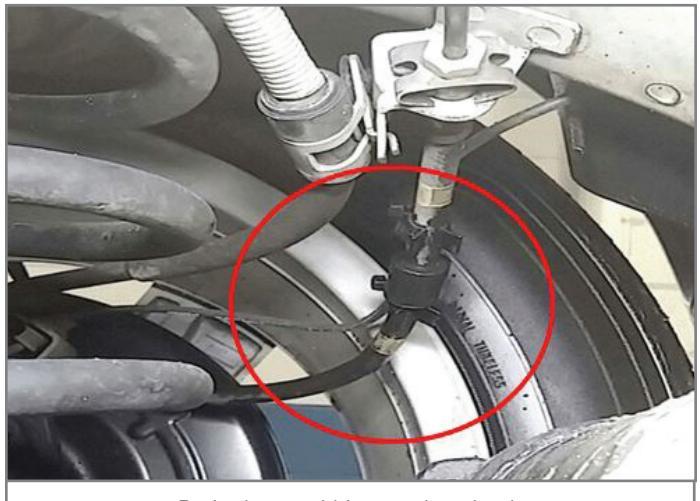
Worn Rubber Brake Hose – If the anti-rotation bracket is not seated into the retaining hole properly or the hose is not properly secured, the rubber brake hose could rub through on the front tire. DTCs C05AD, C0580 (Brake Pedal Position Sensor Performance) and/or P05FF (Brake Pressure Sensor and Brake Pedal Position Sensor Correlation) may set. This condition could lead to a loss of brake fluid. Replace and properly secure the brake hose.

Brake hose rubbing on the wheel

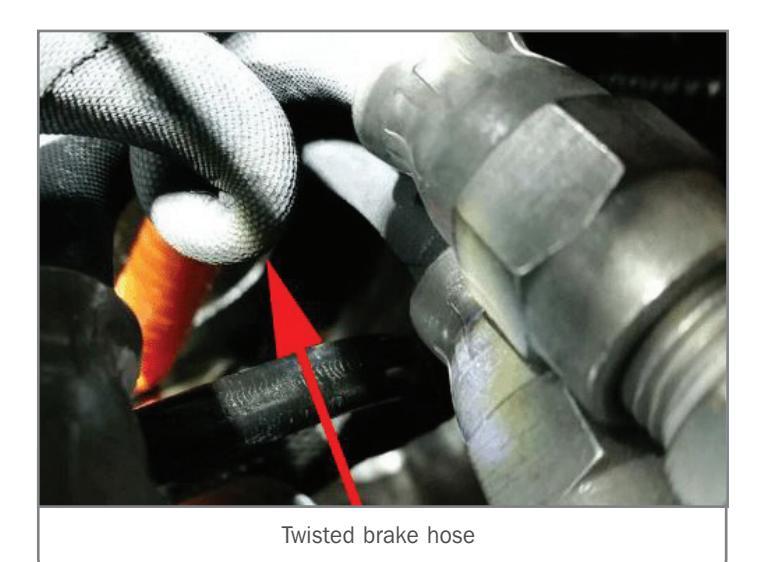
Twisted Rubber Brake Hose – A flexible brake hose that is kinked or twisted at the master cylinder may cause pressure to get trapped in the brake system. DTC C05AD may set. This condition may cause reduced brake fluid apply pressure to the wheels, resulting in brake performance issues. Replace the flexible brake hose at the master cylinder.

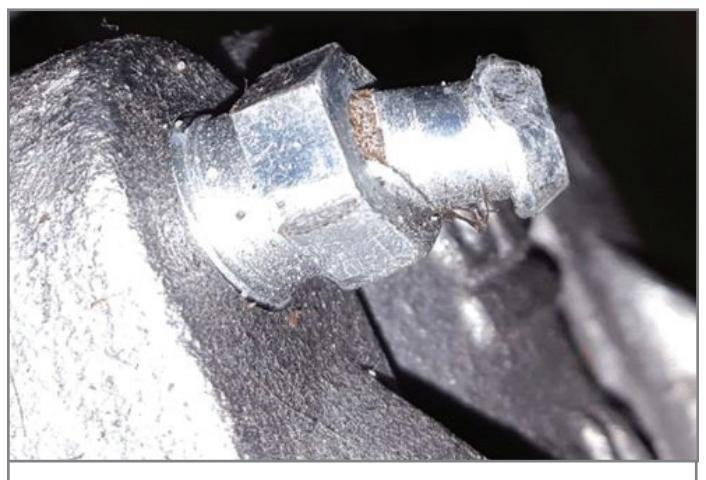
Bent Brake Fluid Bleeder Valve – Each brake caliper has a brake fluid valve. If any of the front or rear brake fluid bleeder valves are bent or cracked, which may be caused by a road debris impact, replace the damaged bleeder valve.

Bent bleeder valve

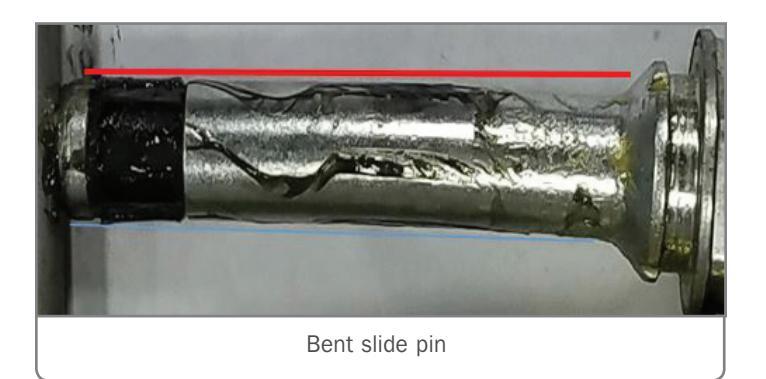
Damaged Brake Caliper Guide Pins – The brake caliper guide pins are designed to align the brake pads to meet the rotor at the correct angle in order to ensure complete application. If the brake caliper guide pins are suspected of causing a brake performance issue, remove the pins and check for any corrosion, damage, distortion, lack of high temperature lubrication, looseness in the caliper mounting bracket, a missing or damaged lower guide pin bushing, a missing or improperly seated guide pin seal, restricted pin movement, damaged guide pin boots, or seized or binding caliper guide pins. DTC C05AD may set. If any of these conditions are found, replace the guide pins.

TIP: The Malibu Hybrid and Volt brake caliper guide pins have several design differences and different removal and installation procedures. Refer to the appropriate Service Information when servicing the brake caliper guide pins.

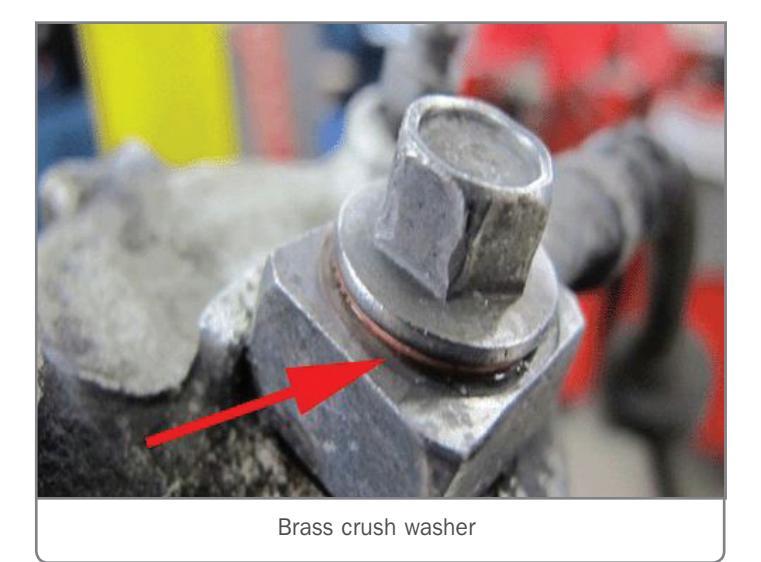
Leak at Caliper Brake Hose to Caliper – A brake hose caliper crush washer can only be used one time. Reusing a brass crush washer may cause a leak. Look for the crush washer to have an

oval shape and witness lines, which indicate multiple use. Always discard the washer and replace with a new brass crush washer.

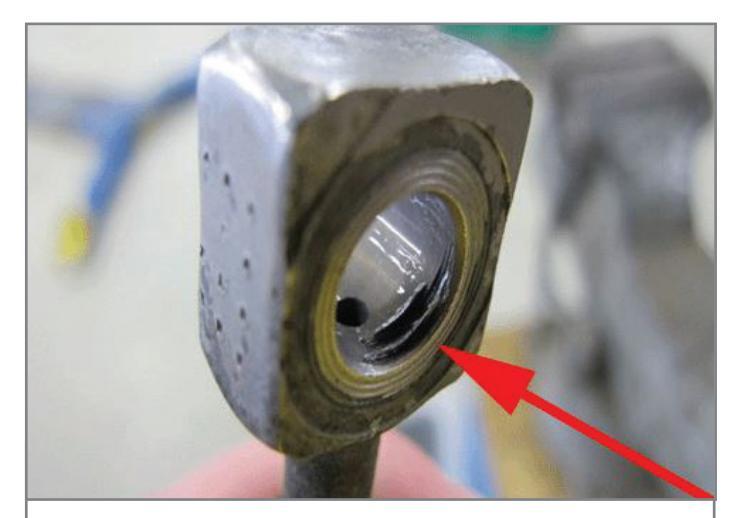
A leak also may be due to the crush washer bolt being cross-threaded and retightened. When tightening the crush washer bolt, make sure to finger tighten the bolt first to avoid cross-threading when reinstalling.

Avoid cross-threading the crush washer bolt.

If either of these conditions are encountered, replace the brake hose.

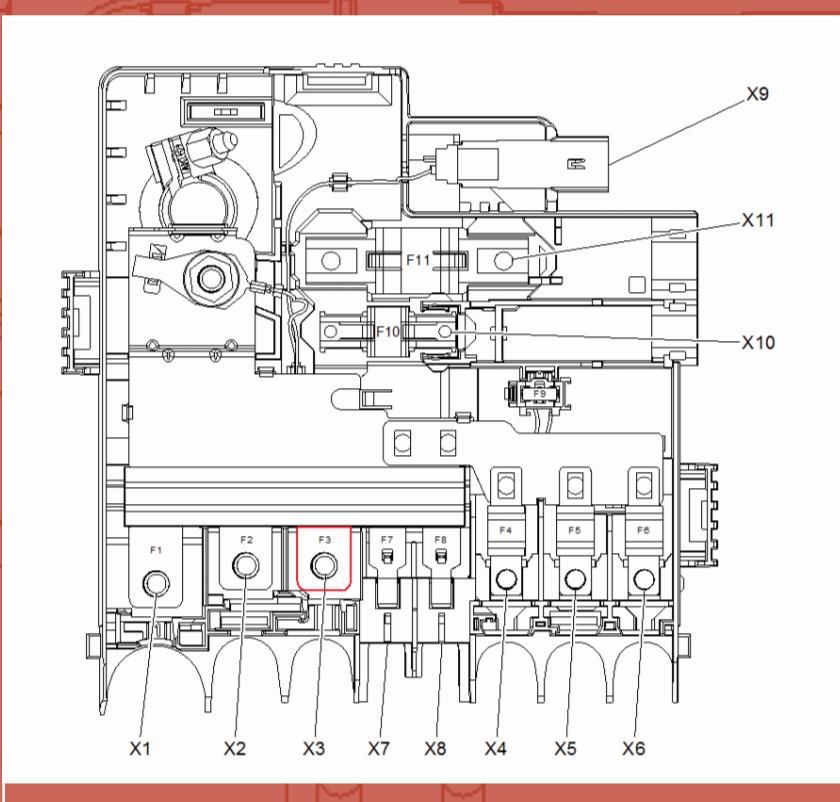
F3BA 400 amp fuse in the X50D Fuse Block–Battery

Some 2019 Silverado and Sierra models equipped with the 2.7L 4-cylinder engine (RPO L3B) may have an engine will not crank condition. If this condition is found and the starter motor does not rotate during an engine crank request, test for an open F3BA 400 amp fuse in the X50D Fuse Block–Battery.

If the F3BA 400 amp fuse is open, test for infinite resistance between the test points: B+ circuit terminal A X2 at the M64 Starter Motor and ground. If there is less than infinite resistance, repair the short to ground condition on the circuit.

If there is infinite resistance, replace the X50D Fuse Block–Battery and retest for proper engine cranking. Do not replace the starter motor.
