Mid-September 2019, Volume 21, No. 18

Exhaust Leak Conditions

Low Oil Pressure on 2.0L and 2.5L 4-Cylinder Engines

Engine Harness Contact

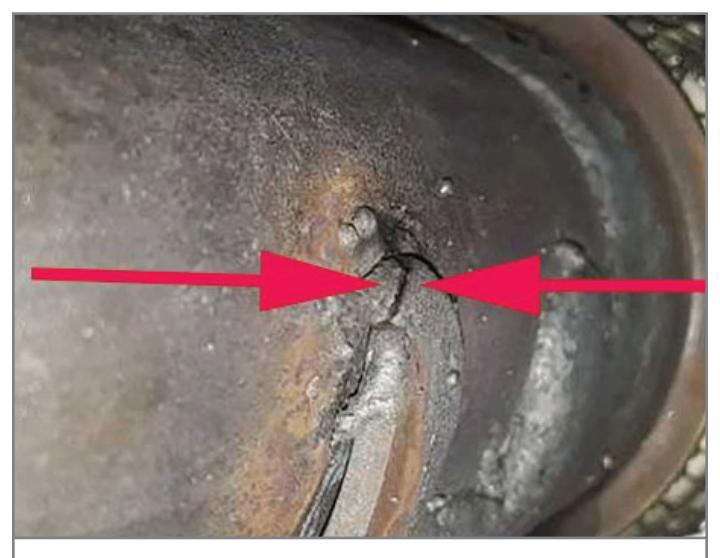
Possible broken exhaust flex pipe bracket

The exhaust conditions may be caused by a broken or poor weld with lack of penetration on the Bank 2 exhaust flex pipe bracket. If a broken Bank 2 bracket is found, also check for any damage to the right catalytic converter and pipes.

To correct the exhaust conditions, replace the Bank 2 exhaust flex pipe from the Bank 2 converter to the mid-exhaust assembly. Be sure to clear any DTCs that have set and retest the vehicle until the conditions for the codes have run and passed.

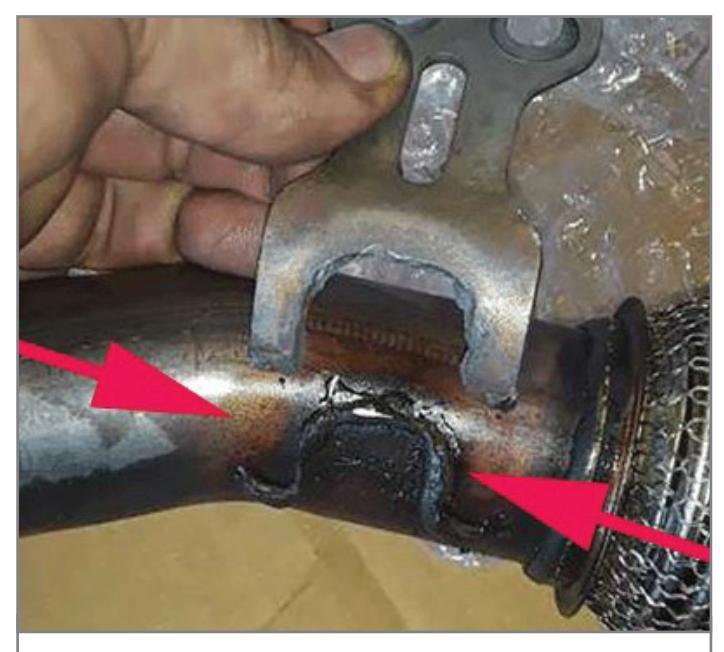
Possible broken exhaust flex pipe bracket

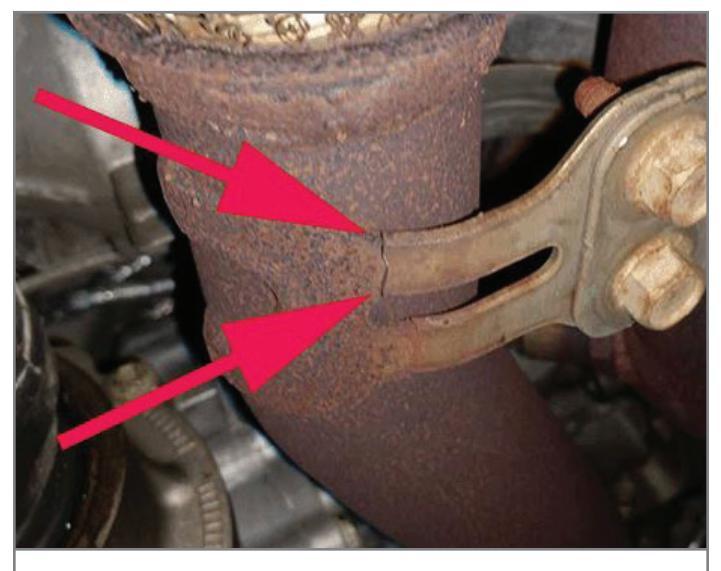
Possible broken exhaust flex pipe bracket

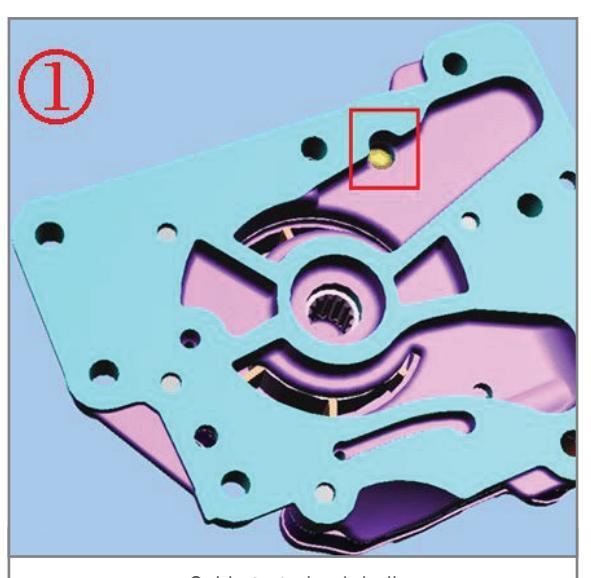
Cold start check ball

Follow the diagnostics for DTC P06DE in the appropriate Service Information. If the diagnostics indicate to inspect the oil pump or if the engine oil pressure is very low or below specification, look for any foreign material near the cold start check ball in the oil pump.

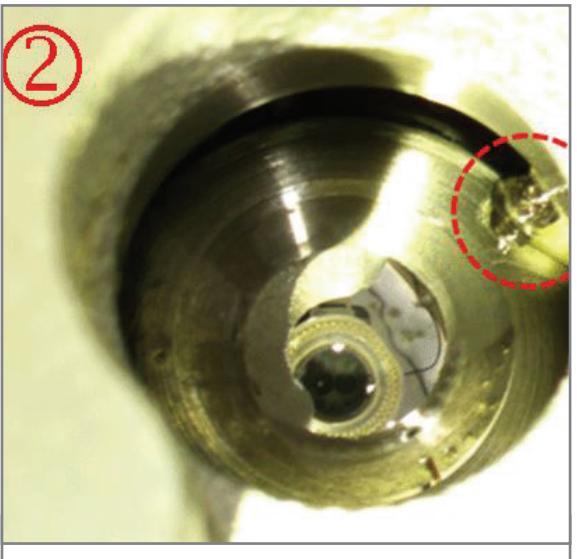
Any foreign material may be very small.

The check ball should be fully seated against the seat in the pump. Any foreign material may be very small.

If any foreign material is found between the cold start check ball and the seat, remove the material and reinstall the engine oil pump. Road test the vehicle to verify proper operation.

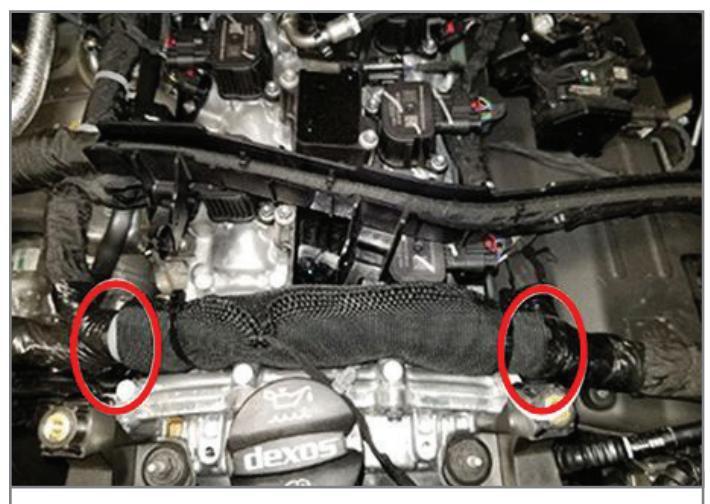
If these conditions are present, there are several areas to check where the engine harness crosses over the top of the camshaft carrier cover.

Harness over the top of the camshaft carrier cover

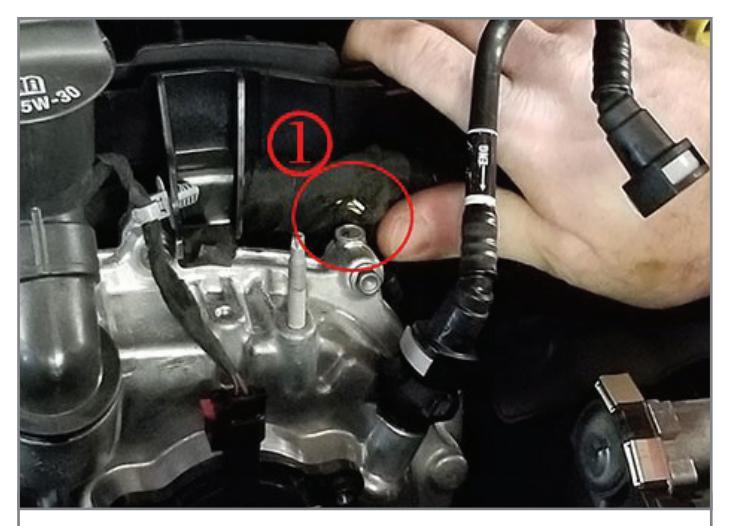
Inspect for engine wiring harness damage near each edge of the camshaft carrier cover.

Possible wiring damage near the camshaft carrier cover

If engine wiring harness contact is isolated during inspection, use a seam ripper type tool to carefully inspect for internal wiring damage. If found, repair the damaged wiring following the wire to wire repair procedures in the appropriate Service Information.

Once repaired, protect the engine wiring harness at all points identified using Woven Polyester (PET) Electrical/Anti-Abrasive Tape.

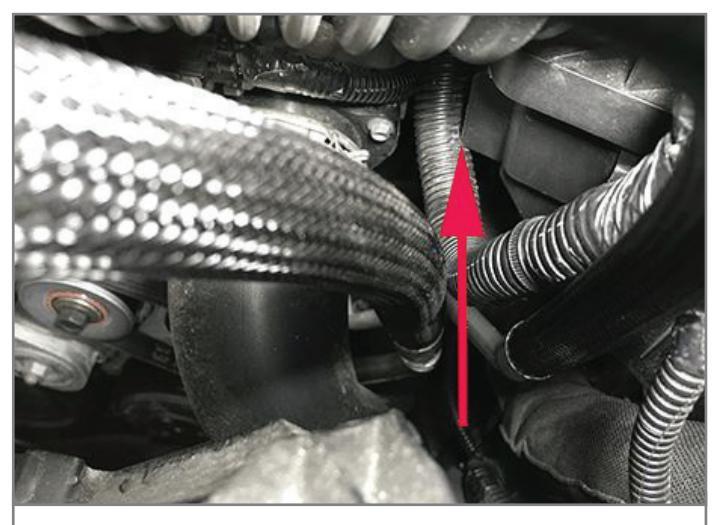
Engine harness at the lower air cleaner housing

Check the engine harness at the lower air cleaner housing.

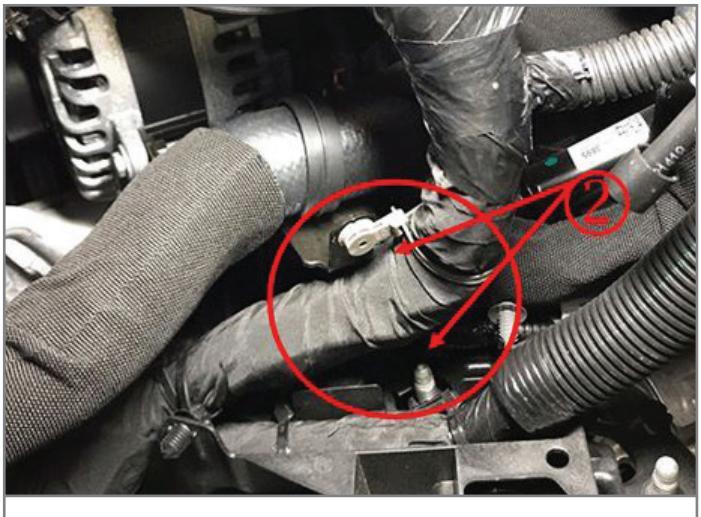
Also check the engine harness at the inlet radiator hose bracket and left front coil spring stud. Under normal conditions, the engine will rock back and forth in its mounts, which may result in harness contact with the hose bracket. The contact will not be evident during inspection with the engine off. If this contact is found, it may be necessary to disconnect several engine harness connections to reposition the harness further inspection.

Harness at the inlet radiator hose bracket and left front coil spring stud

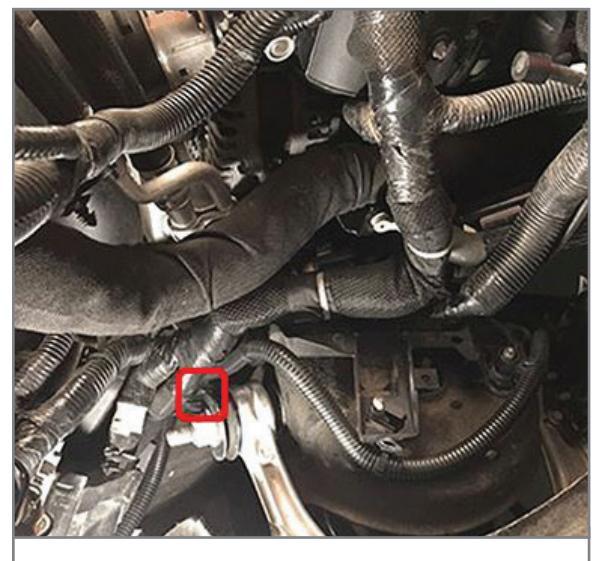
Harness at the left front upper control arm bushing

In addition, inspect the engine harness at the left front upper control arm bushing.

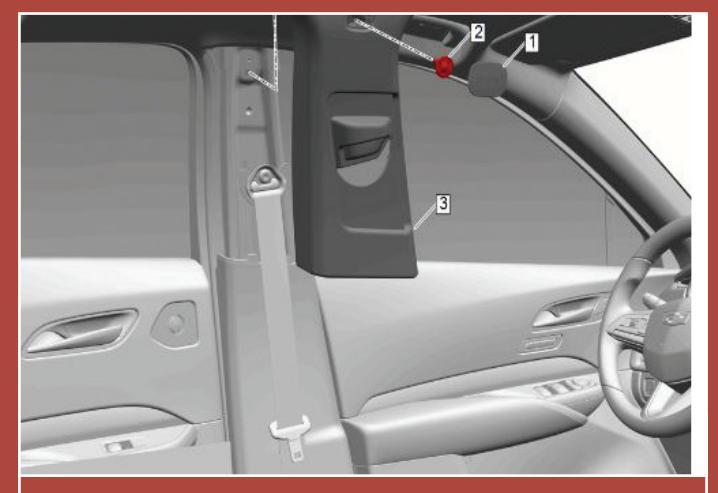
A slight rattle sound may be heard near the B-pillar on the driver's or passenger's side of some 2019-2020 XT4 models. The sound may be due to a design variance that may allow too much clearance between the enter pillar upper trim panel and the seat belt retractor D-ring and seat belt. Verify if the sound is found at one or both B-pillars.

Remove the center pillar upper trim panel.

To eliminate the sound, remove the center pillar upper trim panel

on the affected side of the vehicle and add Kent Automotive BRS Tape or equivalent to the panel.

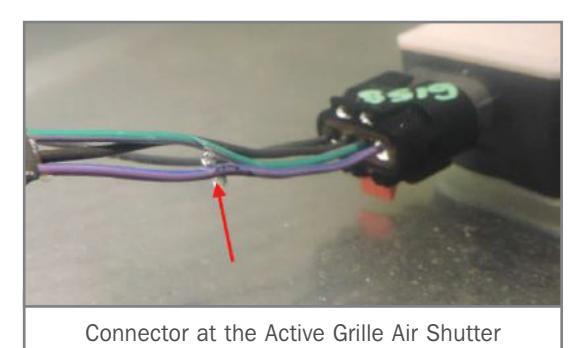
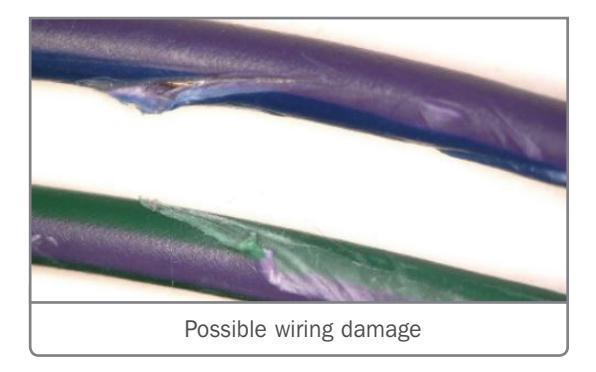
If these conditions are found, there may be a water intrusion issue at the upper or lower connectors of the Active Grille Air Shutter.

Inspect the Active Grille Air Shutter harnesses for any cuts or nicks near the connectors. If no damage is found, refer to the appropriate Service Information to continue diagnosis. If there is damage to the wiring, replace the forward lamp wiring harness connector.

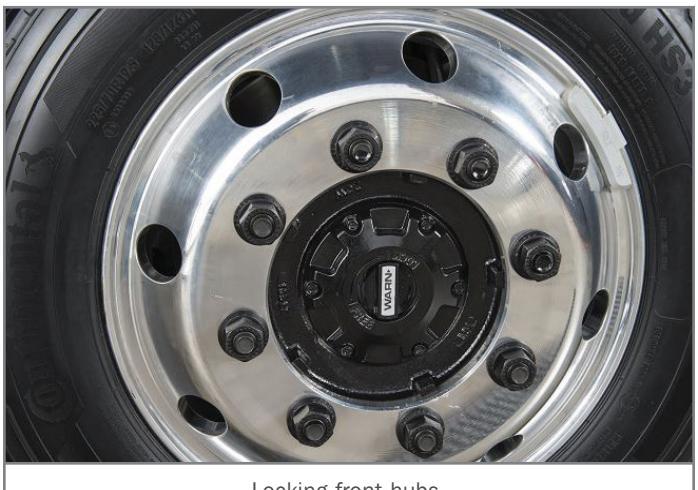
Locking front hubs

If fuel injector driver DTCs are found on some 2019 Silverado 4500 MD, 5500 MD, 6500 MD models equipped with the 6.6L Duramax diesel engine (RPO L5D), it may be due to switching the transfer case into 4WD and driving the vehicle without locking the front hubs.

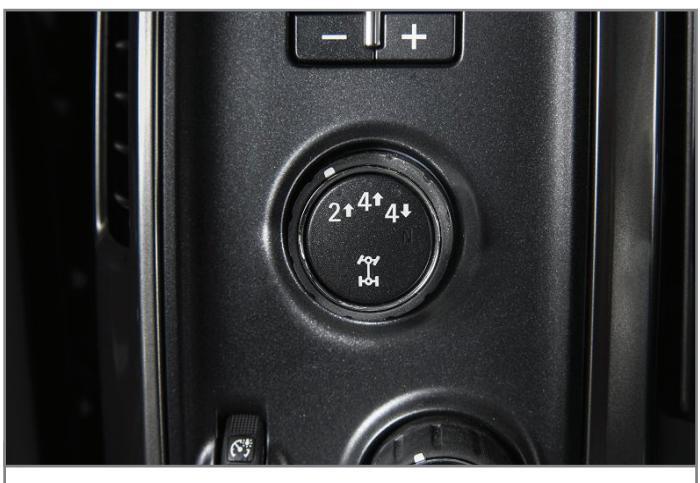
Electronic transfer case knob

If the transfer case knob (located near the exterior lamps knob on the left side of the instrument panel) is placed in 4WD and the vehicle is driven without locking the front hubs, these codes may set. If the vehicle has been driven under these circumstances, clear the DTCs and advise the customer of proper 4WD operation.
