July 2020, Volume 22, No. 13

Corvette Cooling System Draining and Filling Tips 2
Inspecting the Dipstick Tube O-Ring and Lower Oil Pan 5
Harmonic Balancer Sliding Back on Crankshaft6
Spark CVT7 Transmission Replacement7
Loose Instrument Panel-to-Body Harness Connector
Exhaust Brake Feel During Operation

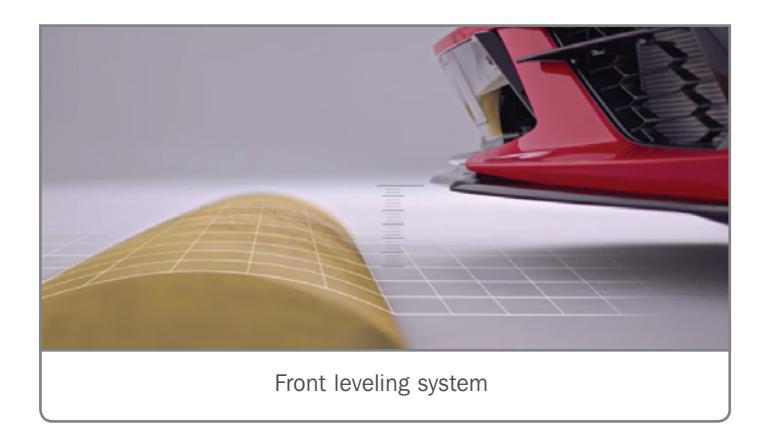
There may be a Service Front Leveling System message displayed on the Driver Information Center on some 2020 Corvette models. DTC U3000 SYM49 (Control Module Internal Malfunction) also may be set.

If these conditions are found, reprogram the Front Suspension Lifting/Lowering Hydraulic Power Pack Module with the latest calibration. Refer to K218 Front Suspension Lifting/Lowering Hydraulic Power Pack Module: Programming and Setup in the appropriate Service Information.

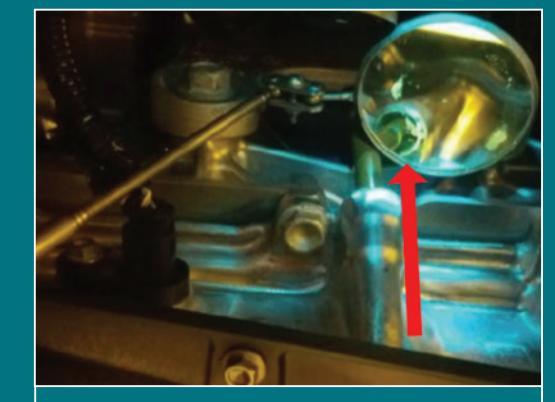
When diagnosing engine oil leaks on 2019-2020 Silverado, Sierra; and 2020 CT4-V models equipped with the 2.7L turbocharged 4-cylinder engine (RPO L3B), inspect the dipstick tube O-ring and areas above the composite oil pan sealing surface. These potential oil leak areas should be checked before identifying the lower composite oil pan as the source of the engine oil leak.

Check for an oil leak from the dipstick tube O-ring.

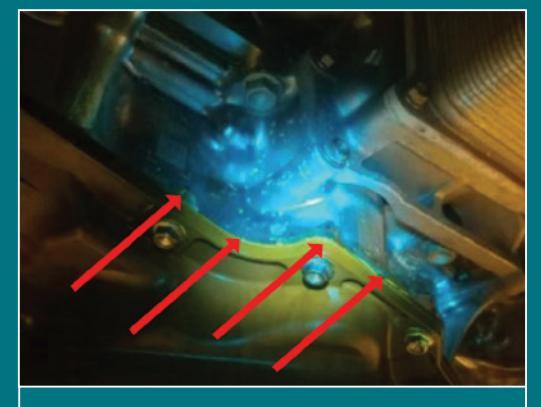
Black light and tracer dye identify an oil leak from the composite oil pan sealing surface.

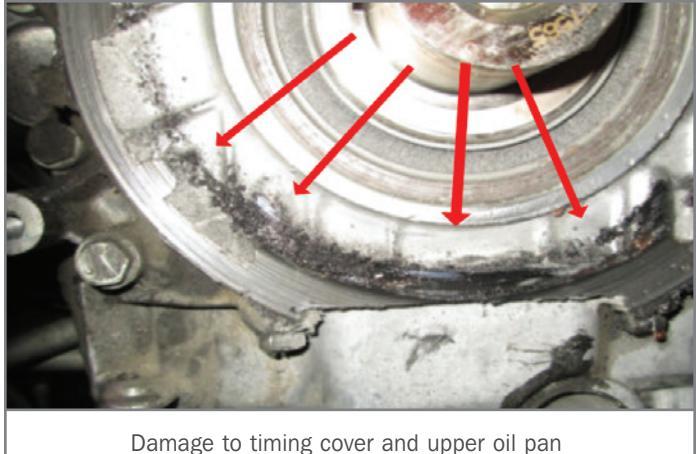
The outer ring of the harmonic balancer may slide back on the crankshaft and cause a misalignment of the accessory belt. If the outer ring slides back far enough, it may contact the timing cover and oil pans.

Inspect the harmonic balancer, timing cover and oil pans for any damage and replace as needed.

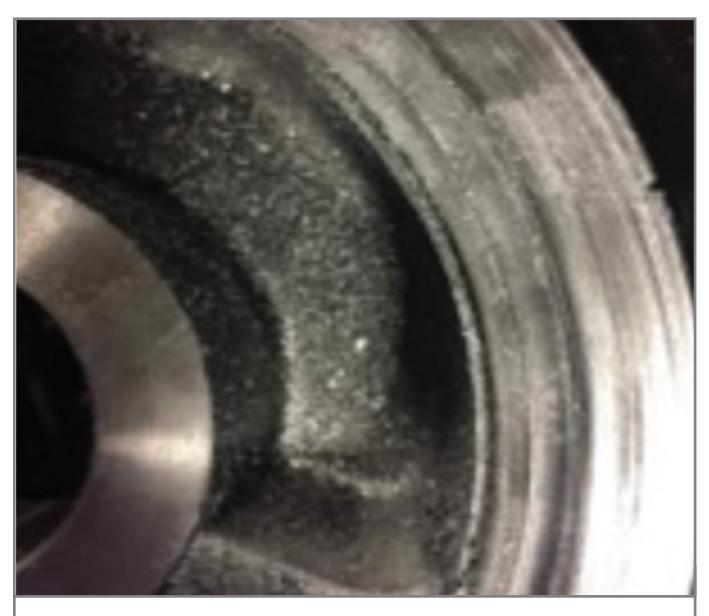
Harmonic balancer damage

Check for damage to the harmonic balancer due to contact.

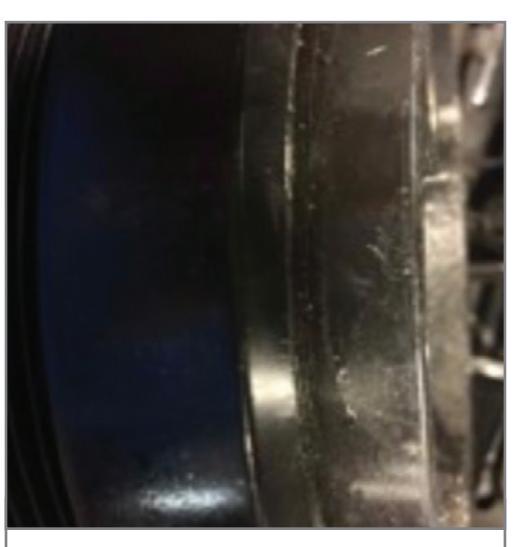
Also check for separation of the harmonic balancer's inner and outer rings.

Separation of the inner and outer rings

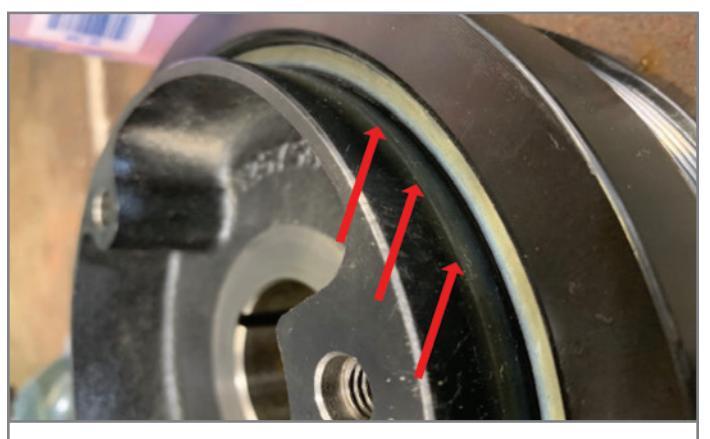
The damper has a hub that is longer than the inertia ring. Look for a witness mark where the elas-

tomer was originally positioned to identify any movement.

Check the hub directly at the elastomer.

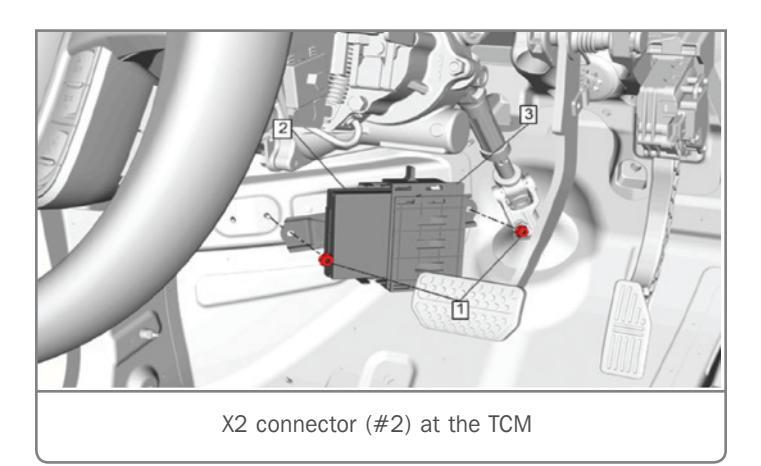
The DTCs may be the result of poor connection conditions. When removing the transmission connector from the transmission and temporarily relocating the wiring harness to allow removal of the transmission, the TCM X2 connector may crack and cause wiring and connection issues.

Follow the diagnostics in the Service Information for the DTCs that set after transmission replacement. If a resolution is not found, replace the TCM X2 connector and install new terminated leads. Do not replace the transmission for any DTCs setting right after the transmission has been replaced.

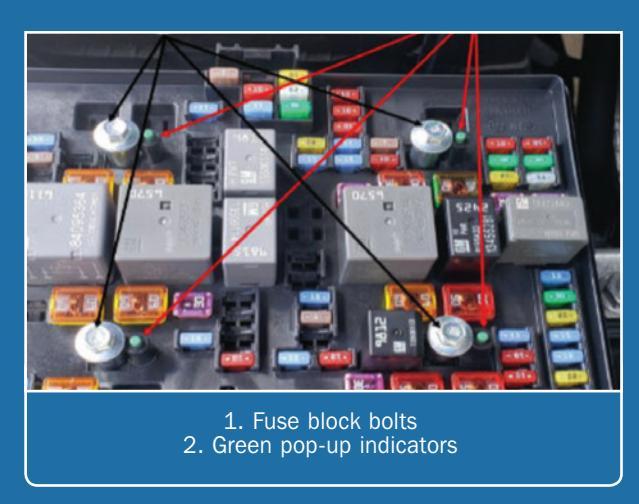
These electrical concerns may be caused by the X50A Underhood Fuse Block bolts being loose. The fuse block has built-in indicators next to the bolts that pop-up as the bolts are tightened to indicate that the fuse block is fully installed. In some cases, the green indicators will be popped up but the bolts may still be loose.

Check the fuse block bolts for properly installation. Verify they are torqued to 53 lb.-in. (6 Nm).

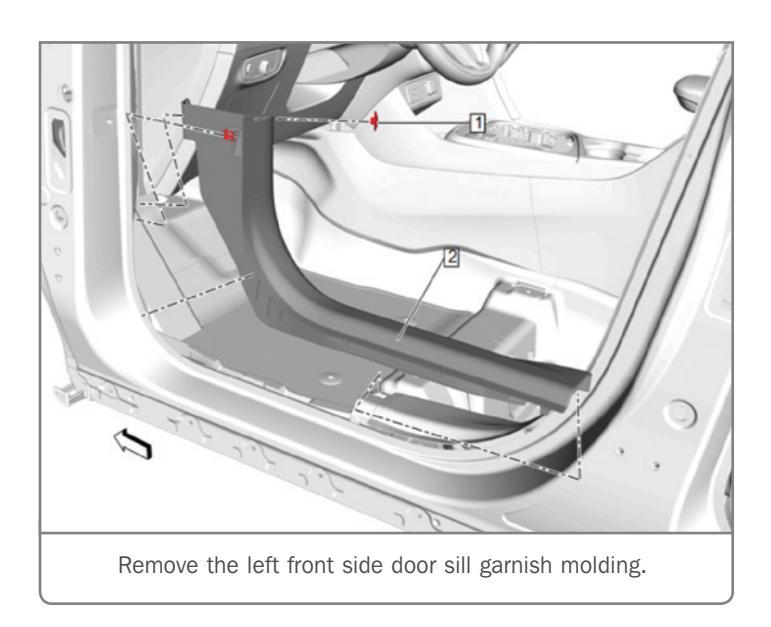
These conditions may be caused by the X200 Instrument Panelto-Body Harness connector not being fully connected and locked, resulting in an open circuit. Inspect the X200 connector, located at the lower left A-pillar. Remove the left front side door sill garnish molding to access the connector.

Inspect the X200 connector for not being seated before disconnecting it. It should be seated correctly on all four sides. Also ensure that the wires are not twisted or too taut, and that the routing is correct.
