December 2016, Volume 18, No. 23

New Essential **Tool GE-5220C** Propulsion System Lift

Harsh Shifting on the 8L90 Automatic Transmission

Unwanted Brake Apply in Reverse without Park Assist Activation

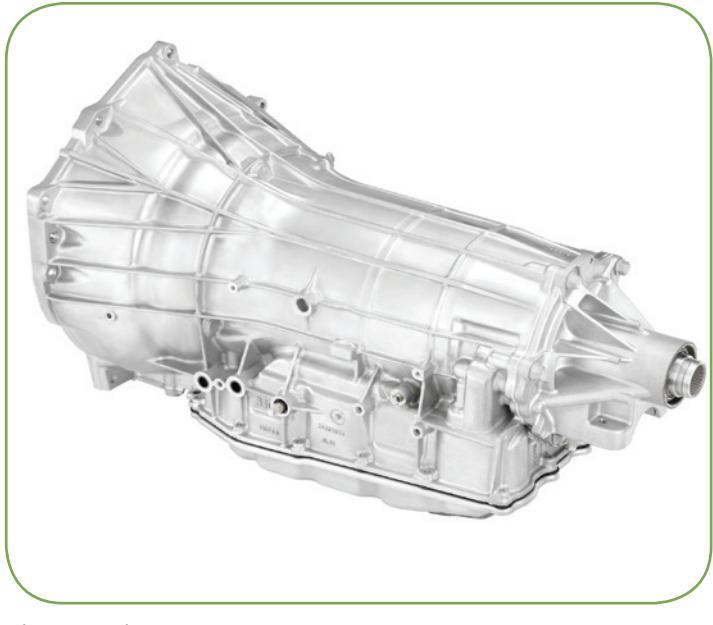
8L90 8-speed transmission

There may be several harsh shifting conditions on some 2015-2016 Silverado, Sierra, Yukon and Escalade models equipped with the 5.3L engine (RPO L83) or 6.2L engine (RPO L86) and the 8L90 automatic transmission (RPOs M5U, M5X). The shift conditions may include:

- Harsh 1-2 upshift (except for the first 1-2 upshift of the day)
- Harsh 3-1 downshift when de-accelerating to a stop
- Harsh downshift under heavy throttle apply
- Active Fuel Management (AFM) V4 to V8 transition harshness (6.2L engine only)
- Coast-down downshifts (6.2L engine only)

The 8-Speed automatic transmission uses a line pressure and volume control system during upshifts to compensate for new transmission build variation as well as the normal wear of transmission components. The variation from new and normal wear of the apply components within the transmission over time can cause shift time (the time required to apply a clutch) to be longer or shorter than desired.

There is new Engine Control Module (ECM) and/or Transmission Control Module (TCM) software that is available to improve these conditions. Use the Service Programming System (SPS) and follow the on-screen instructions to complete the programming. If both controller options are listed in SPS, select K20/K71 Transmission Control Module.

TIP: Installation of the new TCM software will require that the Transmission Service Fast Learn (SFL) procedure be performed using GDS 2 or SPS through the TIS2Web application. The transmission may exhibit poor shift quality until the clutch values are learned. Performing the SFL will reset and relearn all the shift adapts.

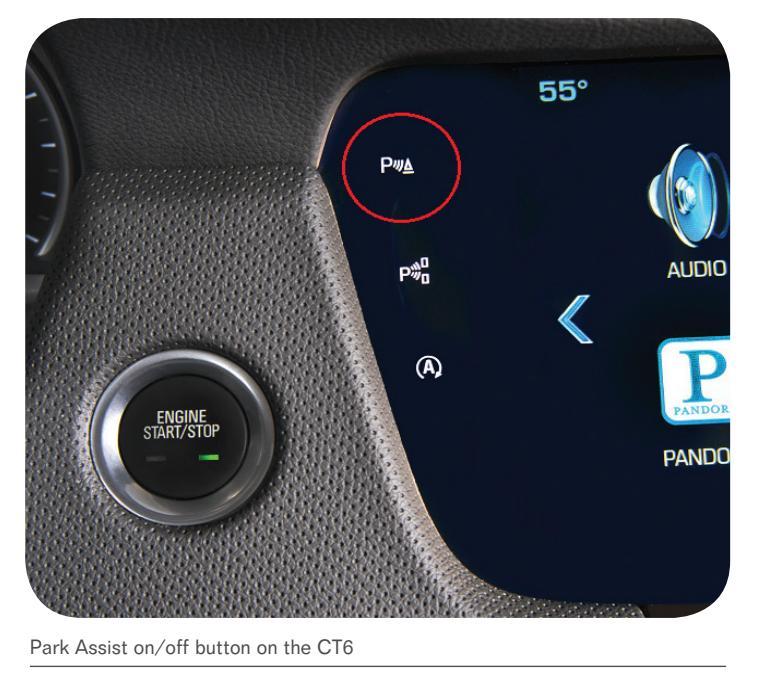
Some 2016-2017 CT6 and 2017 XT5 models may have an unwanted brake apply condition while in Reverse when there is no object behind the vehicle or around the vehicle. This condition may occur most often when the vehicle is cold in the morning (overnight cold soak) or has been sitting outside for several hours in colder temperatures.

of the rear Short Range Radar Sensor may be degraded at cold ambient temperatures below 50°F (10°C), which may result in unintended brake activation while the vehicle is backing up.

Once the rear Short Range Radar Sensor warms up to temperatures above 50°F (10°C), the condition is not present and may not be duplicated in the dealership.

Do not replace any parts or attempt any repairs for this condition. GM Engineering is determining a root cause. To address this condition at this time, use remote start to

start the vehicle before driving, which will allow the rear Short Range Radar Sensor to warm up, or turn off the Park Assist feature when backing up after a cold start.
