GMC

March 2017, Volume 19, No. 5

Duramax Diesel Engine Coolant Leak

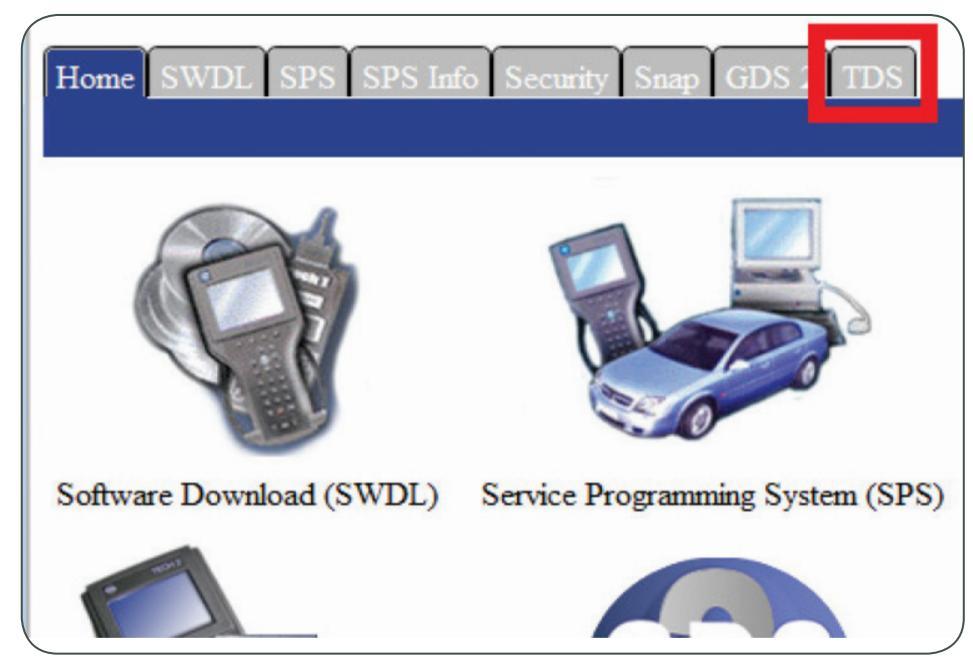
TDS tab in TIS2Web

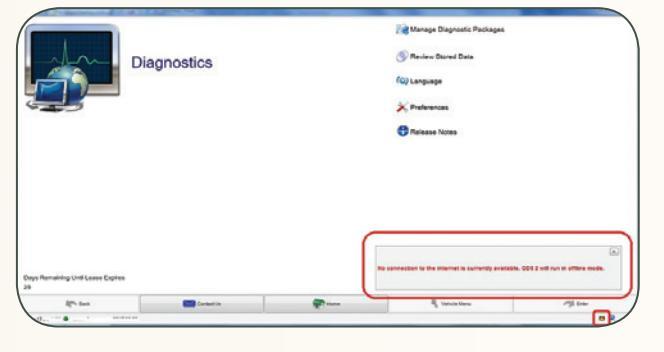
If the PC does not have any network connection, GDS2 will now run in Offline mode, even if the GDS2 Offline mode message PC is connected to a

wireless hub. When no network connection is detected, a message will flash for five seconds stating that GDS2 is in Offline mode.

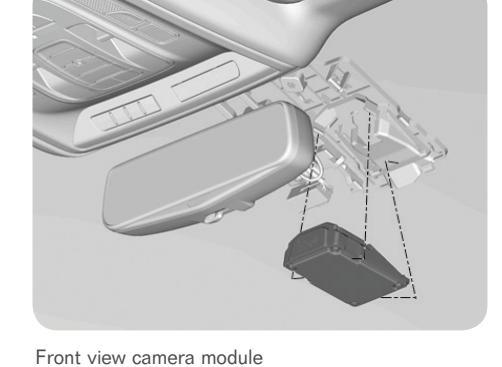
The front view camera detects visual

queues such as lane markings. On a system such as Lane Keep Assist, the front view camera module receives an input from the Lane Keep Assist switch and controls the Lane Keep Assist switch indicator output. The front view camera module also communicates via serial data with the instrument cluster, radio, and memory seat module to request visual, and audible or haptic alerts.
