## Misdiagnosis of Returned Turbochargers

All turbochargers that are returned to the Warranty Parts Center (WPC) are inspected by GM Engineering for root cause failure. Many of the turbochargers from 2011-2016 Cruze, 2012-2018 Sonic, 2013-2018 Encore, and 2014-2018 Trax models equipped with the 1.4L turbocharged engine (RPO LUV, LUJ) being returned have no trouble found.

### CONTENTS

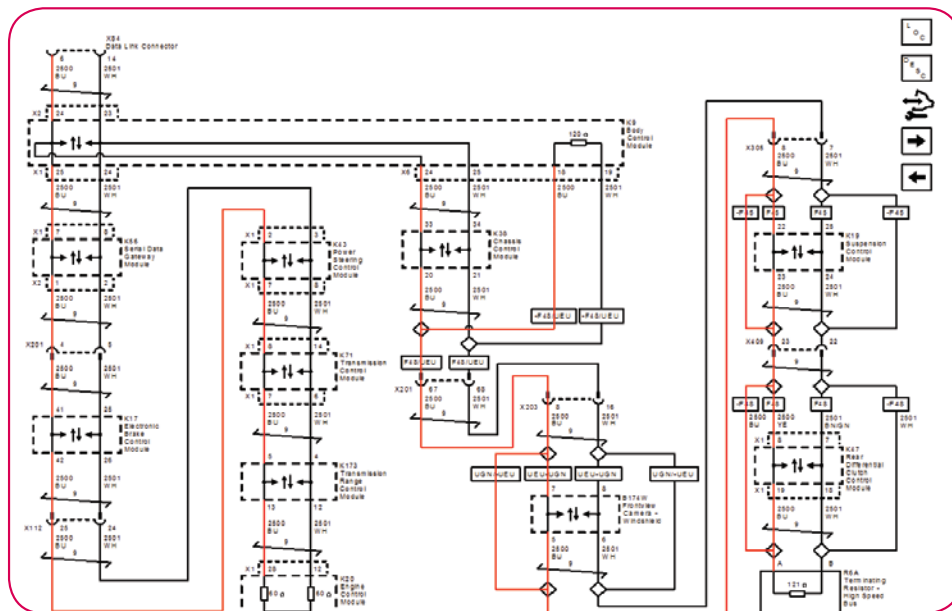
The “Steering Assist Reduced” DIC message mentioned earlier is a condition recently found on some 2017 XT5 and Acadia models. In some cases, the steering gear has been replaced without correcting the actual cause of the condition.

The “Steering Assist Reduced” message is displayed due to an invalid coolant temperature signal from the Engine Control Module (ECM). The Power Steering Control Module looks for a valid coolant temperature so it can compensate for cold and thick grease. As

grease gets cold, it becomes thicker and harder to move, which can cause a heavier than normal steering feel. When the steering module thinks it's cold due to the coolant temperature value, it provides extra assist to support the heavier condition. Since the coolant value on the CAN bus went invalid, this function of the steering module went inoperative.

For this repair, DTC P0128 should be diagnosed first, which is most likely related to a failing thermostat. Once the cause of that DTC is resolved, DTC U0401 can be cleared.

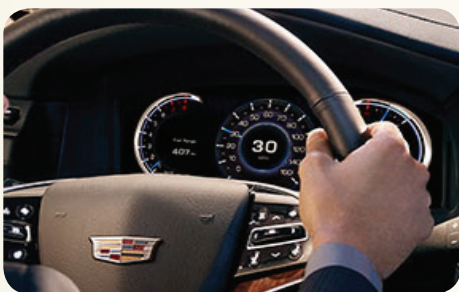
The speedometer reading may be inaccurate on some 2015-2017 Express, Savana, Silverado, Sierra, Tahoe, Suburban, Yukon, and Escalade models. The speedometer may indicate a lower mph than the vehicle is actually traveling. The inaccurate speed-

ometer reading may occur when drivers use two-pedal driving techniques or when there is a short to the four-wheel drive (4WD) Low switch.
