Mid-June 2017, Volume 19, No. 12

Top Questions on New Models

Customer Care and Aftersales

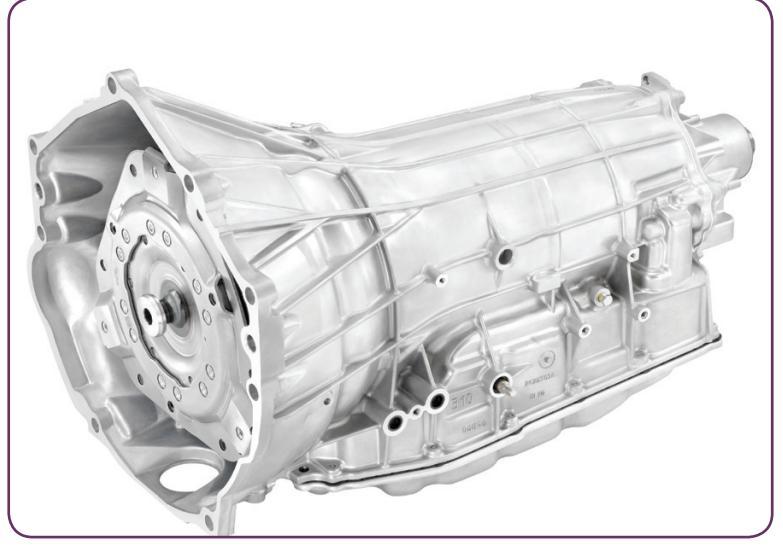
Harsh shifting conditions and delayed garage shift engagements may be noticed on some 2017 Colorado, Canyon, Express, Savana; 2016-2017 ATS, CT6, CTS, Camaro; 2015-2017 Escalade, Silverado, Sierra, Yukon Denali, and Corvette models equipped with the 8L45 or 8L90 automatic transmission (RPOs M5N, M5T, M5U, M5X). The harsh shift conditions may be caused by one or more clutch fill times not completely learned in the Transmission Control Module (TCM).

A test drive of the vehicle should be completed in order to attempt to duplicate the concern. Use GDS2 to capture a session log of the event and bookmark when the shift concern is identified. Review the GDS2 session log to identify which shift(s) are occurring at each bookmark

Transmission, valve body or TCM replacement requires a Service Fast Learn procedure using a scan tool to be performed in order for the TCM to learn individual clutch apply pressures. If the TCM calibration has been updated, a Service Fast Learn procedure is required on vehicles with any mileage accumulation.

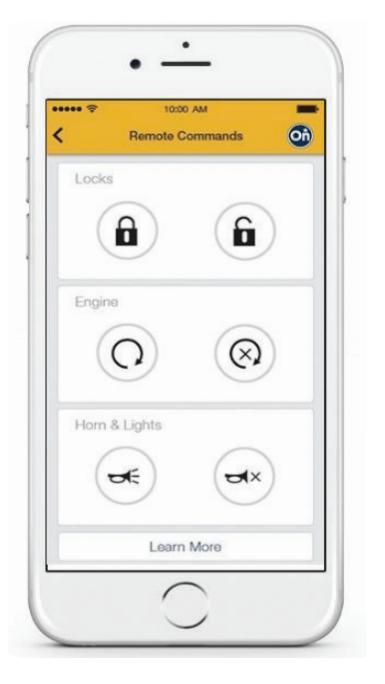
OnStar mobile app with remote commands

2009-2018 GM models may be equipped with remote start or the OnStar mobile app, which enables owners to send a remote start command to the vehicle using a smartphone. In a situation where a technician is working on a repair from underneath the vehicle — where the vehicle would be on a hoist and the hood closed — the vehicle could be inadvertently started using the remote start function or the mobile app remote command.

The inadvertent remote start may occur in a couple of common instances. The vehicle owner may start the vehicle using the OnStar mobile app out of habit, such as during lunchtime or at the end of the day, forgetting that the vehicle is being repaired. Another case could be if dealership personnel accidentally start the wrong

vehicle using an incorrect key fob. The common appearance of key fobs could create a situation where the wrong fob is used, leading to an accidental engine start-up.

When performing repairs in the engine compartment or under the vehicle, always fully open the hood, or open the hood to its secondary latch, so that the remote start function will be disabled. Failure to fully open the hood, or open it to its secondary latch, during service could result in personal injury or damage to the vehicle if an inadvertent remote start occurs.
