Mid-July 2017, Volume 19, No. 14

Driver Assistance Systems Gain Popularity on GM Models

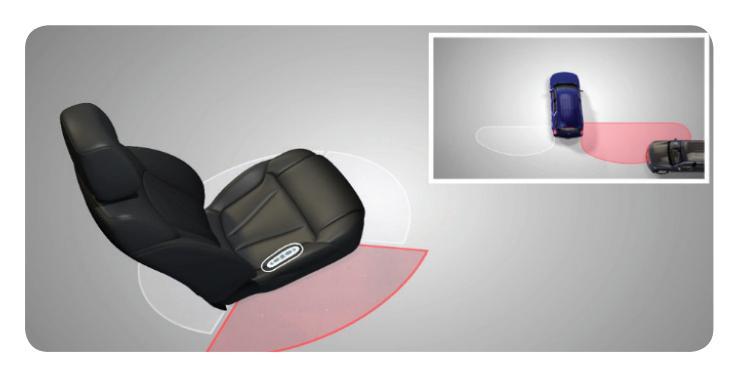
Either the left, right, or both haptic motors will activate to provide a vibration warning.

The Active Safety Seat uses two haptic signal motors in the left and right side of the driver's seat cushion to provide the vibration warning. Depending on the alert, either the left, right, or both motors will activate.

Always check for any set DTCs (B172E – Driver Seat Cushion Left Rear Haptic Alert Motor Control Circuit; B172F – Driver Seat Cushion Right Rear Haptic Alert Motor Control Circuit) when diagnosing the Active Safety Seat. Do not replace the haptic signal motors unless diagnosis clearly points toward the motors as the cause of the condition. If there aren't any DTCs set, first check the Alert Type setting in the vehicle personalization menus.

If the haptic signal motors are to be replaced, remove the driver's seat cushion cover and pad to access the motors and electrical connectors.

Once the haptic signal motors are replaced, the Memory Seat Control Module should be cleared of any DTCs. It is not required to reflash or set up the module.

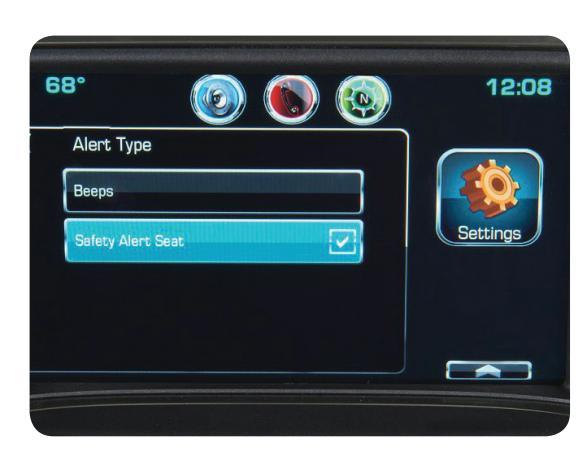
If there is a concern about the operation of the Active Safety Seat in various driving situations, the Alert Type setting should be checked in the vehicle personalization menu to ensure the seat haptic warning is turned on. The driver can select to receive the Active Safety Seat haptic warning or audible alerts (beeps). The setting to turn the Active Safety Seat on/off can be found in the vehicle personalization menus using the infotainment controls. Go to Settings > Vehicle > Collision/ Detection Systems > Alert Type.

Check the Alert Type setting.

Systems > Alert Type. TIP: Check the Alert Type setting in the service lane with the customer before the vehicle is left with the service de-
