## Coaxial Cable Repair Kit Now Available

## Remanufactured V6 Engine Misfire

# Pop Sound from Front Suspension Area while Making Turns

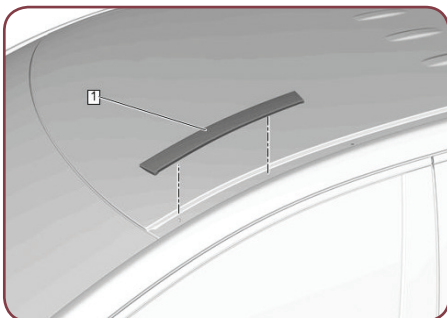
Front ditch molding

**Roof Rack/Ditch Moldings:** Studs through the roof hold on the roof rack. The headliner must be removed to service. Ditch

moldings are now clipped in and it may be difficult to prevent damaging them during removal. They may require replacement when servicing.

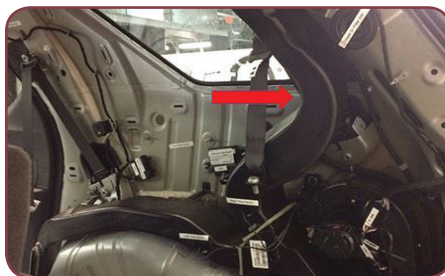
Rear air duct

**Headliner Removal:** Remove 1/4 trim on the right-hand side and remove the rear air duct to prevent the air duct from breaking the integrated duct work in the headliner.

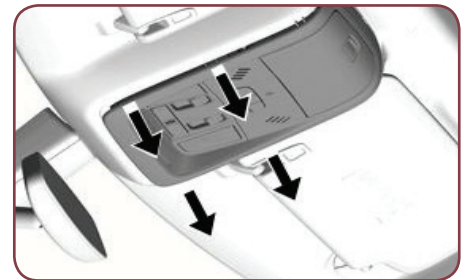
Garage door opener bezel

**Overhead Console:** Use care when pulling down the garage door opener (roof console) bezel to prevent damage to the wiring

harness connector. Since the harness is glued to the headliner, carefully removing the bezel will prevent damage to the connector.

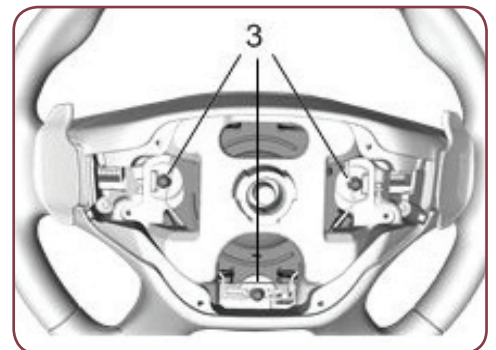
Enc airbag spring fasteners

**Driver's Airbag:** Removing the driver's airbag requires turning the wheel left, right, and then bottom side up to release the spring fasteners in order to remove the airbag.
