## Instructional Videos and Active Website Links Now Included in GM Service Information

# Rear Differential Clutch Module Corrosion

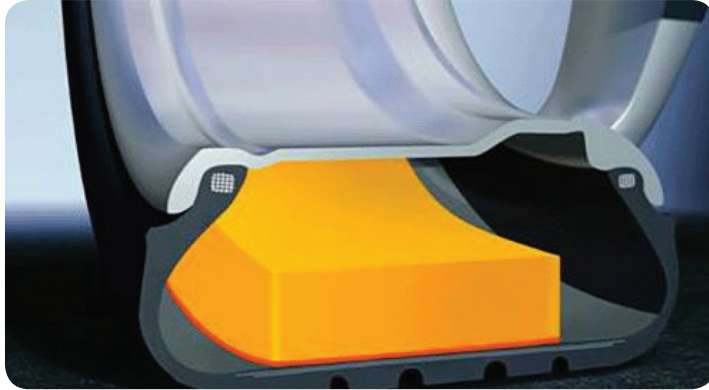
The new 2018 Regal features the first GM application of Continental ContiSilent tires, which are manufactured with quiet foam within the tires for a quieter ride on the road. If the ContiSilent tires have a puncture in the tire tread area, the tire can be repaired but requires some additional repair steps compared to a traditional tire repair.

Tire with quiet foam

First, identify the location of the object that has punctured the tire in the tread area. If the tire can be repaired, the quiet foam must be removed prior to sealing the puncture.

After the tire repair has been made, reinstall the foam piece using the cement that was used to plug the puncture.
