New Medium-Duty Truck Essential Tools

Shipped to Dealerships

Customer Care and Aftersales

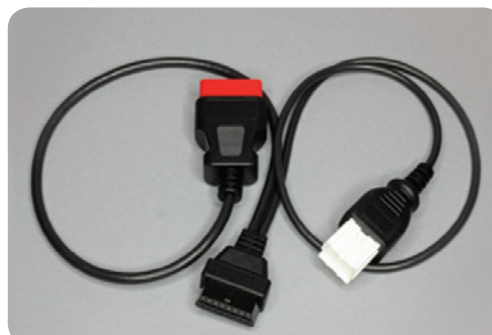
EL-52509 FTR ABS DLC Y-Cable

The Anti-Lock Brakes (ABS) diagnostic communication circuits on the medium duty trucks are not located in the Data Link Connector (DLC). In order to properly diagnose the ABS system, the FTR ABS DLC Y-Cable must be connected between the scan tool DLC cable and both the vehicle DLC connector and the Mimamori Download 10-pin connector under the instrument panel.

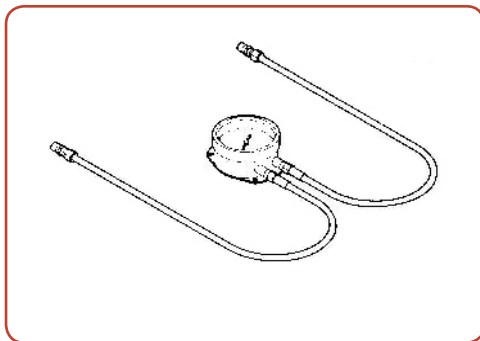
J-42206 Dual Air Pressure Gauge

The Dual Air Pressure Gauge is used to diagnose the air brake pressure at various locations in both the cab and trailer (if equipped). Using the gauge, pressure readings can be obtained at each axle or the control valve.

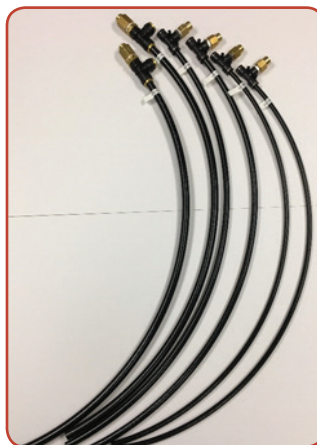
J-42206 Air Brake Line Adapter Set

The Air Brake Line Adapter Set is used with the Dual Air Pressure Gauge to diagnose the air brake pressure.

Each hose (red and black) is 35-feet (10.7 m) long so it's easy to reach each axle. Connections are made using the specific line size required (3/8", 1/2" or 5/8" line) at each air brake chamber or the control valve.

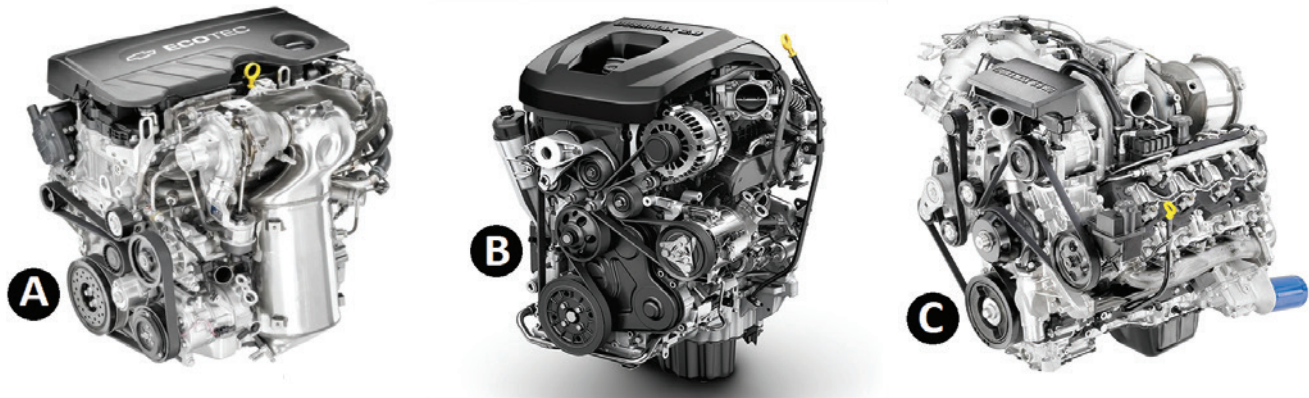
A. 1.6L diesel engine
B. 2.8L Duramax diesel
C. 6.6L Duramax diesel

A change was implemented recently in the values of the Diesel Particulate Filter (DPF) Soot Accumulation parameter displayed in GDS 2. On all 2016-2018 Colorado and Canyon models and 2017-2018 Express and Savana models equipped with the 2.8L Duramax diesel engine (RPO LWN); 2017-2018 Silverado and Sierra models equipped with the 6.6L Duramax diesel engine (RPO L5P); and 2017-2018 Cruze models equipped with the 1.6L diesel engine (RPO LH7), the DPF Soot Accumulation is measured in percent instead of grams.

On these vehicles, the Engine Control Module (ECM) will not try to perform a regeneration until the DPF Soot Accumulation increases to approximately 100%. If the DPF Soot Accumulation increases to 115% and the system has not been able to regenerate due to driving conditions, a Continue Driving message will be displayed on the Driver Information Center (DIC). If the DPF Soot Accumulation increases above a calibrated percentage (based on diesel engine application), DTC P2463 (Diesel Particulate Filter Soot Accumulation) will set and a Service Regeneration will be required to clean the DPF.

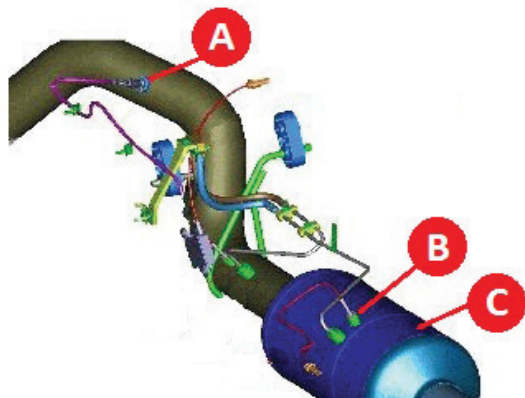
A Service Regeneration is designed to lower the soot accumulation in the DPF in a very controlled way. It is not as effective as a Regeneration Enable followed by driving the vehicle. A Service Regeneration should only be performed if the procedure is called out in the appropriate Service Information.

A. Exhaust Particulate Sensor
B. Exhaust Temperature Sensor (position 4)
C. Diesel Particulate Filter

TIP: During a service regeneration, the vehicle will need to be parked outside the facility and away from nearby objects, such as other vehicles and buildings, due to the elevated exhaust gas temperature at the tail pipe during regeneration. The service regeneration can be terminated by applying the brake pedal, commanding service regeneration OFF using the scan tool, or disconnecting the scan tool from the vehicle.
