Preventing an Inadvertent Airbag Deployment

Preventing an Inadvertent Airbag Deployment
Latest GDS2 Core Software Updates VIN Field
Install API Manager Message Displayed After Radio Replacement
Repair for Suspension Leans to the Left Condition
Updated Battery Part Numbers and CCA Chart
Recovery of Failed USB Radio Programming 6
Service Know-How6

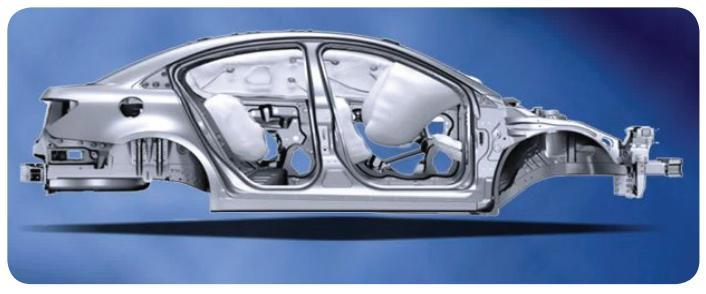
Common airbag locations

When performing service on or near the SIR components or the SIR wiring, the SIR system must be disabled. Failure to observe the correct procedure could cause deployment of the SIR components. Serious injury can occur. Failure to observe the correct procedure could also result in unnecessary SIR system repairs.

In order to help avoid accidental airbag deployment, anytime a vehicle requires repair of the SIR system and another vehicle system, it's recommended that repairs be made to the SIR system first, and then repairs made on the other system.
