Common Questions on Super Cruise Operation

Updating the Super Cruise Digital Map Module

Customer Care and Aftersales

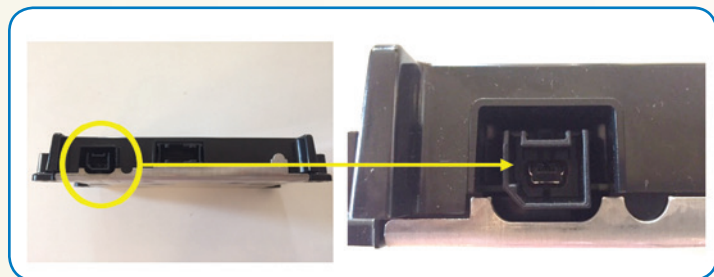
DMM MINI B connection

To upload the latest map using SPS, a USB programming cable with a MINI B connection is required.

A USB cable with a MINI B connection is included in the EL-50334-6 Audio System Diagnostic Kit. Use the EL-50334-14 Infotainment Test Cable to connect to the module. A USB flash drive or memory stick is not required.

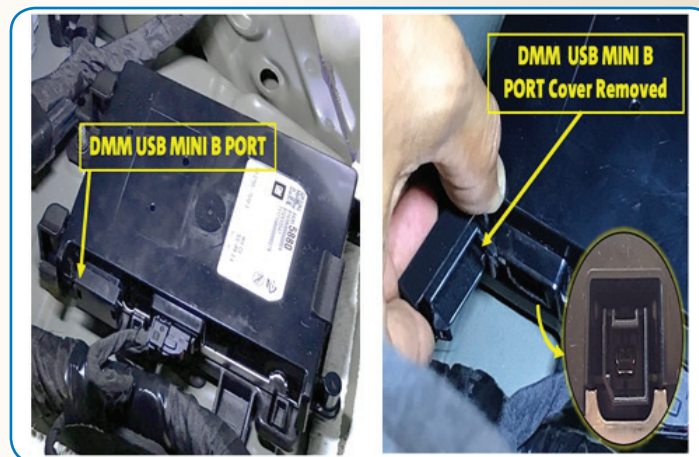
DMM USB MINI B port of the side of the module.

The USB MINI B port on the DMM is located behind a cover on the side of the module.

Before the DMM can be programmed, verify the Clock Status and GPS Accuracy scan tool information is valid. If the displayed value is not valid, drive the vehicle with a clear view of the southern sky for five minutes.
