New Wireless Charging System Retrofit Kit

Properly Connect AFIT Cables to Avoid TCM Damage

Low Air Conditioning Refrigerant Charge or Leak

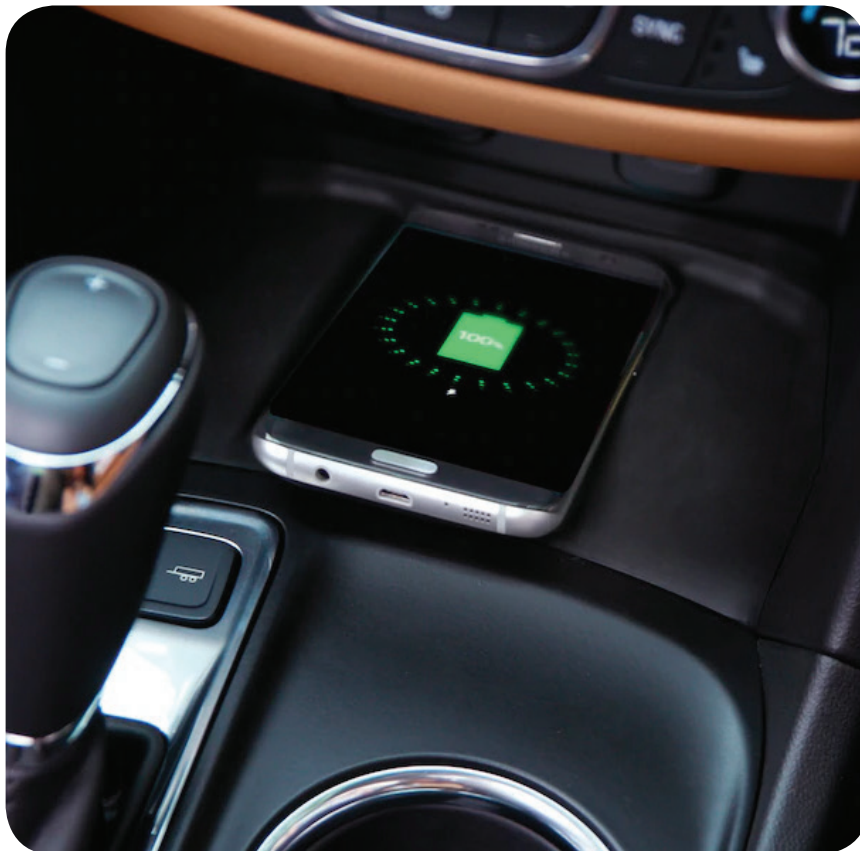
The first generation (Gen I) wireless charging system in these models may not be compatible with the latest smartphones. Before attempting any repairs on the wireless charging system, check the compatibility of the smartphone.

A new Gen II wireless charging retrofit kit is now available to accommodate the latest smartphones.

The new Gen II wireless charging retrofit kit, part number 84526978, is now available to GM dealerships. Upgrading the system to the Gen II kit is a customer-pay repair. It is not covered under warranty.

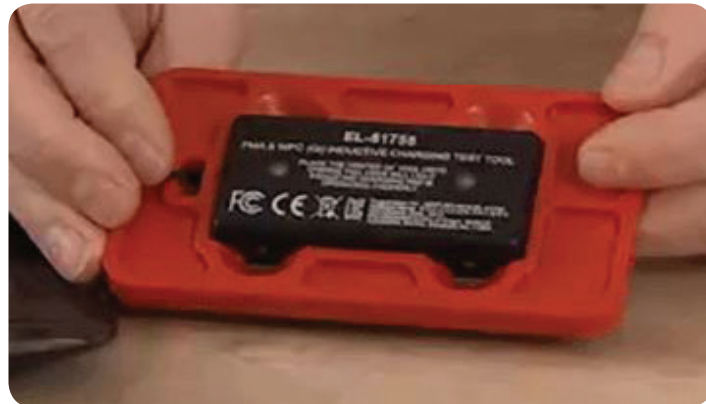
EL-51755 Inductive Charging Test Tool and sleeve

The EL-51755 Inductive Charging Test Tool can be used to verify charging system operation in a vehicle. There is no need to remove the rubber sleeve from the pocket or pad for testing. An updated sleeve also was shipped to dealerships to ensure proper positioning of the tool in all inductive charging applications.

To verify the operation of the charging system, simply position the tool on the charging pad or in the charging pocket. If the tool's wireless charging indicator is on, the charging system is operating properly and any charging concern may be caused by an incompatible or defective mobile device. If the charging indicator is off, continue diagnosis using the appropriate Service Information.

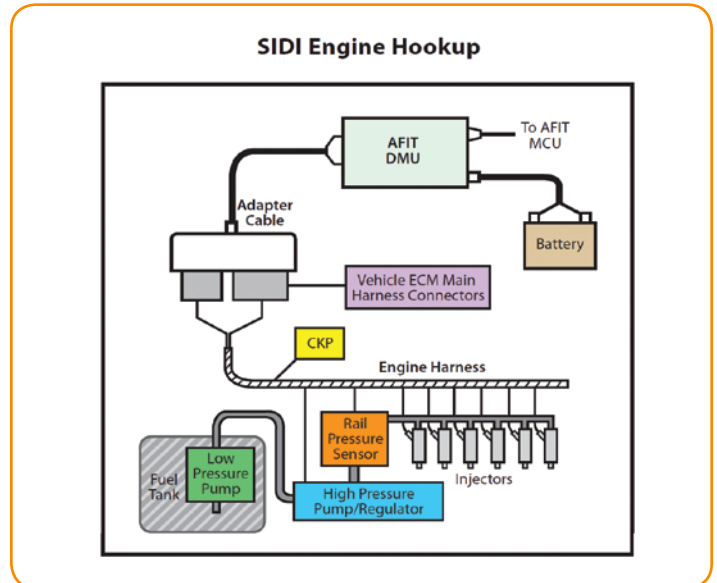
Connect the DMU cable when prompted.
