Mid-May 2018, Volume 20, No. 10

Super Cruise Update Provides Messaging Features

QR Code on Certification Label Offers More RPO Codes

Properly Connect Sensors during Air Distributor Case Replacement

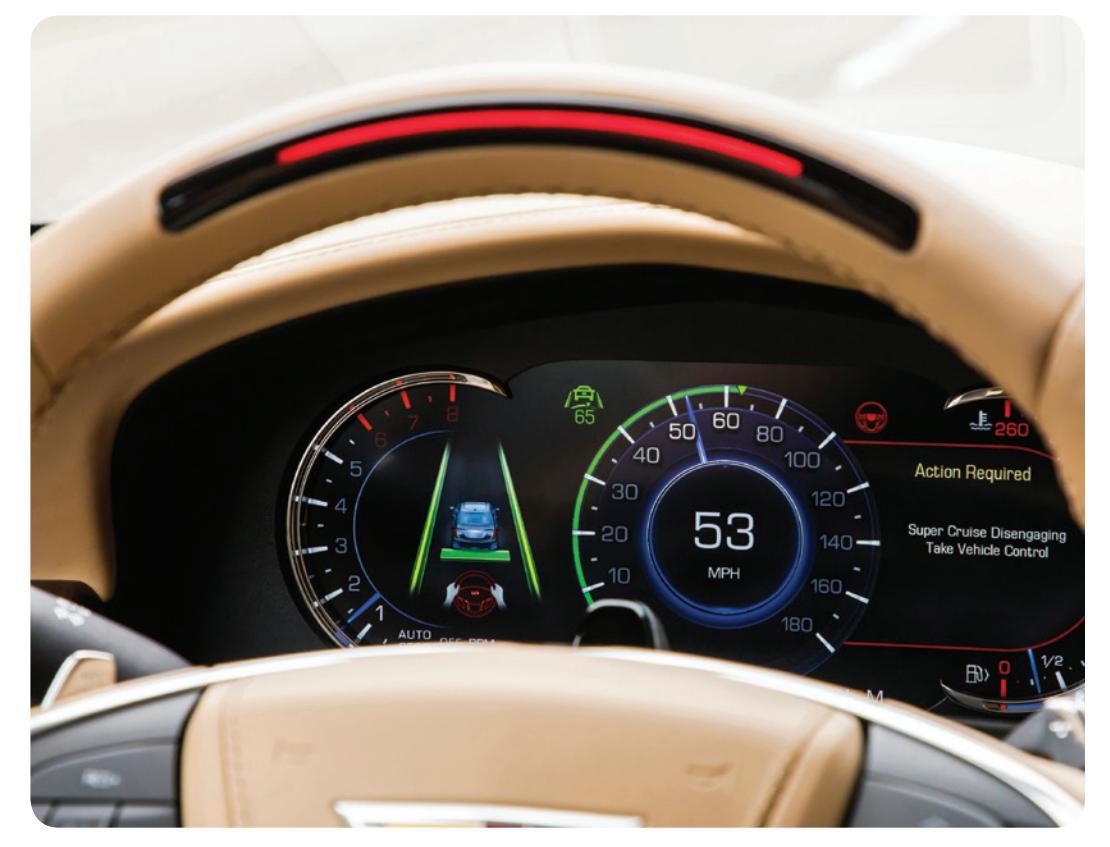
Super Cruise message displayed on the instrument cluster

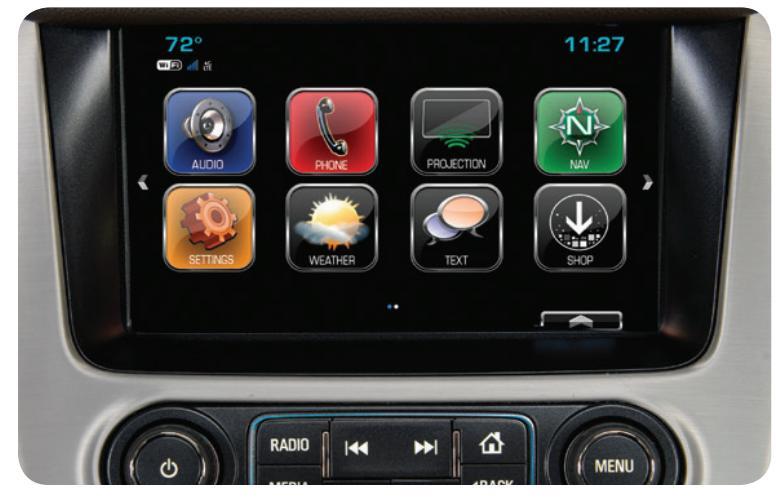
Infotainment System RPO IO6

After replacement or programming the amplifier on some 2015-2017 Silverado, Tahoe, Suburban, Sierra, Yukon, Escalade and 2014 Silverado 1500 and Sierra 1500 models equipped with infotainment system RPO IO5, IO6 or RAO, several audio conditions may be present. These audio conditions may include abnormally loud voice prompts, fade/balance that does not adjust correctly, and DTC B101E (Electronic Control Unit Software) sym 42 (Calibration Not Programmed) set in the amplifier.

If these conditions are found, use GDS2 to view the amplifier calibrations. Do not replace any parts if any calibrations are blank or read zero. GM is working toward a service solution for this condition. Contact the Techline Customer Support Center (TCSC) for programming assistance to correct the amplifier calibration.

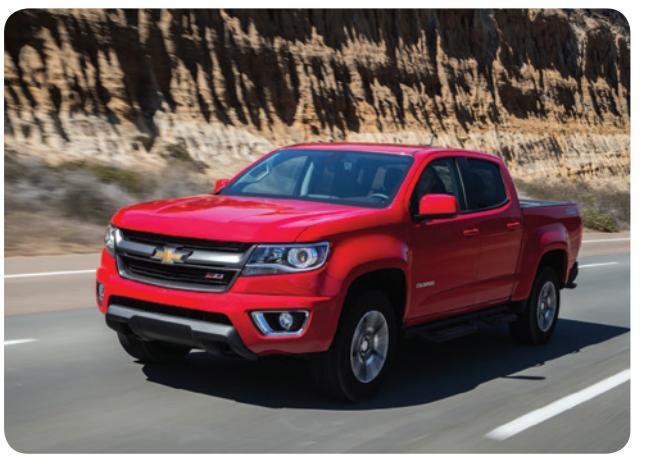
- Chugging and/or lack of power when accelerating at speeds of 12-15 mph (19-24 km/h) in 2nd gear.
- Chugging, lack of power, or no downshift when accelerating at speeds of 30-40 mph (48-64 km/h) in 6th gear.

Spark knock under light acceleration or when climbing an incline under load.

These conditions are most likely to occur while driving on a smooth road and up a slight or moderate grade when accelerating. DTC P0326 (Knock Sensor Performance Bank 1) may be set in history in the Engine Control Module (ECM).

The lack of power conditions may be caused by an anomaly in the ECM and Transmission Control Module (TCM). An updated software calibration is available to address these conditions.

The ECM and TCM must be reprogrammed sequentially to the latest software calibration available to avoid other malfunctions and drive quality degradation. If both the ECM and TCM are not updated, they will be incompatible and will not perform correctly.
