2019 Model Year Full-Size and Medium-Duty Truck Names and Identification

Brake Shudder While Towing Gooseneck or 5th-Wheel Trailers

Proper Seat Cover Installation

Center Console Sliding Door Latch Replacement

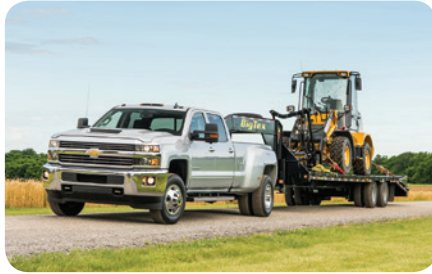
Some 2011-2019 Silverado 2500/3500 and Sierra 2500/3500 models may have a shudder, bounce or bucking condition from the rear of the truck while braking when towing a gooseneck or 5th-wheel trailer. The brake shudder is found on vehicles with gross combined weights usually exceeding 20,000 lbs. No DTCs are stored that are related to the Trailer Brake System or Electronic Brake Control Module (EBCM).

Heavy gooseneck and 5th-wheel trailers have the ability to impose a dynamic pulsing force on the tow vehicle when driving on smooth roads. The pulsing force acts in a forward and reverse direction on the tow vehicle at a rate of 3 to 5 times per second and can be subtle to the driver. As the combination decelerates, the trailer induced pulsing force is still present and, while braking, the driver may unintentionally begin to fluctuate the force on the brake pedal in response to the trailer's pulsing input force. As the brake pedal force fluctuates, the resulting alternating deceleration forces that the truck produces magnifies the trailer impulse forces, resulting in the shudder condition.

Silverado towing a gooseneck trailer

The following tips may help verify the issue and minimize its potential to occur. Trailer, trailer loading, and trailer hitch characteristics will influence the magnitude of a trailer's pulse force.

Measure the actual truck and trailer weights, with the trailer loaded to the point that exhibits the condition. If any weight parameter is exceeded, such as the Front Gross Axle Weight Rating (FGAWR), Rear Gross Axle Weight Rating (RGAWR), Gross Vehicle Weight Rating (GVWR) or Gross Combined Weight Rating (GCWR), the load must be reduced before investigating further.

Play and lack of stiffness between the truck and trailer's hitch components will affect the trailer-induced pulse forces. Gooseneck ball and 5th-wheel kingpin sizes and load ratings must be correct for the trailer weight used. Trailer gooseneck extension set screws must be at the manufacturers specified torque value. Gooseneck ball and coupler parts showing indication of wear should be replaced and 5th-wheel pivot assemblies must be functioning as intended.

Observe the trailer hitch and trailer tongue during acceleration and deceleration events. If excessive movement is noted, a different style/brand of hitch may be required focusing on the weight rating and base structure. A hitch structure with a wider base that is mounted to the provisions on the frame for the 5th-wheel hitch is recommended. Also verify the load rating of the installed hitch.

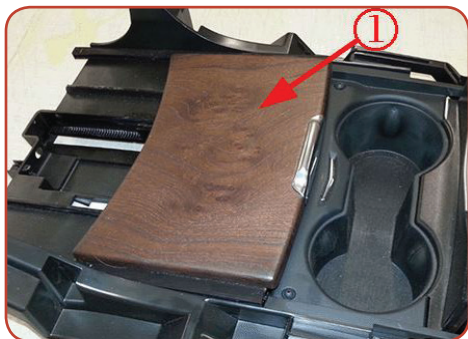
The sliding compartment door latch on the floor center console may be damaged and the door may not open on some 2015-2018 Escalade models.

Sliding compartment door

The sliding compartment door is a “push-push” door, which means it is designed to be pushed to open and pushed to close. When the door is pushed forward to close, the latch releases and the door closes. If the push handle on the door is used as a pull handle to close the door, the door latch can be damaged.

If the sliding door latch is damaged, do not replace the floor center console compartment assembly. The sliding door latch is available separately to repair this condition without having to replace the complete console assembly. Follow the Front Floor Console Cup Holder Door Latch Replacement procedure in the appropriate Service Information to replace the latch.

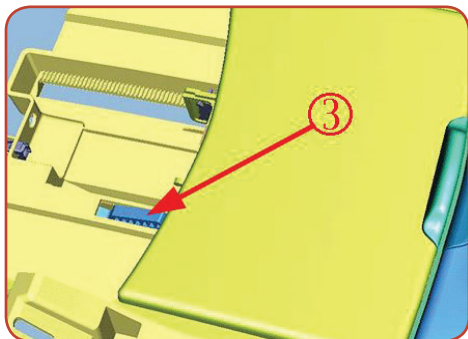
Sliding door inertia lock
