New V8 Engines Feature Dynamic Fuel Management

Customer Care and Aftersales

TECH LINK

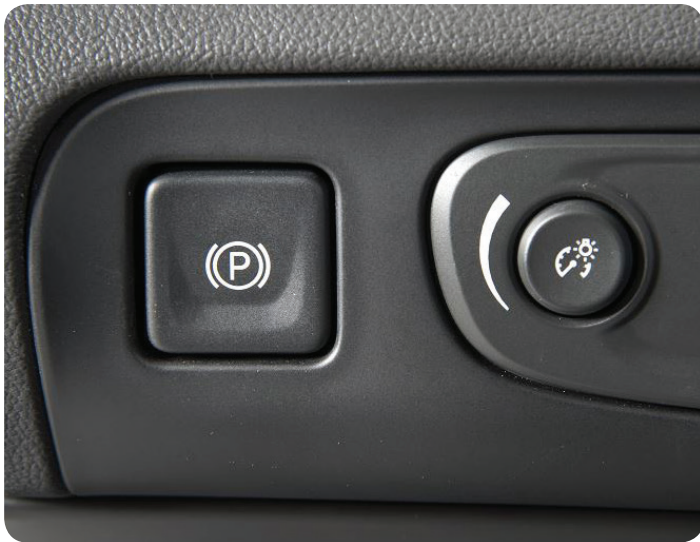
EPB button

The electric parking brake (EPB) may be inoperative on some 2018 Acadia, Enclave, Traverse and XT5 models. The Service Park Brake warning lamp also may be illuminated.

An inoperative electric parking brake may be due to several different conditions.

If the electric parking brake is inoperative and DTC C028F (Left Park Brake Actuator Circuit) or DTC C1586 (Right Park Brake Actuator Circuit) is set in the Electronic Brake Control Module (EBCM), check for water leaking into the rear actuator, causing a short to ground.

If the electric parking brake is inoperative and there has been a previous repair to the brake actuator, the inoperative condition may be caused by a software anomaly in the EBCM.

If DTCs C028F 04 (short to ground) and/or C1586 04 (short to ground) are set, verify which EPB actuator set the DTC and replace the actuator following the appropriate Service Information.

If there are not any DTCs set and the brake actuators have previously been replaced, program the K17 EBCM with the latest calibration available using the Service Programming System (SPS).
