New Sliding Cam Valve Lift System Provides Power and Economy

TECH LINK

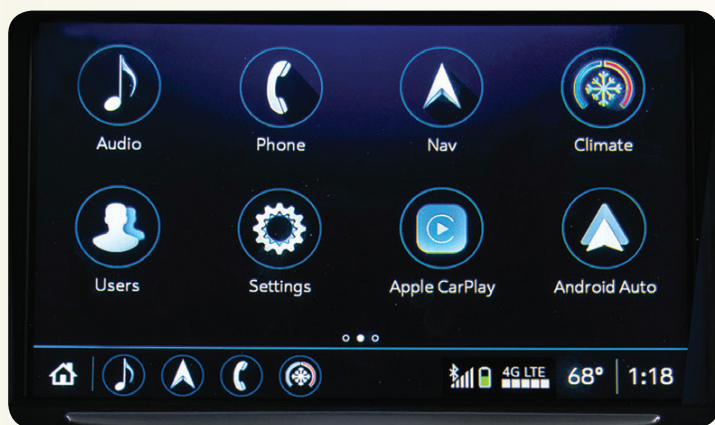
Infotainment system RPO IOT

When some 2017-2019 CTS; 2018-2019 ATS, XTS, Terrain; 2019 CT6, XT4, Camaro, Colorado, Equinox, Silverado, Volt, Canyon and Sierra models equipped with infotainment system RPOs IOS, IOT, or IOU are in demo mode (unsold vehicle), a phone may lose pairing to the infotainment system after the vehicle is turned off and Retained Accessory Power is no longer active (after 10 minutes).

In addition, some other operations of the infotainment system may not be retained, including stored favorites, last station tuned, Bluetooth synced devices, volume level, last app or screen view, and audio/equalizer settings.

The loss of functionality of these settings is the design intent of the infotainment system while it is operating in demo mode. No repairs should be made.

TIP: If a device was paired while the infotainment system was in demo mode, a similar condition could occur that randomly drops Bluetooth pairing after exiting demo mode. If the infotainment system is no longer in demo mode, but the device was originally

paired while in demo mode, delete the device from the infotainment system as well as delete the infotainment system from the device's Bluetooth settings, and then pair the device again.
