6.6L Duramax Diesel Engine Operating Characteristics

Customer Care and Aftersales

TECH LINK

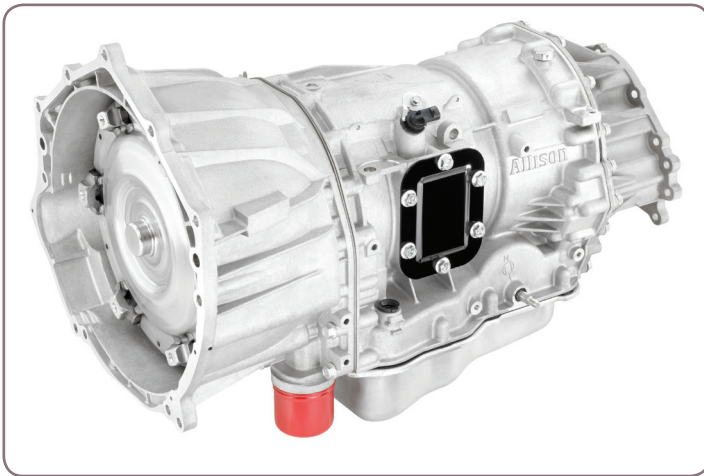
Following are several operating characteristics of the 6.6L Duramax diesel engine and Allison 6-speed transmission that should be considered normal operation.
