## All-New 2019 Blazer Arrives with **ATTITUDE**

## TECH LINK

GM TechLink is published for all GM retail technicians and service consultants to provide timely information to help increase knowledge about GM products and improve the performance of the service department.

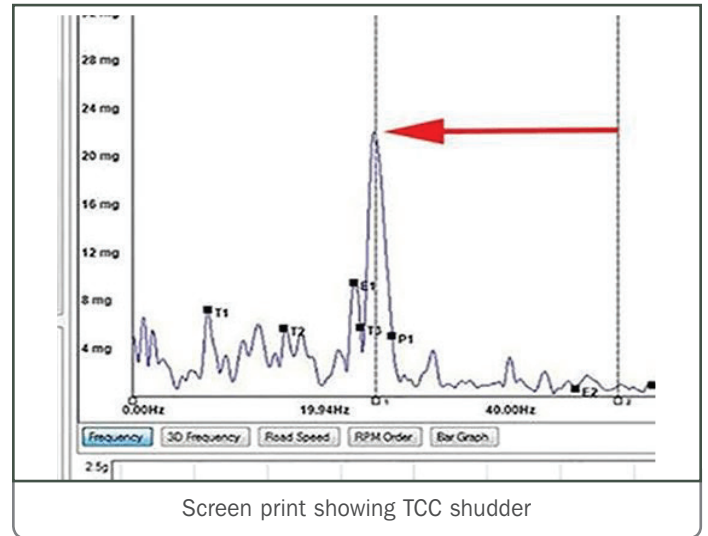
The TCC shudder condition is related to moisture content in the transmission fluid. The current fluid tends to be hygroscopic, or absorbs moisture, which increases the chance of TCC shudder. There are three different fluid exchange procedures to follow,

New fluid exchange procedure using a TransFlow adapter (1), transmission fill adapter (2) and new tool kit components.

The new fluid exchange procedure requires the use of the DT-45096 TransFlow Cooler Flush Machine and DT-52263 Transmission Fluid Exchange Tool Kit. The tool kit began shipping to dealerships at no charge in late January 2019. All GM dealerships should receive the tool kits by the end of March 2019.

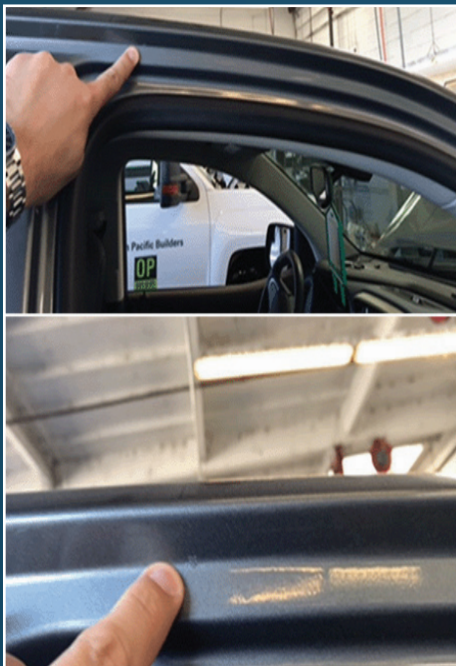
Good photos show location and details

In this first set of photos, shown left, the first one is zoomed-out to establish the location of the condition. The additional picture is zoomed-in closer to show the defect that is being photographed.

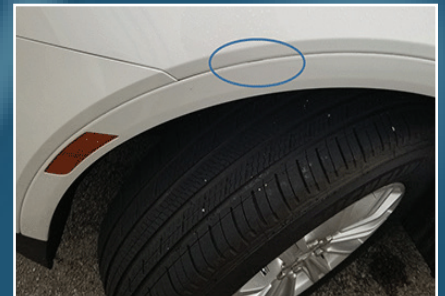
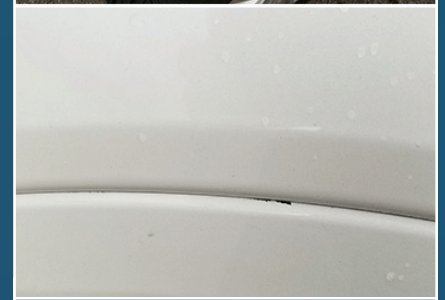
Good photos show location and details

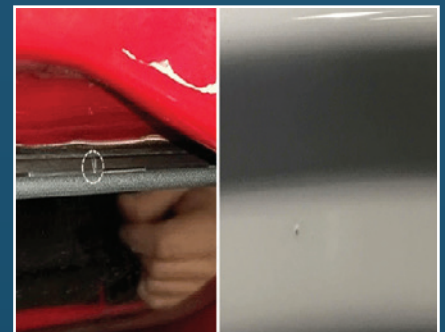
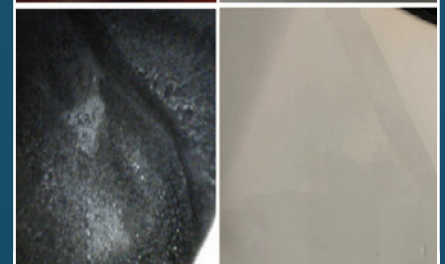
The following set of photos, shown lower right, show some unacceptable images that do not clearly show

Poor examples that do not offer additional information.

the region of the concern in question. The photos are taken so close to the defect that it is difficult to determine where the location is on the vehicle.

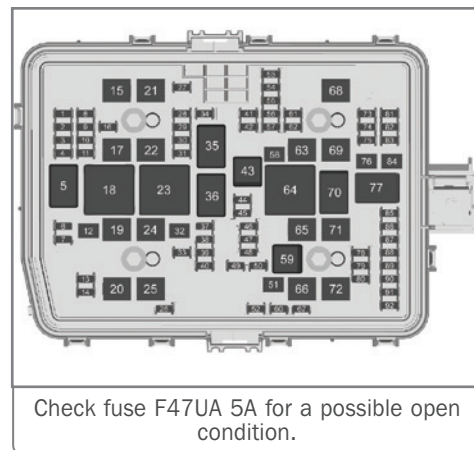
If DTC C119B is set in the TCCM, DTC P0700 is set in the TCM, and DTC P2534 is set in the ECM, check fuse F47UA 5A for a possible open condition. If the fuse is open, refer to the appropriate Service Information and Bulletin #18-NA-301.

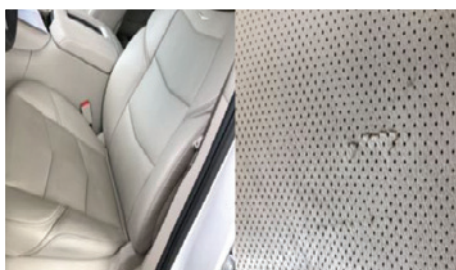
The next set of photos, shown right, show an overall shot of the concern along with a close-up photo, but does not identify where the condition is in the photo.

Poor photo that does not show location.
