Chevrolet teamed up with premier offroad aftermarket supplier AEV (American Expedition Vehicles) to create the new 2019 Colorado ZR2 Bison (RPO ULV).

Colorado ZR2 Bison Offers Extreme Off-Road Performance

Shift Lever Rattle Sound

New Trailering App Trailer Connection and Lighting Diagnosis

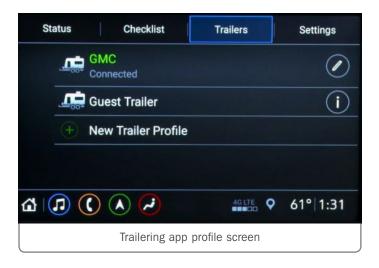
When a trailer is connected, the Trailer Lighting Control Module senses the trailer connection using the Park and Stop/Turn Signal lighting circuits and alerts the driver by requesting a trailer profile setup through the trailering app on the infotainment screen (P17 Info Display Module). The Trailer Detection Alert setting must be enabled for the alert to display when a trailer is connected.

With a trailer connected and the ignition off, the Trailer Lighting Control Module will periodically pulse the lighting circuits of the trailer to verify it is still connected. Depending on the configuration of the trailer lights, the trailer lights may periodically flash as part of the trailer theft deterrent function. These flashes may be more visible in dark ambient light environments and correspond to when the Trailer Lighting Control Module pulses the lighting circuits to ensure the trailer is still connected. The flashing or flickering lights is a normal condition.

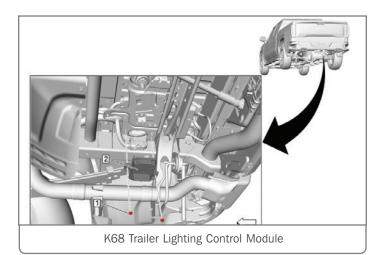
On some trucks, a Trailer Disconnected, Check Connection message may display on the DIC without a trailer being connected. If the Trailer Lighting Control Module detects enough of a load on any of the trailer tail lamps or stop/turn signal circuits, it may determine that a trailer has been connected. However, any moisture or corrosion in the trailer receptacle or Trailer Lighting Control Module connector, of anything left plugged into the trailer receptacle, such as trailer adapters with built-in test LEDs, may cause the module to think that a trailer is connected.

If this condition is found, remove anything plugged into the trailer receptacle and inspect for any moisture or corrosion in the trailer receptacle at the rear bumper, the chassis harness connector that plugs into the trailer receptacle, and the Trailer Lighting Control Module connector. Clean and repair any connection issues.

If the condition is not corrected after performing these checks, do not replace the Trailer Lighting Control Module. GM Engineering is currently evaluating this condition and working on a repair recommendation. For additional information, refer to #PIT5648.
