New Techline Connect Application Brings It All Together for Technicians

TECH LINK

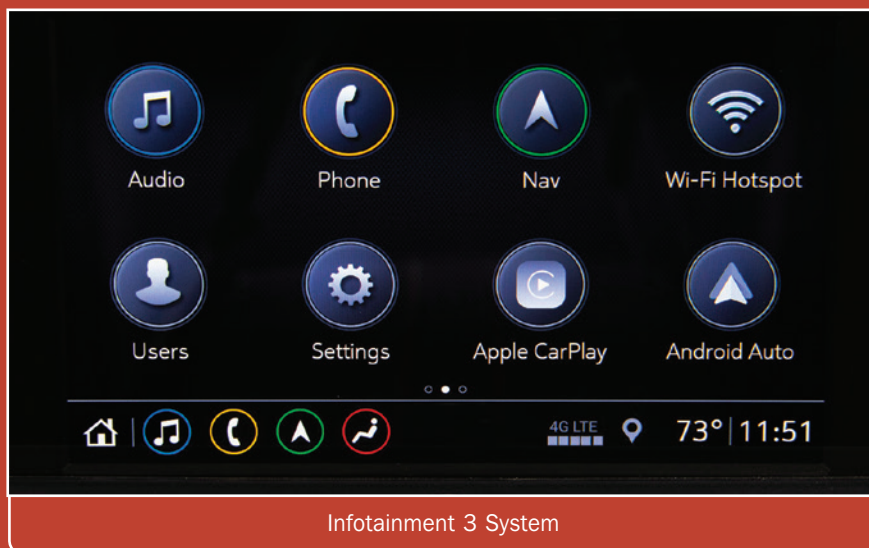
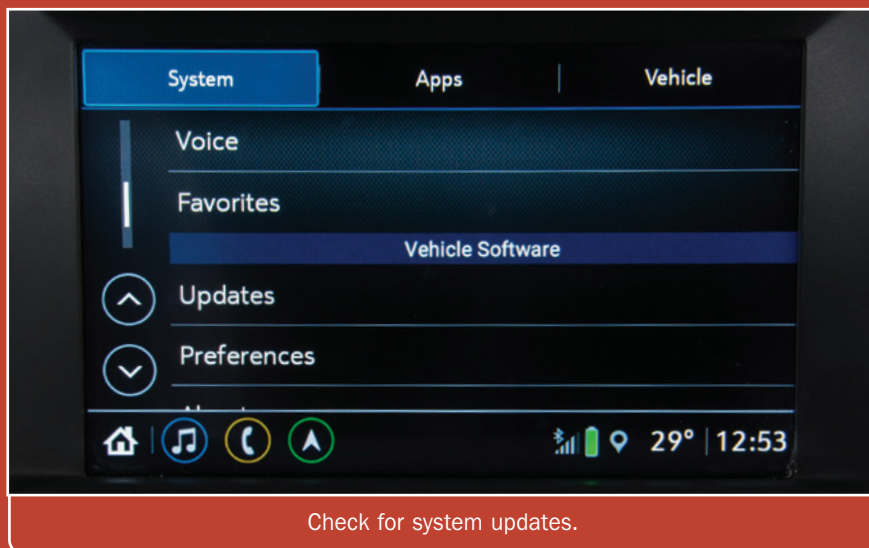
Several radio-related performance issues may appear if all steps are not completed when programming the radio on 2018-2019 Regal, ATS, CTS, XTS, Terrain; 2019 CT6, XT4, Blazer, Camaro, Colorado, Equinox, Malibu, Silverado 1500, Volt, Canyon, and Sierra 1500 models equipped with the Infotainment 3 System (RPO IOS, IOT, IOU). Failure to follow all programming steps will result in repeat repair attempts and possible control module damage.

The radio programming procedures include programming software, calibrations, and resetting the Manufacturer Enable Counter (MEC). Do not load only the radio calibrations without loading the radio software.

Before proceeding with USB programming, using a USB 2.0 flash drive with a minimum capacity of 16 GB, check for any Infotainment System Over-the-Air (Info Sys OTA) updates. Go to Settings > System > Updates on the infotainment screen. If an update is available, decline the update by selecting Details and then scroll to the Decline Update option. After selecting Decline Update, a Decline Update confirmation is then needed. If there are not any Info Sys OTA updates that are available, proceed with USB programming.

If USB programming is interrupted, a five minute recovery time period may be necessary before the software will reinitialize. Wait three minutes with the ignition off, all doors closed, and all vehicle systems off. When restarting the USB portion of the programming, the display will show a count-down timer for up to five minutes before proceeding with the USB File Transfer.

Upon completion of USB programming, remove the USB drive and follow the instructions on the infotainment screen. At the end of programming, choose the Clear DTCs function on the SPS screen.

When replacing a radio, the Manufacturer Enable Counter (MEC) must be reset. If the MEC is not reset, it can cause Wi-Fi Hotspot concerns. The counter is reset using GDS 2. After identifying the vehicle, select Module Diagnostics > Radio (select appropriate RPO) > Configuration/Reset Functions > Reset Manufacturer Enable Counter and follow the on-screen instructions.

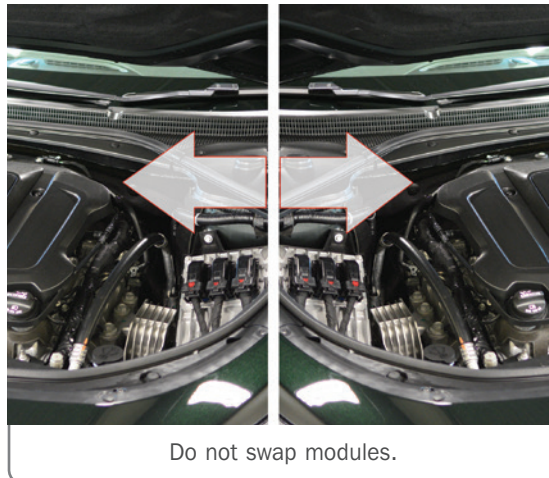
Swapping control modules, including the ECM, BCM, EBCM, SDM, TCM, ECC (HVAC), EPS, HPCM, IPC, and Radio, between vehicles will damage both controllers and will result in a no start condition on both vehicles due to the new vehicle security code protocol.

These modules all have IDs that must match in order for the BCM to allow starting the engine. The control modules are coded to the vehicle when they are first programmed, which results in a unique ID being permanently stored in that module. Swapping these security-related modules will cause difficult and time-consuming remediation processes that may include the purchase of new components for both vehicles.

GM's diagnostic strategy does not support the practice of swapping control modules during the course of diagnosis or in order to expedite a repair. Features in today's vehicles are increasingly software-configurable. They can affect vehicle safety systems, anti-theft systems, performance, and customer personalization information.
