BOLT EV

Front Seatback Cover Replacement

The front seatback cover on some 2017-2019 Bolt EV models may become detached between the upper seatback cover and the side air bag. An updated seatback cover design has been released to address this condition. The new design features additional J-hooks that secure more tightly to the side air bag in order to keep the seat cover from becoming detached.

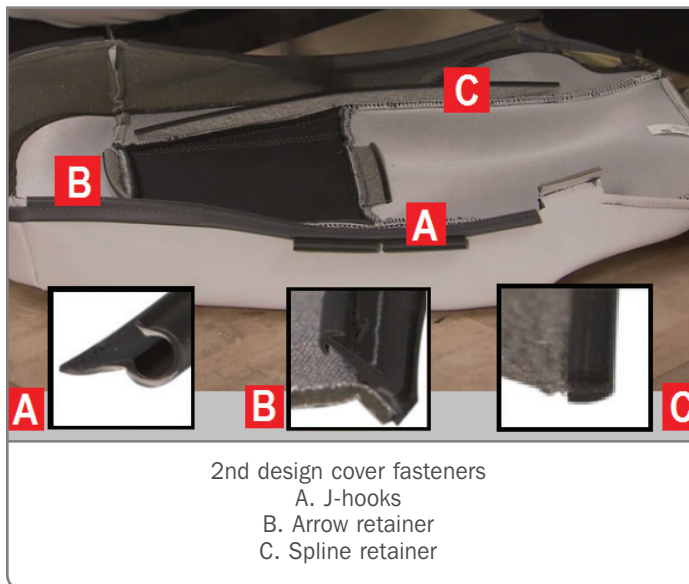
The 2nd design seatback cover comes with two additional J-hooks in the lower seatback area. It also uses J-hooks around the side air bag, arrow retainers around the edge and bottom of the seatback cover, and a black spline retainer along the inner edge of the cover.

Begin the installation of the new cover by aligning the middle section of the seatback cover with the channel in the middle of the seatback. Use a trim stick to seat the retainer into the channel.

Work around the edge of the seatback cover to seat the black spline retainer into the channel.

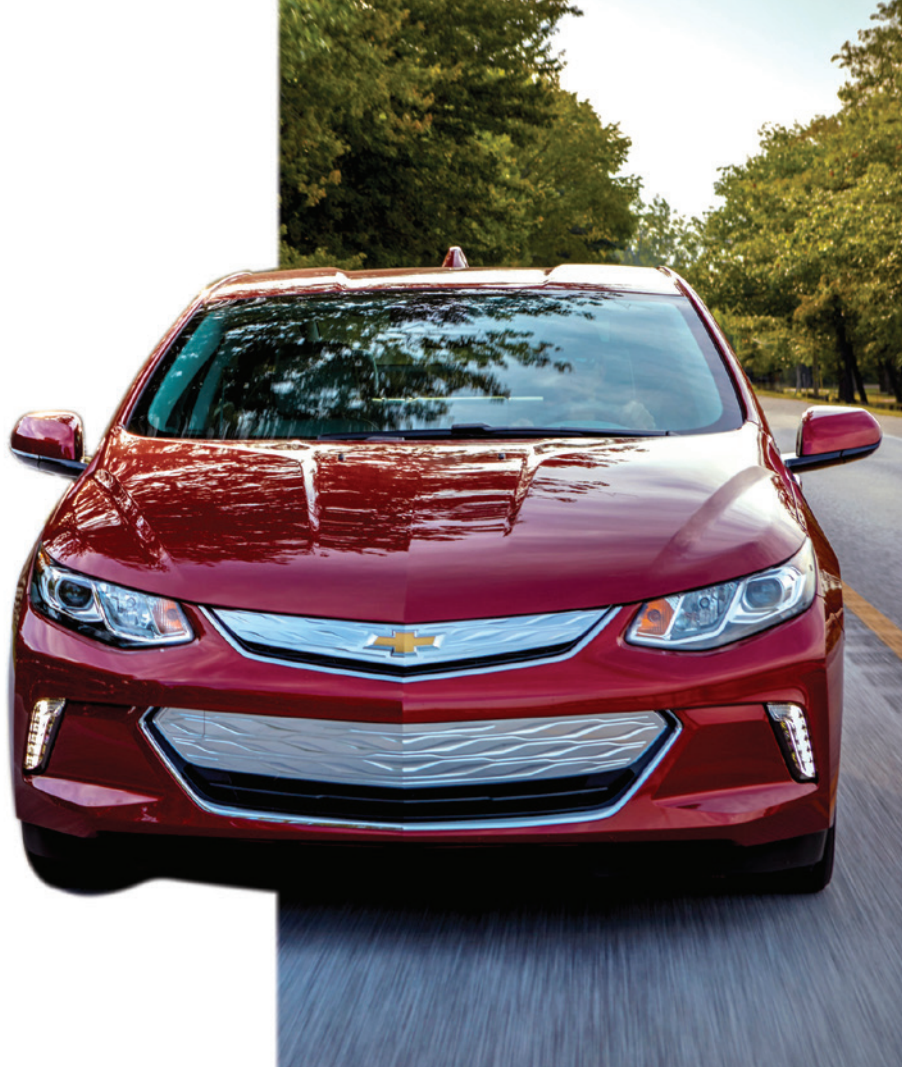
The first step in diagnosis of the pull condition is to inspect the vehicle's tires. The most common cause is usually related to incorrect tire pressure, tire wear or uneven tread depth, an incorrect installed tire or a mis-matched brand of tires.

The regenerative braking system applies torque evenly to both axles while braking in a straight line.

To verify that the tires are in the proper condition, inspect the tires for wear and correct installation. Also correct the tire pressure, if necessary. Authorization will be needed to replace any tires if needed. Review Bulletin #00-03-10-003 (U.S.) or #01-03-10-003 (Canada) for what constitutes tire damage vs. normal wear and tear.

If none of the conditions are present with any of the tires, switch the front tires to the rear to see if the pull condition goes away or is lessened. If the pull is less, it may be necessary to replace those tires on the rear of the vehicle.

If the pull condition is still present, get authorization to replace all four tires and wheels from another vehicle to determine if the pull condition goes away. If the tires are confirmed to be good, follow further diagnostics in the appropriate Service Information.

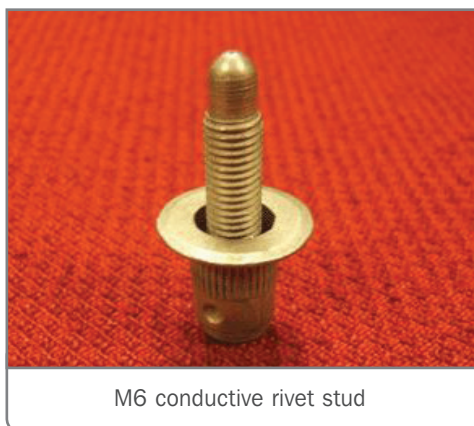
Corroded or stripped electrical ground connections can cause a loss of module communication and other electrical system malfunctions, leading to unnecessary repairs and parts replacement. The electrical system relies on a secure, corrosion-free ground connection in order to function properly, so any damaged ground connections must be repaired to provide a good mounting point with a low resistance ground path as well as prevent future corrosion.

Before installing a new fastener in the current ground location or at a new mounting location, remove any grease from the repair area using a residue-free solvent. Select a location that has 20 mm (0.79 in.) clearance behind the panel surface and 20 mm (0.79 in.) clearance surrounding the stud flange.

After drilling the mounting hole (for a new location), remove any paint and primer from the area until bare metal is visible.

Install the appropriate new fastener and check that it is securely fastened without any detectable movement.

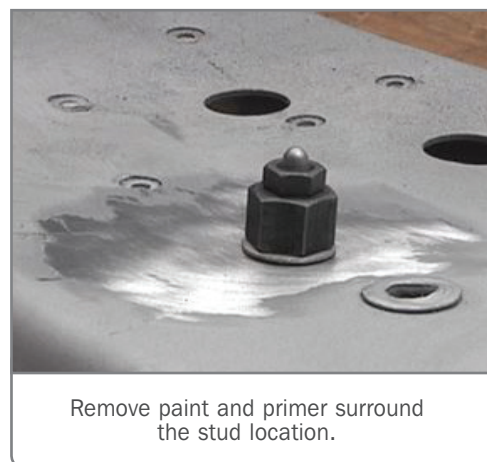
TIP: The surrounding area must be properly finished prior to the installation of the ground wire terminal and conductive nut to maintain a secure, stable and corrosion-free electrical ground.

Cover the stud threads with painter's tape or equivalent and refinish the repair area using an anti-corrosion primer.

Thoroughly clean the stud threads using a residue-free solvent. Once dry, apply dielectric lubricant to the threads.

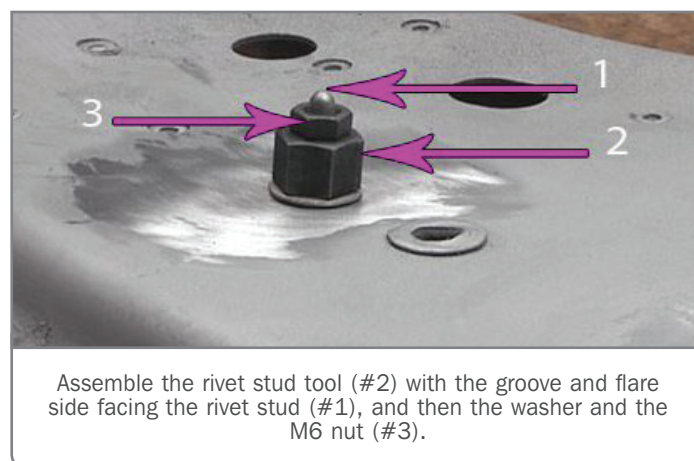
TIP: Fretting corrosion is a build-up of insulating, oxidized wear debris than can form when there is a small motion between electrical contacts, causing electrical resistance across the connection.

Remove any corrosion or contamination on the electrical ground wire terminal. Install the terminal, tighten the conductive nut to the proper torque and verify system operation.
