GE-52200-A Powertrain Lift Table . . . . .	1
Coolant Entering Engine Cylinders . . . . .	4
Camshaft Position System Performance DTCs Set in History . . . . .	5
Infotainment Screen Flicker . . . . .	6
Intake Manifold Vacuum Leak . . . . .	7
Dealer Case Management Enhancements . . . . .	8
Click Sound from the Torque Tube . . . . .	9

GM TechLink is published for all GM retail technicians and service consultants to provide timely information to help increase knowledge about GM products and improve the performance of the service department.

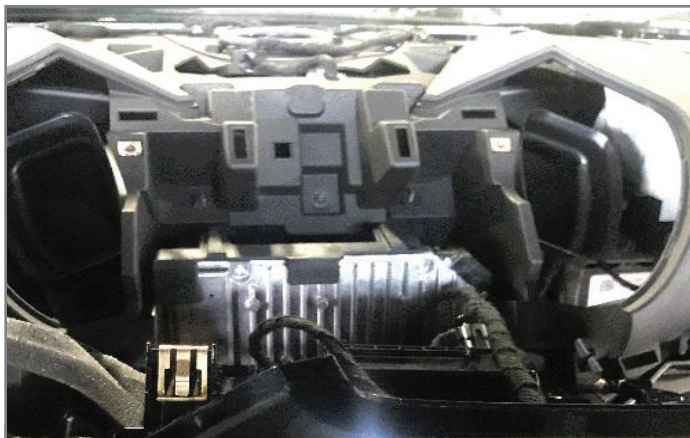
Access the back of the infotainment screen.

Refer to Radio Control Assembly Replacement in the appropriate Service Information to access the back of the infotainment screen.

On the rear of the screen, reroute the wires to prevent covering the Wi-Fi antenna on the instrument panel. The components include the Wi-Fi antenna, Branch Integrated Center Stack (ICS) power cable, and Branch Low Voltage Differential Signaling (LVDS) cable.
