New GM Service Technical College App	1
Corvette ZR1 Rear Spoiler Adjustment.....	3
Proper GM Accessory Assist Step Installation	6
Whine Sound from Under Center of Vehicle	7
Viewing and Emailing GDS 2 Session Files	8
PCV Crankcase Pressure Control Diaphragm	9
Rattle Sound Near Front of Engine	10

TECH LINK

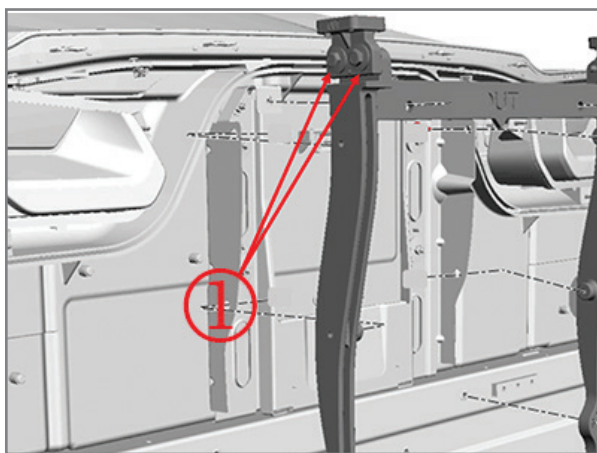
The rear spoiler of the 2019 Corvette ZR1 is installed at the dealership during the Pre-Delivery Inspection (PDI). After installation of the rear spoiler, it may be noticeable that the spoiler has a crooked appearance. If this condition is evident, the Rear End Secondary Spoiler Bracket may be out of adjustment.

Rear End Secondary Spoiler Bracket

To correct the position of the rear spoiler, remove the rear fascia and adjust the Rear End Secondary Spoiler Bracket as needed until the spoiler is level.
