July 2019, Volume 21, No. 13

Re-Centering the Transmission Range Control Module

Pinched Instrument Panel Harness

Rough Idle After Engine Repairs

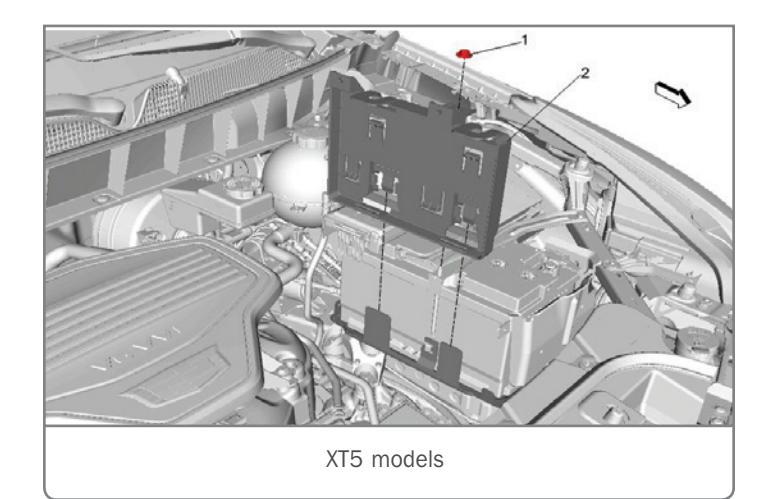
Some 2017-2019 XT5 and 2017 LaCrosse models may have a Service Transmission message displayed on the Driver Information Center along with one or more of the following DTCs: P0722, P0729, P0730, P0731, P0732, P0733, P0734, P0735, P073D, P073E, P07A2, P07E4, P07E5, and P1769. These conditions may be caused by misalignment of the coupler between the Transmission Range Control Module (TRCM) and the transmission. The TRCM will need to be re-centered.

With access to the TRCM, loosen (approximately 1/4 inch) the automatic transmission range selector actuator hardware module bolts.

Rotate the automatic transmission range selector actuator hardware module clockwise to the right lock position (blue line). Next, rotate the module counterclockwise to the left lock positon (green line). Finally, rotate the module clockwise until it is centered between both full lock positions (red line). **TIP:** The turning radius of the module will be very slight when centering.

With the module re-centered, perform the TRCM learn procedure (not for new modules). If the test fails, re-adjust the module and retest. The test fails again, refer to the appropriate Service Information for further diagnostics on the DTC set.

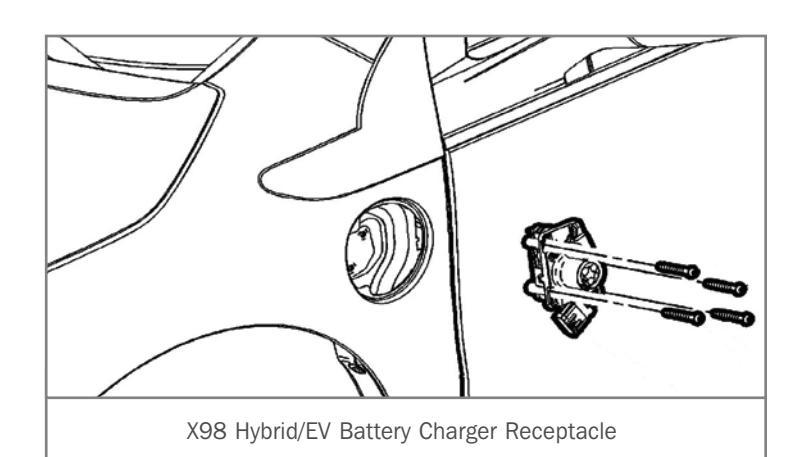
Battery charger receptacle

Some 2011-2015 Volt models and 2014-2016 ELR models may not shift out of Park. If this condition is present, there may be water intrusion in the X98 Hybrid/EV Battery Charger Receptacle, which may cause the vehicle to determine that the charging cord is plugged in. When the charging cord is plugged in, the vehicle will not shift out of Park.

- 1. Disable the high voltage system using SI Document ID 3610665
- 2. Unplug the charger receptacle and check if the vehicle now can be shifted out of Park.
- 3. If the condition is resolved, replace the Drive Motor Battery Charger Receptacle. Updated part numbers have been released.
