New Turbocharged 2.7L 4-Cylinder Engine

6.6L V8 Gasoline Engine Exchange

Throttle Body Connector Terminal Tension

TECH LINK

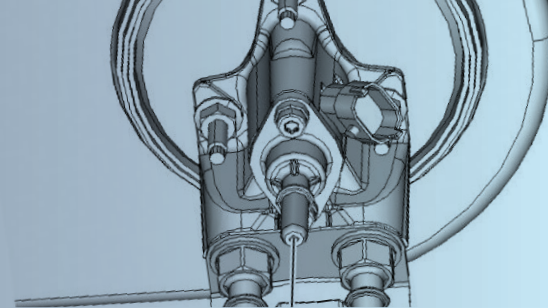
DEF Injector Replacement

Some 2016-2019 Chevrolet Low-Cab Forward (LCF) trucks equipped with the 3.0L diesel engine (RPO IZ3) or 5.2L diesel engine (RPO I1B) may have an illuminated Check Engine MIL and DTC P208E (DEF Injector) set in the Diesel Exhaust Fluid (DEF) control module.

Follow the appropriate Service Information diagnostics for DTC P208E. The DEF control module detects DEF injector sticking by monitoring current change when commanded on. An expected current change should be detected when the interval valve is operated. DTC P208E will set when the DEF control module detects that the current change is small when the DEF injector is commanded on longer than 120 seconds, which indicates a stuck DEF injector.

If diagnostics lead to replacing the DEF injector, replace the DEF supply pump filter element as well as the DEF injector. Place the supply pump filter element in a bag to be returned with the DEF injector.

When removing the DEF injector, do not disassemble the DEF injector by removing the two central bolts on the injector. Disconnect the injector by remove the three nuts on the outer edges of the injector. If the two bolts are removed instead, the resin portion may be damaged and the sealing performance may be lost, resulting in an exhaust gas leak. Also, do not reuse the gasket.

During installation, use a clean cloth to wipe off any foreign matter attached to the DEF injector. Using air to blow off any foreign matter may cause it to enter in the urea passage, resulting in a failure.
