# Multiple Electrical Conditions, Illuminated Instrument Cluster Warning Lamps, and DIC Messages

# Lack of A/C Performance in High Ambient Temperatures

# Bluetooth Microphone Poor Performance

# Rear Brake Squeal Sound

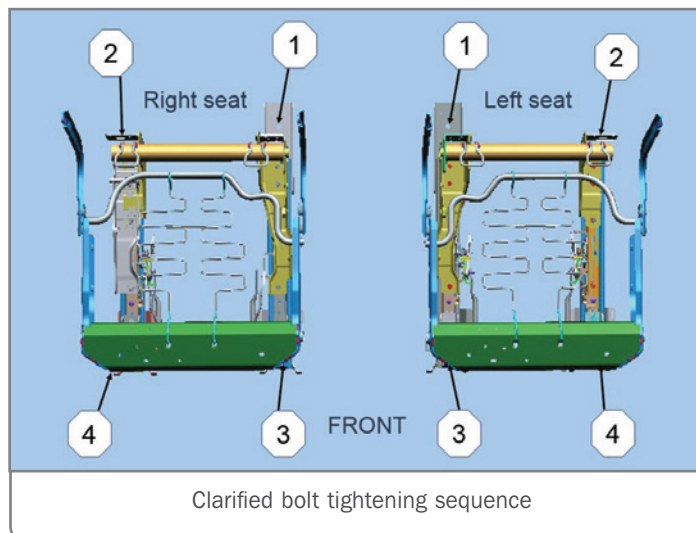
The circled numbers in the Service Information illustration indicate the tightening sequence. The sequence is the same for both bucket seats and the 60/40 seats.
