All-New Cadillac CT5 Debuts

UPDATE:

Rattle Sound near Front of Engine

TECH LINK

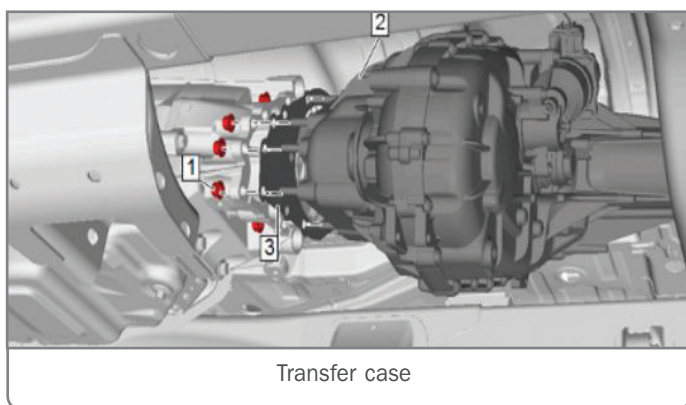
A transfer case noise, vibration and harshness (NVH) concern may be found on some 2020 Silverado 2500HD/3500HD and Sierra 2500HD/3500HD models equipped transfer cases RPO NQF (Electric Shift Cont, Two Speed Transfer Case) or NQH (Active, Two Speed, Switch Activated Transfer Case). In some instances, a clunk sound may be heard during a coast-down event.

The NVH condition may be the result of a misalignment between the transmission output shaft and the transfer case input. The misalignment could cause the transfer case shift collar to slip out of engagement.

If these conditions are evident, road test the vehicle up to 40 mph (64 km/h) on a smooth, flat road. Allow the vehicle to coast in Drive to below 10 mph (16 km/h), without using the brakes, and listen and feel for any bumps or clunk sounds from under the vehicle. Repeat these steps at least eight times in order to verify the condition.

Loosen all 12 transfer case bolts, but do not remove the bolts. It may be helpful to use a screw jack to raise and lower the transmission for better access to all of the bolts.

With the bolts loosened, slide the transfer case rearward so there is a minimum gap of 1/2 inch (13 mm), but not more than 1 inch (25 mm). Next, slide the transfer case forward until it is contacting the transmission again.

TIP: When tightening bolts 10, 11, and 12 in the sequence, remove the bolts and clean the threads on each bolt and in the transmission with brake cleaner, and then blow out the hole with compressed air to ensure there is no fluid left in it. Failure to do this may lead to stripped threads.
