Mid-November 2019, Volume 21, No. 22

New TechPRO Diagnostic App for Non-GM Vehicles 2
Unable to Deactivate Brake Boost System in GDS 2 5
Unwanted Power Door Unlock Command 6
Lane Keep Assist Icon Missing from Instrument Cluster 6
Parking Brake Cable Squeak Sound 7
Your Thoughts? Tell Us in the TechLink Survey8

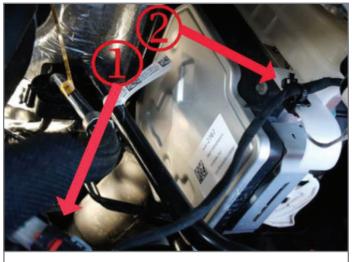
Engine Coolant Temperature Sensor 4 (#1)

After the Brake Master Cylinder Assembly has been replaced on 2019-2020 XT4 models, a GDS 2 error message may display when trying to deactivate the brake boost system when performing the hydraulic bleed procedure.

Being unable to deactivate the brake boost system may be caused by the B20 Brake Fluid Level Switch and the B34D Engine Coolant Temperature Sensor 4 Connector being swapped during reassembly. If these connectors are swapped, DTCs C0049 SYM05 (Low Brake Fluid Indicated) will be stored in the Electronic Brake Control Module (EBCM) and a P2AFF SYM (Engine Coolant Temperature Sensor 4 Circuit High Voltage) will be stored in the Engine Control Module (ECM).

The Brake Fluid Level Switch Connector and the Engine Coolant Temperature Sensor 4 Connector are identical and can be easily swapped. The harness retainers and the wire colors are different.
