Use Dielectric Grease to Prevent SPARK PLUG Carbon Tracking

Broken or Loose Engine Ground Cable

Extended Engine Crank Time

Cooling Fans Running for an Extended Period

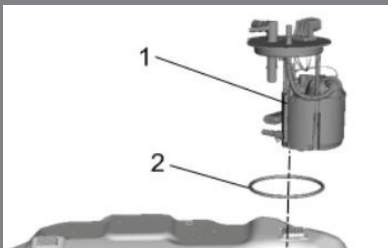
Extended Engine Crank Time

Some 2018-2019 Equinox and Terrain models may have an extended crank time that occurs intermittently after the vehicle has been sitting for at least 20 minutes. In this case, it may take three seconds of crank time before the engine starts.

If there is an extended crank time condition, it may be caused by the check valves stuck open in the fuel feed front pipe and the fuel tank fuel pump module. After verifying the extended crank time, replace both the fuel feed front pipe and the fuel tank fuel pump module.

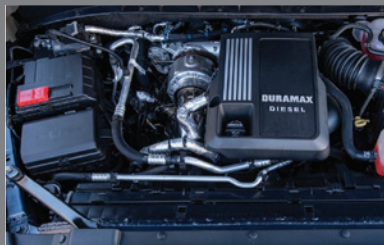
Cooling Fans Running for an Extended Period

Some 2020 Silverado 1500 and Sierra 1500 models equipped with the 3.0L diesel engine (RPO LM2) may have the engine cooling fans running continuously for an extended period of time. The Check Engine MIL also may be illuminated.

Currently, an engine calibration in the Engine Control Module (ECM) will falsely set DTC P0111 (Intake Air Temperature (IAT) Sensor 1 Performance), which occurs when the engine block heater is used in ambient temperatures above 0°F/-18°C. As a result, the cooling system will go into remedial action and turn on the cooling fans at 100%. The remedial action will continue until the engine goes through a six hour cold soak.
