Duramax Diesel Warm  
Engine Idle Knock Sound . . . . . 3

Unable to Deactivate  
Brake Boost System . . . . . 5

Poor Heater Performance Due to  
Coolant Hose Restriction . . . . . 6

### TECH LINK

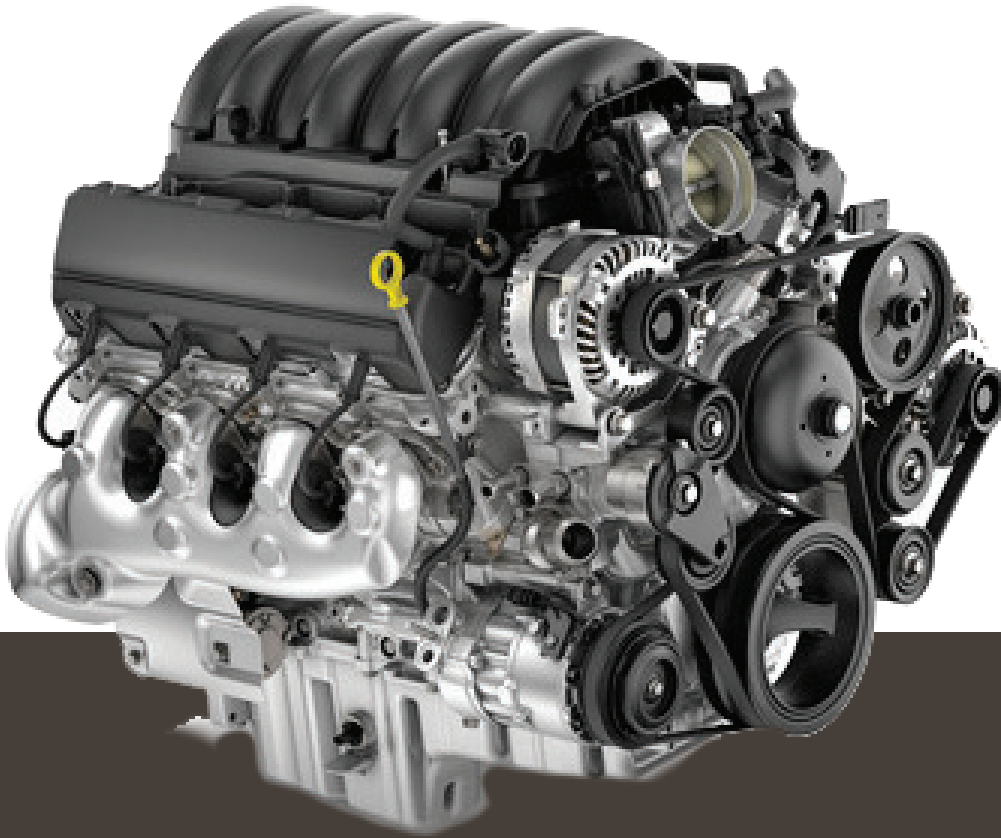
A Low Oil or Add Oil message may be displayed on the Driver Information Center (DIC) on some 2019 Silverado 1500, Sierra 1500; 2020-2021 Silverado 1500, Silverado 2500/3500, Sierra 1500, Sierra 2500/3500; 2021 Tahoe, Suburban, Yukon, and Escalade models equipped with the 5.3L V8 engine (RPO L82, L84), 6.2L V8 engine (RPO L87) or 6.6L V8 engine (RPO L8T). The DIC message may display prior to the first oil change.

The oil level condition may be caused by new engine RTV sealant leaching silicone into the engine oil.

When the silicone leaches into the oil, it can contribute to aeration of the oil and cause an erroneous oil level switch response. During normal engine operation, the Engine Control Module (ECM) checks the oil level dynamically between the RPM range of 1,000-1,400 RPM. Other Small Block engine RPOs check the oil level at idle.

The oil condition will most likely occur before the first scheduled oil change or after the recent addition of new RTV sealant, for example, during an oil pan replacement. In addition, the new one-piece oil pan design used on these engines may also increase the occurrence of this condition.

If this condition is found, verify the engine oil level is full. Also check that there are not any oil level switch-related DTCs set and that the oil switch reads OK using GDS 2 (engine off/ignition on).
