Diesel Exhaust Fluid Consumption

Rushing Air Sound in PCV Tube

Fuel Injector Replacement Guidelines

TECH LINK

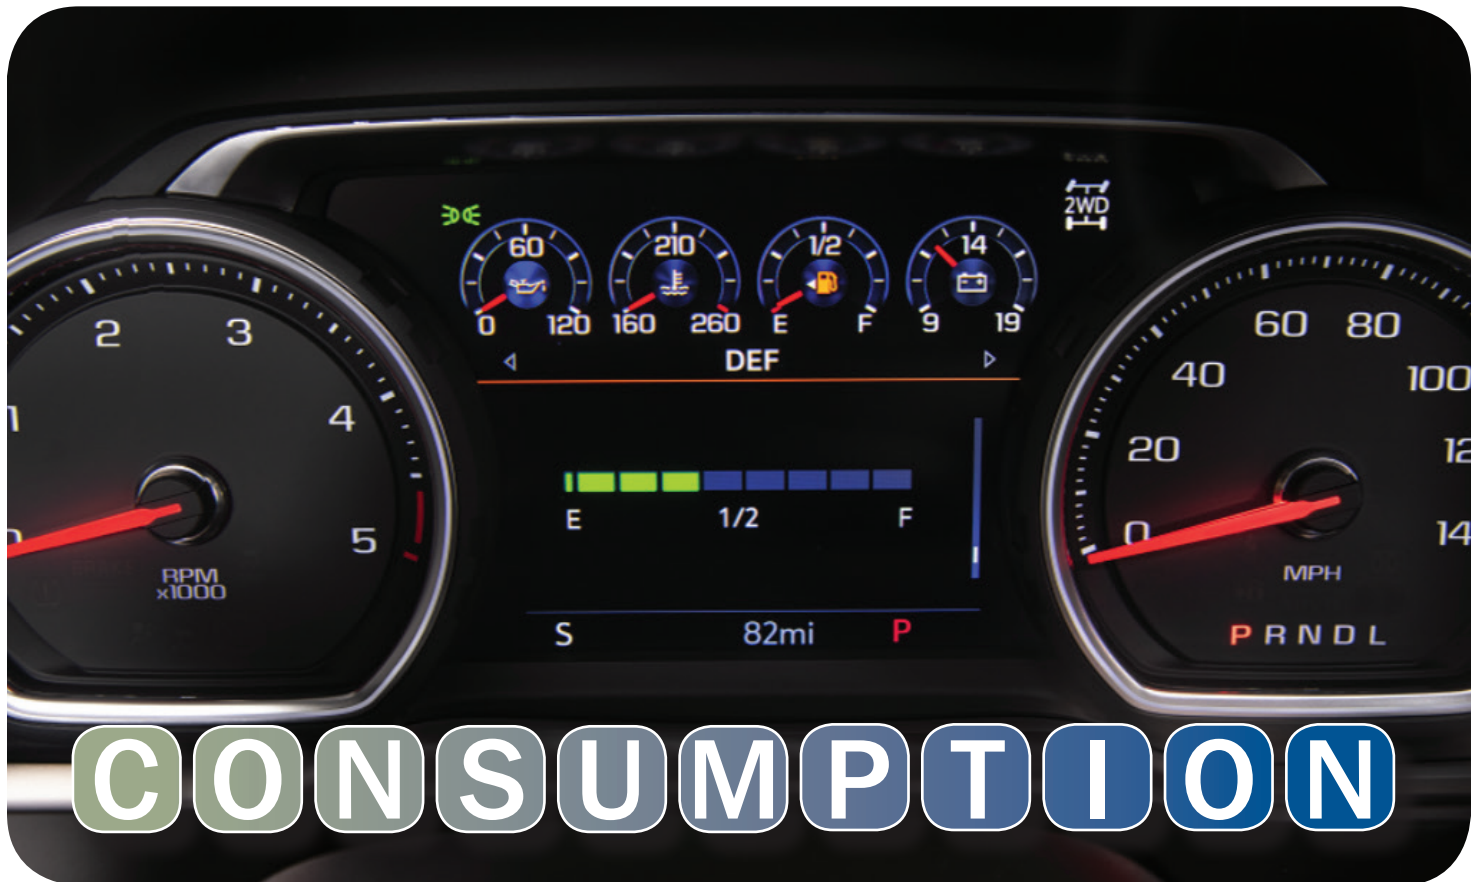
The diesel engines (RPOs LWN, LM2, L5P, L5D) available on 2020 Colorado, Express, Silverado 1500, Silverado 2500HD/3500HD, Silverado 4500HD/5500HD/6500HD, Canyon, Savana, Sierra 1500, and Sierra 2500HD/3500HD models use Diesel Exhaust Fluid (DEF) in order to reduce the exhaust Oxides of Nitrogen (NOx) levels within the Selective Catalyst Reduction stage of the exhaust aftertreatment system.

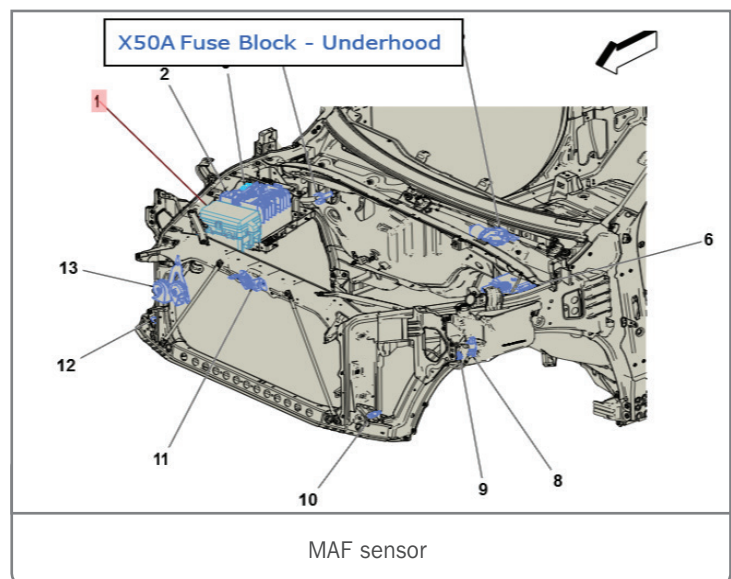
Also diagnose any applicable DTCs before replacing the MAF sensor. Refer to the appropriate Service Information for diagnosing each DTC.
