## Corvette Stingray

### TRACK PREPARATION

## TECH LINK

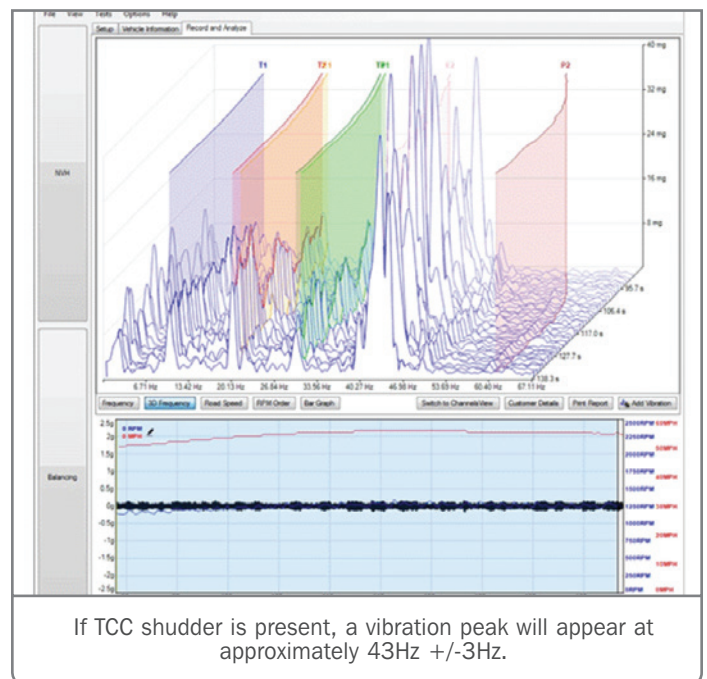
To confirm TCC shudder, the vibration concern must be present in normal operation, but not present with the torque converter clutch disabled or with the torque converter clutch locked. Also perform a TCC slip control test. If TCC shudder is present, a vibration peak will appear at approximately 43Hz +/-3Hz. If the vibration frequency follows engine, tire, or driveshaft speed, then it is not a TCC shudder vibration.

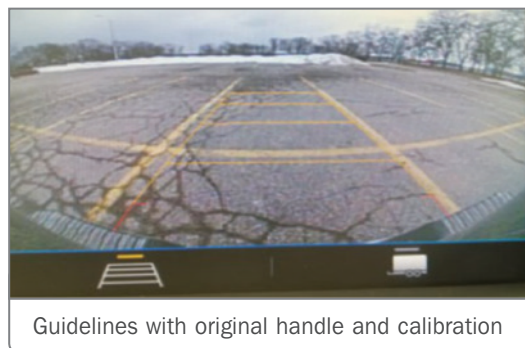
The rear camera guidelines may be incorrect or misaligned after the tailgate handle or the entire tailgate has been replaced on some 2020 Silverado 2500/3500 and Sierra 2500/3500 models equipped with tailgate RPOs QK1 and QT2/QT3 and infotainment system RPO IOR.

Guidelines with original handle and calibration

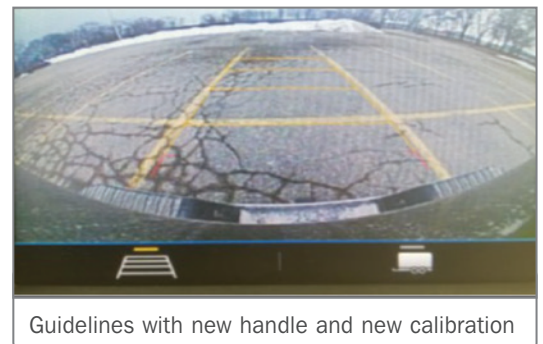
The incorrect guidelines may be caused by a different rear camera angle in the replacement tailgate handle compared with the original tailgate handle. The new rear camera angle requires the infotainment system (radio) software to be updated when the tailgate handle/tailgate is replaced.

Guidelines with new handle and new calibration
