## Repair or Replace?

### NEW PROGRAM IDENTIFIES 9T65 TRANSMISSION REPLACEMENTS

GM TechLink is published for all GM retail technicians and service consultants to provide timely information to help increase knowledge about GM products and improve the performance of the service department.

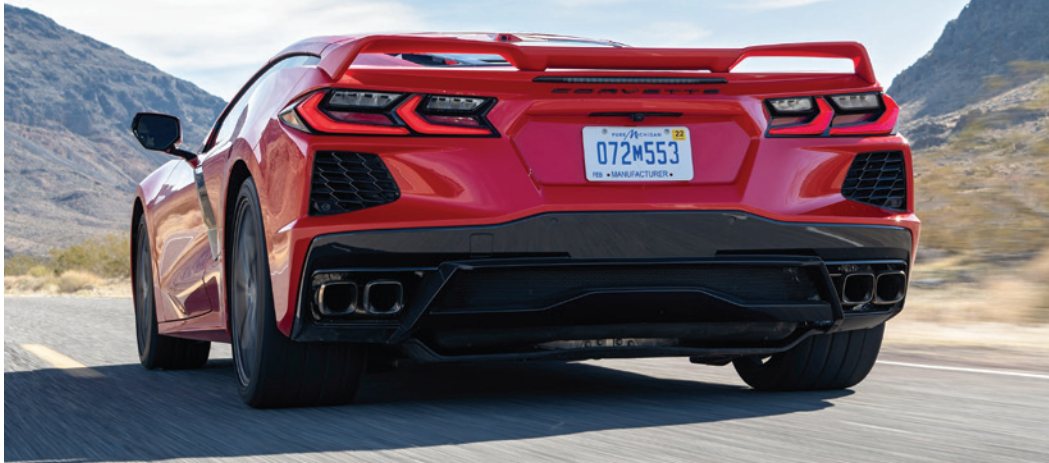
2020 Corvette Stingray models equipped with the Z51 Performance Package feature a rear spoiler that adds downforce to improve high-speed stability. If the Z51 spoiler is to be replaced with the high wing accessory spoiler, there may be some concern about applying heat to soften the two-way tape retaining the spoiler without damaging the rear fascia paint. The fascia paint may not be able to withstand high heat generated by a heat gun.

To remove the Z51 rear spoiler, it's recommended to use 50 lb. test monofilament fishing line. Position the line between the spoiler and fascia and, with a sawing motion, move the fishing line through the two-way tape to remove the spoiler. Using the fishing line method will eliminate any possibility of damage to the painted fascia surface.

Do not use a heat gun, or attempt to pry the spoiler off the fascia with a plastic, metal or wood trim removal tool, in order to loosen the adhesive tape.

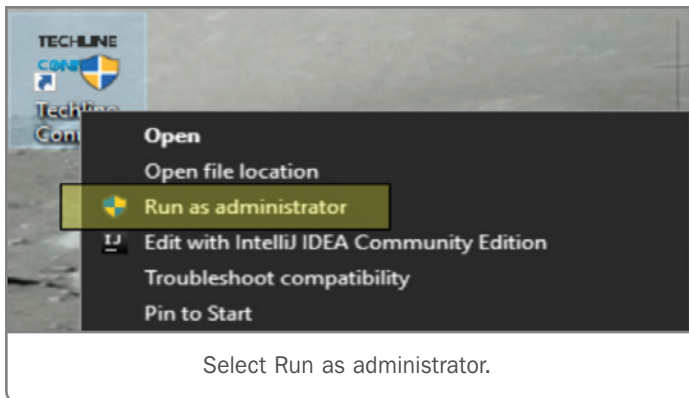
Many dealership networks have elevated administrative rights, which may limit automatic updates. To ensure all Techline Connect system updates are received, it's necessary to set up the app to be run as an administrator. The following steps only need to be performed once on each desktop.

1. Right-click the Techline Connect desktop icon and select Run as administrator.
2. To set Techline Connect to run as an administrator permanently:
  - Right-click the Techline Connect icon and select Properties.
  - Select the Compatibility tab at the top and check the "Run this program as an administrator." box. Click Apply and OK.
