July 2020, Volume 22, No. 13

Corvette Cooling System Draining and Filling Tips 2
Inspecting the Dipstick Tube O-Ring and Lower Oil Pan 5
Harmonic Balancer Sliding Back on Crankshaft6
Spark CVT7 Transmission Replacement7
Loose Instrument Panel-to-Body Harness Connector
Exhaust Brake Feel During Operation

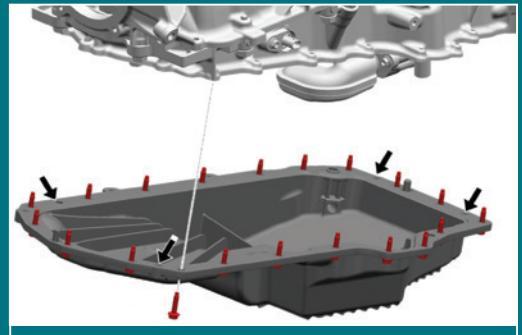
The composite oil pan is attached at the engine block lower structural extension (LCE). The oil pan incorporates four jack screws (threaded inserts) that need to be used during the removal procedure. Tighten the jack screw by hand 1 to 2 turns. Turn each uniformly and move to the next screw until the oil pan has full separation from the LCE. Do not pry on the oil pan to LCE or the sealing surface may be damaged.

The oil pan incorporates four jack screws to help with removal.

TIP: Do not gouge or scratch any engine sealing surface during the cleaning process. GM recommends using a plastic razor blade, plastic gasket scraper, a wood scraper or a non-metallic scraper

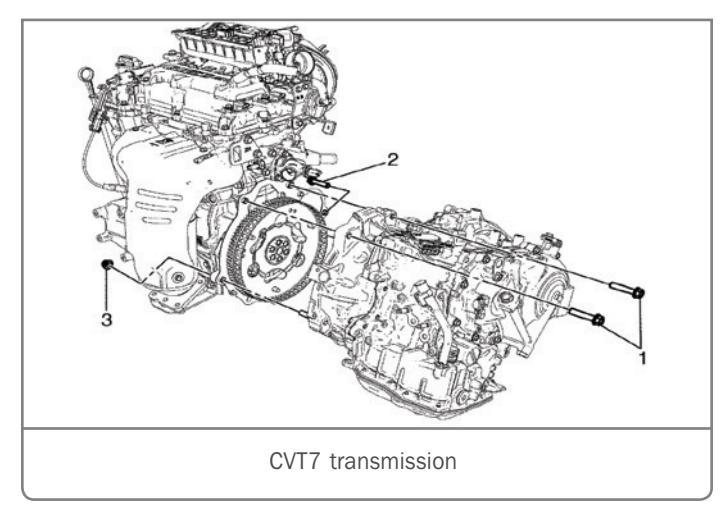
Several DTCs may set after replacing the CVT7 transmission (RPO M4M) in some 2014-2015 Spark models. The most common codes that may set are P0797 (Pressure Control Solenoid Valve 3 – Stuck On), P0841 (Transmission Fluid Pressure Sensor Performance), P0863 (TCM Communication Circuit), P0961 (Line Pressure Control Solenoid Valve Performance), P0965 (Pressure Control Solenoid Valve 2 System Performance) or P2714 (Pressure Control Solenoid Valve 4 – Stuck Off). Other DTCs also may set.

The DTCs may be the result of poor connection conditions. When removing the transmission connector from the transmission and temporarily relocating the wiring harness to allow removal of the transmission, the TCM X2 connector may crack and cause wiring and connection issues.

Follow the diagnostics in the Service Information for the DTCs that set after transmission replacement. If a resolution is not found, replace the TCM X2 connector and install new terminated leads. Do not replace the transmission for any DTCs setting right after the transmission has been replaced.

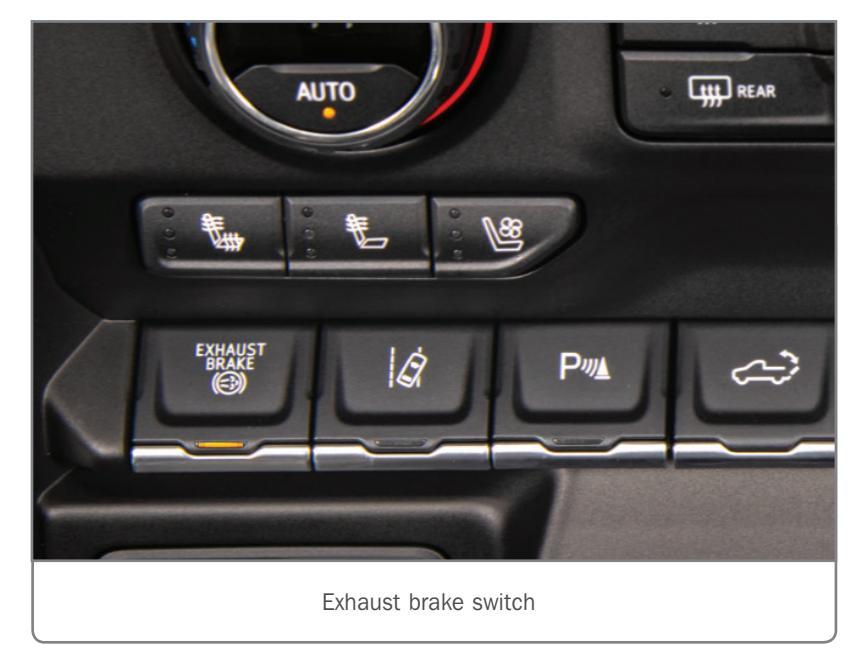
Prior to the 2020 model year, the movement of the turbocharger vanes was very rapid and the engagement of the exhaust brake could be felt by the driver. For 2020, the movement of the vanes is slower, which can give the feeling that the exhaust brake is not operating correctly.

As long as the Driver Information Center (DIC) message "Exhaust Brake On" is displayed and no DTCs are set, the vehicle is functioning properly.
