Techline App Enhancements

TECH LINK

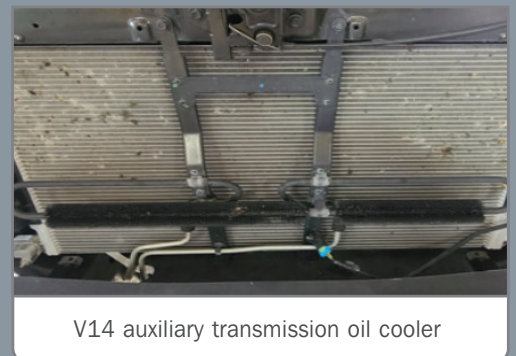
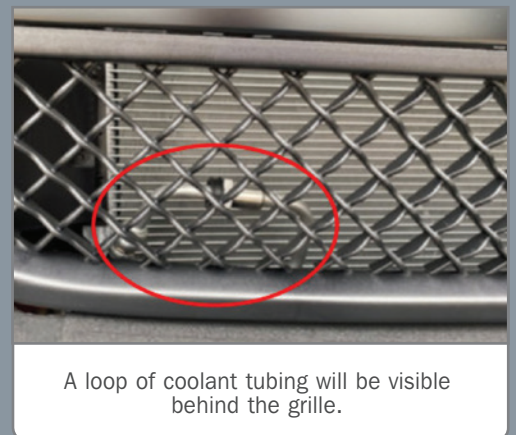
2021 Express and Savana models equipped with the 4.3L V6 engine (RPO LV1) or 6.6L V8 engine (RPO L8T) may have a build list that includes a V14 auxiliary transmission oil cooler, but the auxiliary cooler is not installed on the vehicle as it was on previous model years.

For the 2021 model year, engineering has validated that an external transmission oil cooler is not needed and new models will no longer have the auxiliary cooler installed. A loop of coolant tubing will be visible behind the grille. Vehicles without the auxiliary cooler are built correctly and no repairs are necessary.

Elimination of the auxiliary cooler does not affect transmission performance. All durability testing on the transmission was passed without the additional cooler.

2021 models without the auxiliary cooler should not have an external transmission oil cooler installed at the dealership or have a warranty claim submitted for the missing auxiliary cooler.

Refer to Bulletin #21-NA-021 for additional information.

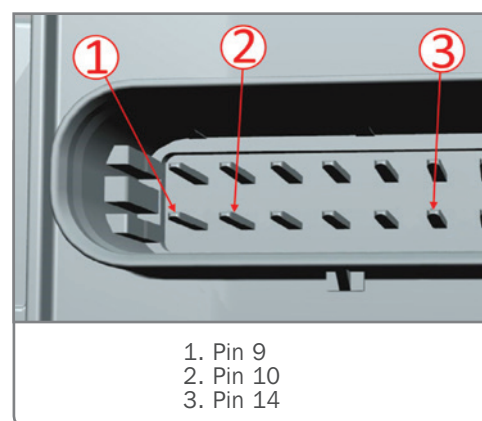
The faulty Emission Reduction Fluid Tank heater may be caused by the tank heating elements being exposed to Diesel Exhaust Fluid (DEF) and shorting to the pump ground. Within the Emission Reduction Fluid Tank is the Emission Reductant Fluid Supply Pump Module, which contains an electrically operating reductant pump; reductant level, quality, and temperature sensors; and reductant system heaters. The reductant control module is mounted outside the tank.

If either resistance reading is less than 10M ohm, the heater is faulty and the Emission Reduction Fluid Tank should be replaced. If both resistance readings are greater than 10M ohm, continue with diagnostics according to the appropriate Service Information.

For more information, refer to Bulletin #21-NA-002.
