TIPS FOR { Over-The-Air Software Programming

9T65 Transmission Replacement Pilot Program Update

Whining/Groaning Sounds Due to Front Intermediate Shaft Fretting 5

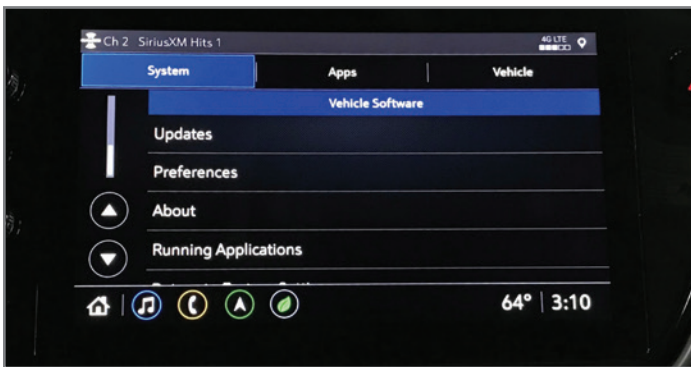
Updates can be installed through the Settings menu.

If the OTA update installation is deferred by the customer, it can be installed at a later date through the Vehicle Software menu under Settings > System on the infotainment screen.

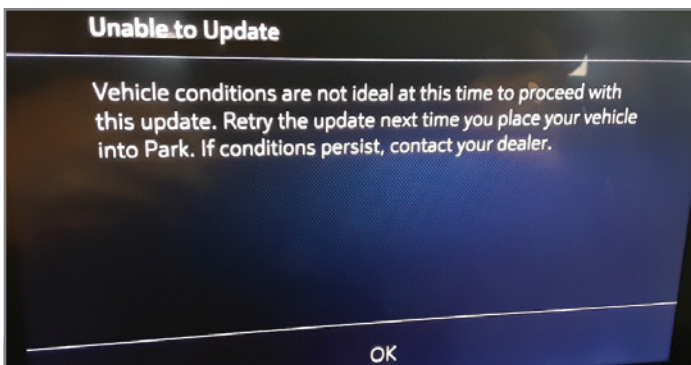
There are a number of criteria that must be met in order to successfully complete the software update installation on a vehicle. The most common cause of being unable to complete an installation is the State of Charge (SOC) of the 12V battery. If the 12V battery does not meet the minimum SOC requirement of 70 percent or greater along with an Outside Ambient Temperature (OAT) greater than 14°F (-10°C), the OTA update installation will not occur. The colder the ambient air temperature is, the higher the target SOC becomes. To determine the battery SOC for VIP

Several conditions will affect an OTA update installation.
