## PROGRAMMING WITH THE Vehicle Intelligence Platform

GM TechLink is published for all GM retail technicians and service consultants to provide timely information to help increase knowledge about GM products and improve the performance of the service department.

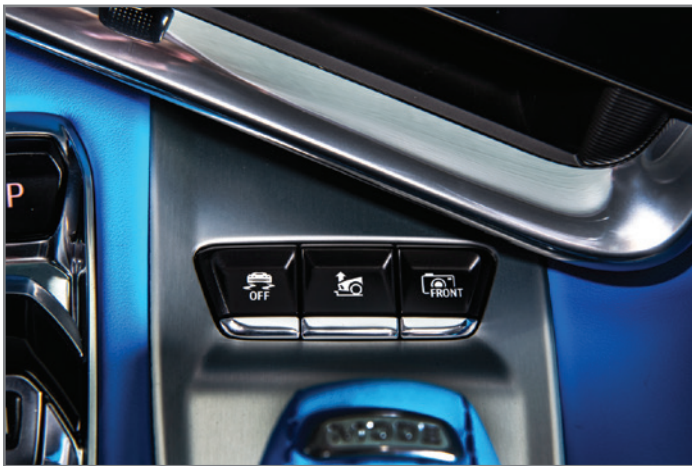
Some 2020-2021 Corvettes may display a Service Front Suspension Lift System message on the Driver Information Center (DIC). DTCs C103C (Left Front Strut Position Sensor Signal) and/or C103E sym64 (Right Front Strut Position Sensor Signal – Signal Plausibility Failure) also may be set.

If these conditions are present, check the mileage and service history on the vehicle. If the vehicle has low mileage or if previous service work on the front suspension lift system has been done, check for possible air entrapment in the system.

Attempt to operate the front lift system several times using the Lift/Lower Select Switch.

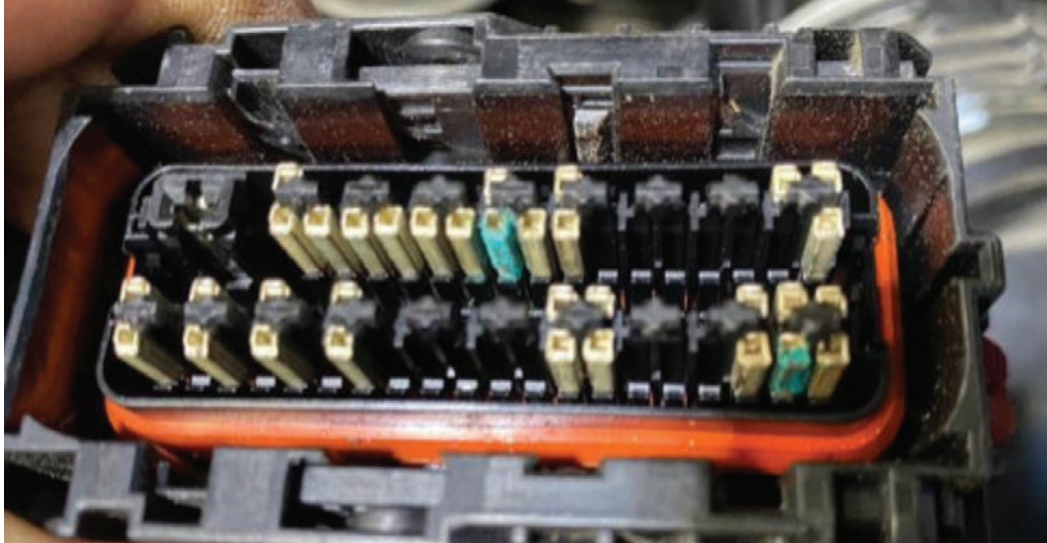
# Corroded Terminals in ECM CONNECTOR

2013-2019 ATS models equipped with the 2.0L 4-cylinder engine (RPO LTG) or 2.5L 4-cylinder engine (RPO LCV) may have a crank, no start condition with an intermittent Check Engine MIL illuminated. Some of the following DTCs may be set: P0014, P0013, P0017, P0192, P0236, P0237, P0335, P0336, P0340, P0341, P0365, P0366, P0420, P0452, P0641, P2123, P2138, P2227, P2228, and/or P2618.

Use a bright light to inspect all the terminals in all three connectors for green corrosion, coolant or oil. Inspect all terminals regardless which DTCs may have set. Every terminal must be inspected since circuits that are corroded or contaminated can back feed into other circuits that are not corroded and set DTCs for associated systems.

Any terminal that has signs of green corrosion should be replaced with terminated leads. Do not clean the terminals. The contact area is difficult to clean and will lead to poor connections and intermittent DTCs. Solder all terminated leads and cover with

If the ECM terminals inside the ECM socket are corroded, the ECM must be replaced.

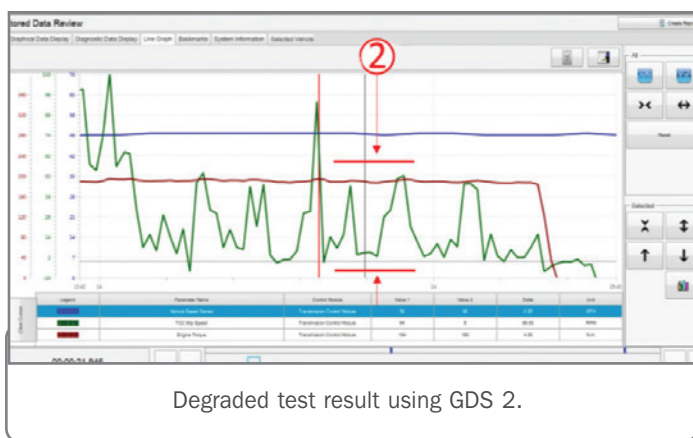
The TCC Slip Control Test using GDS 2 or the TCC Shudder/PicoScope Test should be followed to diagnose a TCC shudder condition. These diagnostic methods are covered in Bulletin #21-NA-047.

Evaluate the vehicle on a smooth road with transmission sump temperature at 122°F–158°F (50°C–70°C), engine speed between 1,100 rpm and 1,500 rpm, and engine torque between 150Nm and 250 Nm.

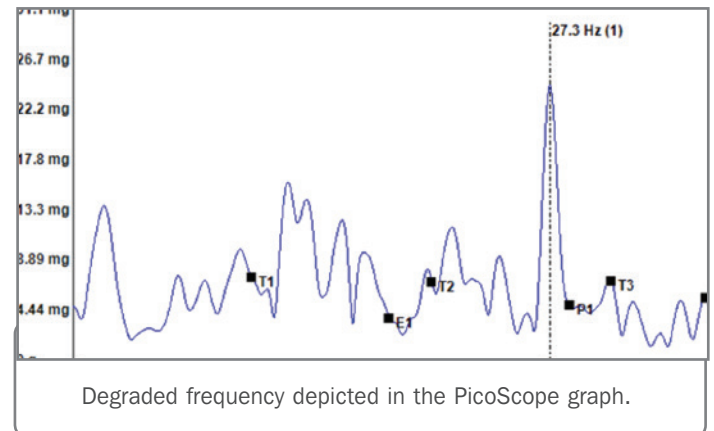
is present, a vibration peak (using the PicoScope) will appear. TCC shudder vibration frequency is stationary in 8th gear. If the vibration frequency follows vehicle speed or engine speed, then it is not TCC shudder.

If the test results show a vehicle has a degraded TCC RPM slip at steady throttle or TCC shudder frequency at slight tip-in, the appropriate fluid exchange procedure should be completed using the DT-52263 Transmission Fluid Exchange Kit and the DT-45096 TransFlow Cooler Flush Machine.
