## Let's Take a Look

# False Park Assist Alerts

# Testing Setup and Valid Test Codes

# Engine Overheating Message

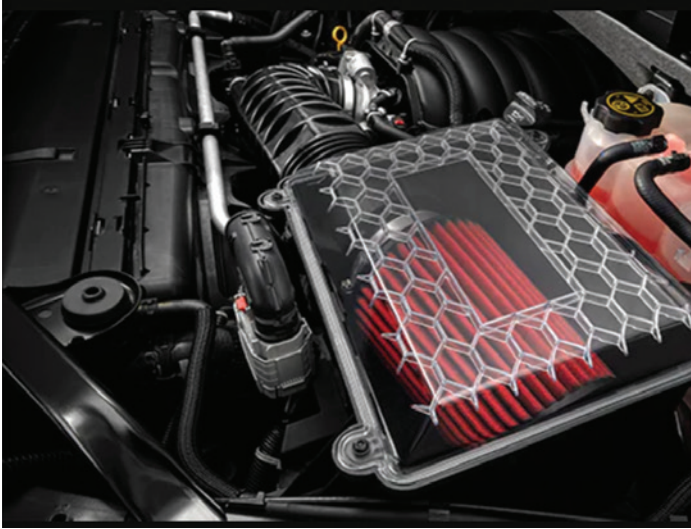
## Cold Air Intake System Requires Calibration

The Cold Air Intake System is a Limited Production Option (LPO) that can be ordered with the vehicle at the time of purchase. It is not to be installed or sold as an Accessory Catalog Offering (ACO), or over-the-counter accessory, as the calibration is not available for ACO applications. If installed on an incorrect vehicle, the Check Engine MIL may illuminate and DTCs P0172 (Fuel Trim System Rich) and P0175 (Fuel Trim System Rich Bank 2) may set.

The Chevrolet Performance, GMC and Cadillac Cold Air Intake System (RPO 5W7, RVK) available on 2021 Camaro, Silverado, Tahoe, Suburban, Sierra, Yukon and Escalade models equipped with the 5.3L V8 engine (RPO L84), 6.2L V8 engine (RPO L87) or 6.2L V8 engine (RPO LT1) should only be installed on vehicles that were ordered with the RPO/LPO (dealer installed) option. The Cold Air Intake System requires a calibration from the Techline Customer Support Center (TCSC), which is not available for vehicles without the proper RPO/LPO 5W7 or RVK option.
