GMC

Mid-September 2017, Volume 19, No. 18

# Using the TransFlow Transmission Oil Cooler Flush and Flow Test Tool

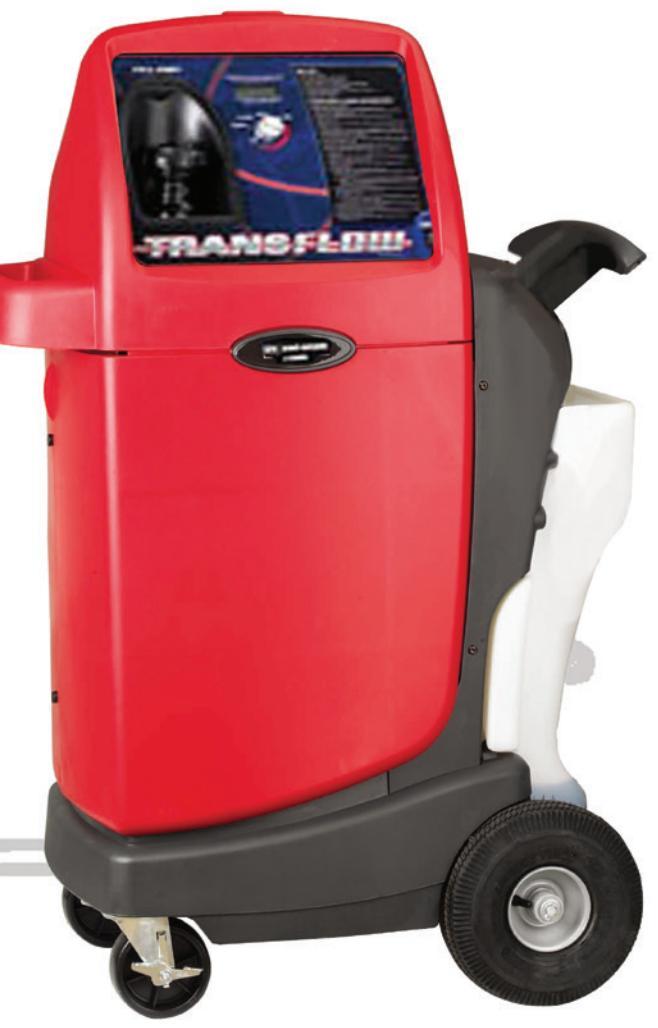
The DT-45096 TransFlow includes:

- 32 quart (30 liters) supply vessel
- 34 guart (32 liters) waste oil vessel
- Air pressure supply fitting
- · Digital flow rate indicator
- 12V DC power cable
- Black supply oil hose with guick connect fitting

- Clear waste oil hose with guick connect fitting

The DT-45096 (previously J-45096) TransFlow® transmission oil cooler flush and flow test tool can be used to flush and flow test the transmission oil cooler and the oil cooler pipes after the transmission has been removed for repairs. The TransFlow tool is designed to measure oil flow capability within the transmission oil cooler and performs a flow rate test meeting GM flow rate specifications. It is a self-contained unit using a 12-volt flow meter, shop air supply and DEXRON VI automatic transmission fluid (ATF).

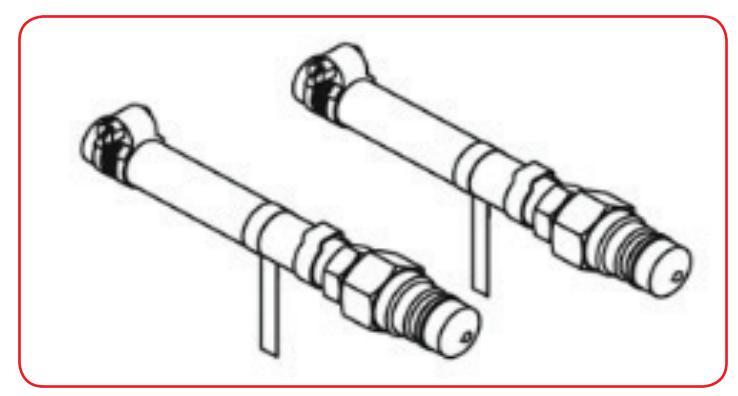
The TransFlow equipment is connected to the vehicle's transmission oil cooler lines using the current cooler line adapters. Two adapters are included with the TransFlow. Five other adapters also are available. The most commonly used adapters are the DT-45096-30

(for 6-speed, 8-speed and 10-speed longitudinally-mounted transmissions) and DT-45096-50 (for 6-speed and 9-speed transverse-mounted transmissions).

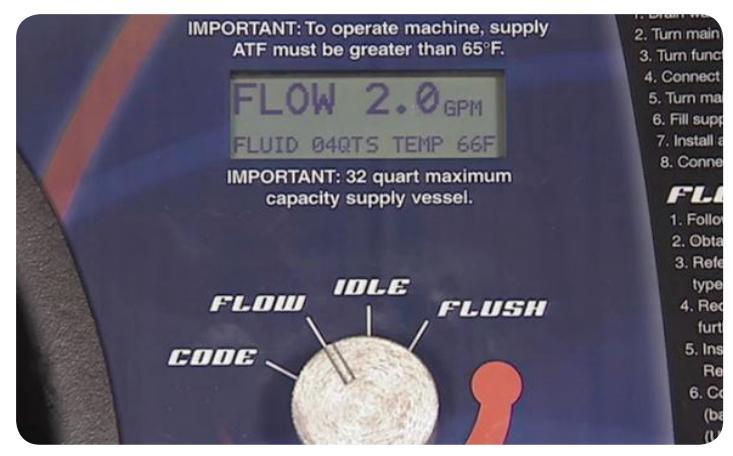
Published flow rates are based on the tool calibrated at 2.0 GPM.

The published flow rates are based on the tool calibrated at 2.0 GPM (7.6L/minute) using ATF at 65° F (18° C) with 90 psi of air pressure. Dealership tools should be calibrated using the same specifications. If the tool is set up with higher temperature ATF, then artificially high flow rates could be seen. Remember, the tool is only measuring minimum flow rates. Fluid warmer than room temperature may result in higher self-test readings.

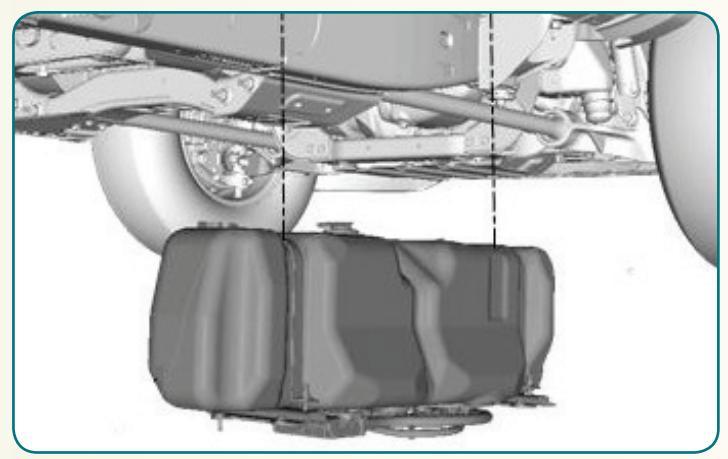
Ensure the Reduction Fluid tank isn't frozen before diagnosis.

- Using a scan tool, check the reductant concentration in the reductant system data.
- The reductant concentration temperature reading may be inaccurate if the reductant is frozen or contains ice crystals. If the reductant temperature is below 25 degrees F (-4 degrees C), warm the fluid in the tank by parking the truck in a warm environment until the DEF tank temperature is warmer than 25 degrees F (-4 degrees C).
- If the concentration is not between 28.8% and 36.2%, replace the DEF and continue with the following steps.

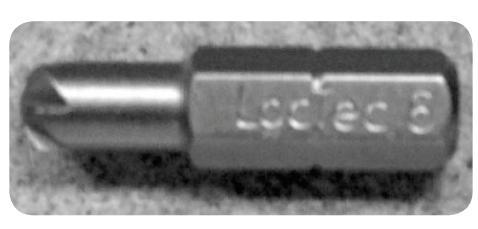
Current EN-50956 bit

The GR-6 bits in the Tamper-Proof Drive Bit Set (EN-50956-A) will install a fastener only, making it ARB compliant. The set includes three tamper-proof bits, and replaces the single bit (EN-50956) previously released.

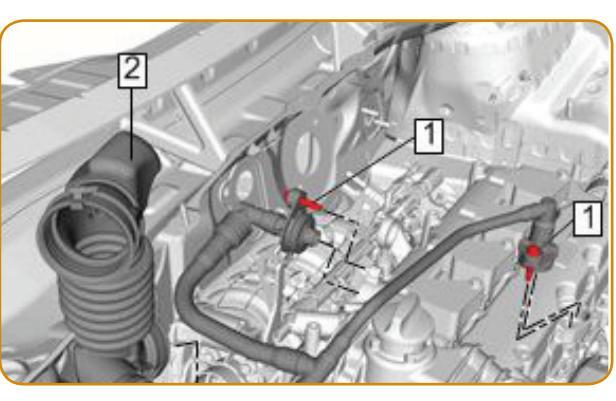
Tamper-resistant PCV bolts on the air cleaner outlet duct

using a suitable tool to cut a

slot in the tamper-resistant

PCV bolt heads (1) and re-

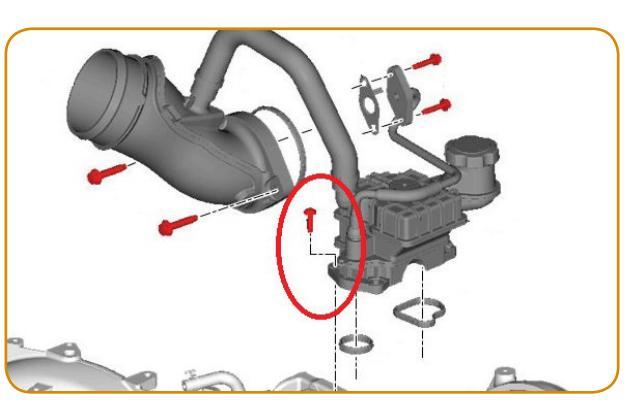
Tamper-resistant bolt on the PCV oil separator
